# Geotechnical Report

The Kaikoura Trustee Company  
1516 State Highway 1, Mangamaunu

October 2021

Our Ref: 7945

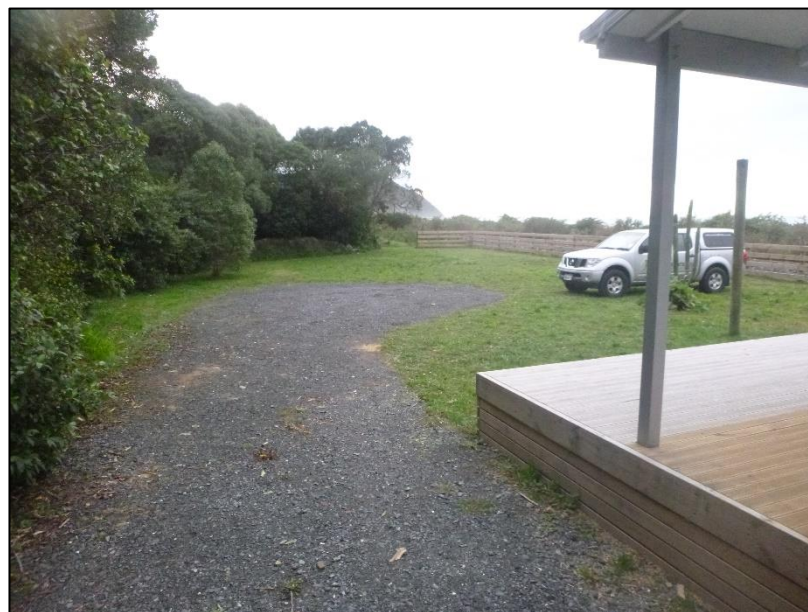
Figure 1: Photograph looking north-east towards the new allotment, with tree and fence line forming the approximate boundary.

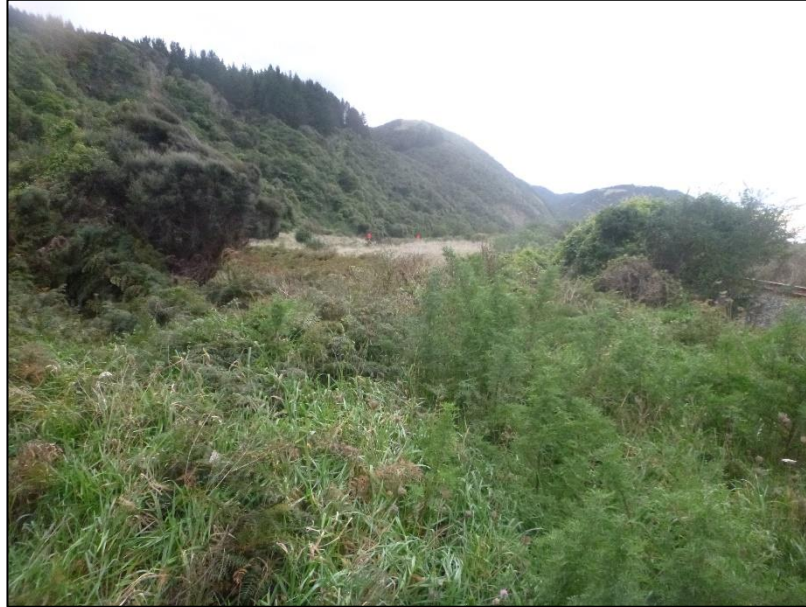
Figure 2: Photograph looking north across the proposed new allotment with proposed new build site in foreground.

The potential building site for the new allotment is located immediately northwards of the proposed new boundary (see Appendix A). A photograph of the potentially developable area is shown in Figure 2 above.

On the basis of the foregoing, it is considered that the proposed building site is suitable for the proposed residential development and for construction on conventional foundations designed and constructed in accordance with NZS 3604:2011 at a minimum depth of 200 - 1150mm below ground level. Alternatively, foundation systems can be engineer designed with reference to the attached test results.

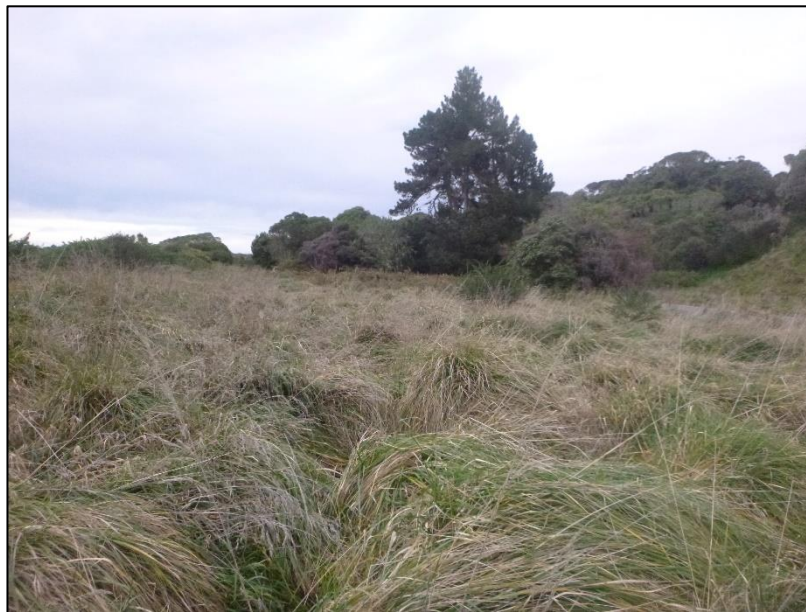
Figure 3: Photograph looking south across the proposed new allotment.

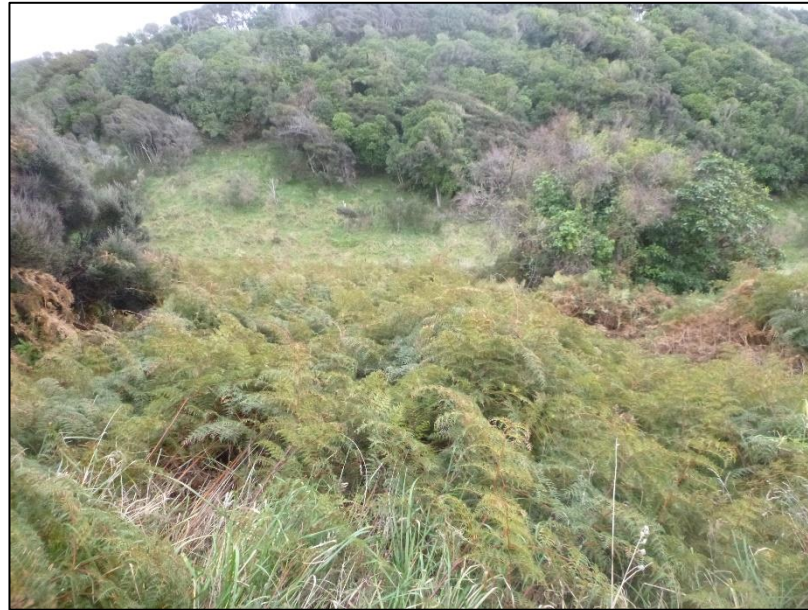
Figure 4: Photograph looking north-west towards the proposed access of the new allotment.

New access is proposed along the western boundary, at the boundary between the proposed allotments. Access to the proposed building platform on the new allotment is currently provided via the existing driveway. It is recommended that all topsoil material (approximately 300mm) be excavated from the proposed new access footprint and replaced with suitably compacted A65 material, or equivalent, to create a surface for vehicles to pass over.

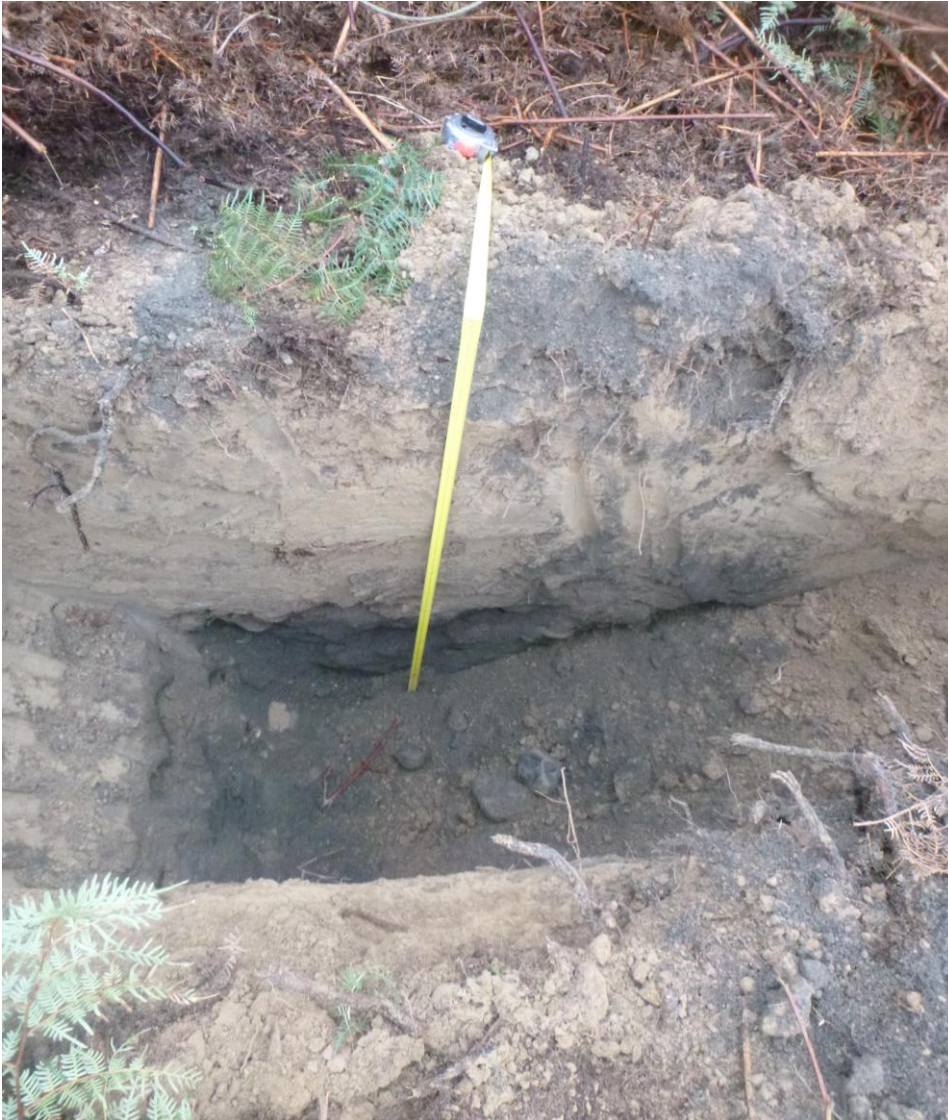
**Date:** 15-Jul-21  
**Logged by:** TH  
**Project No:** 7945  
**Site No:** TP1

- Notes:**
1. Weather Overcast.
  2. Minor collapse of sidewall of horizon C.
  3. No Groundwater Encountered.

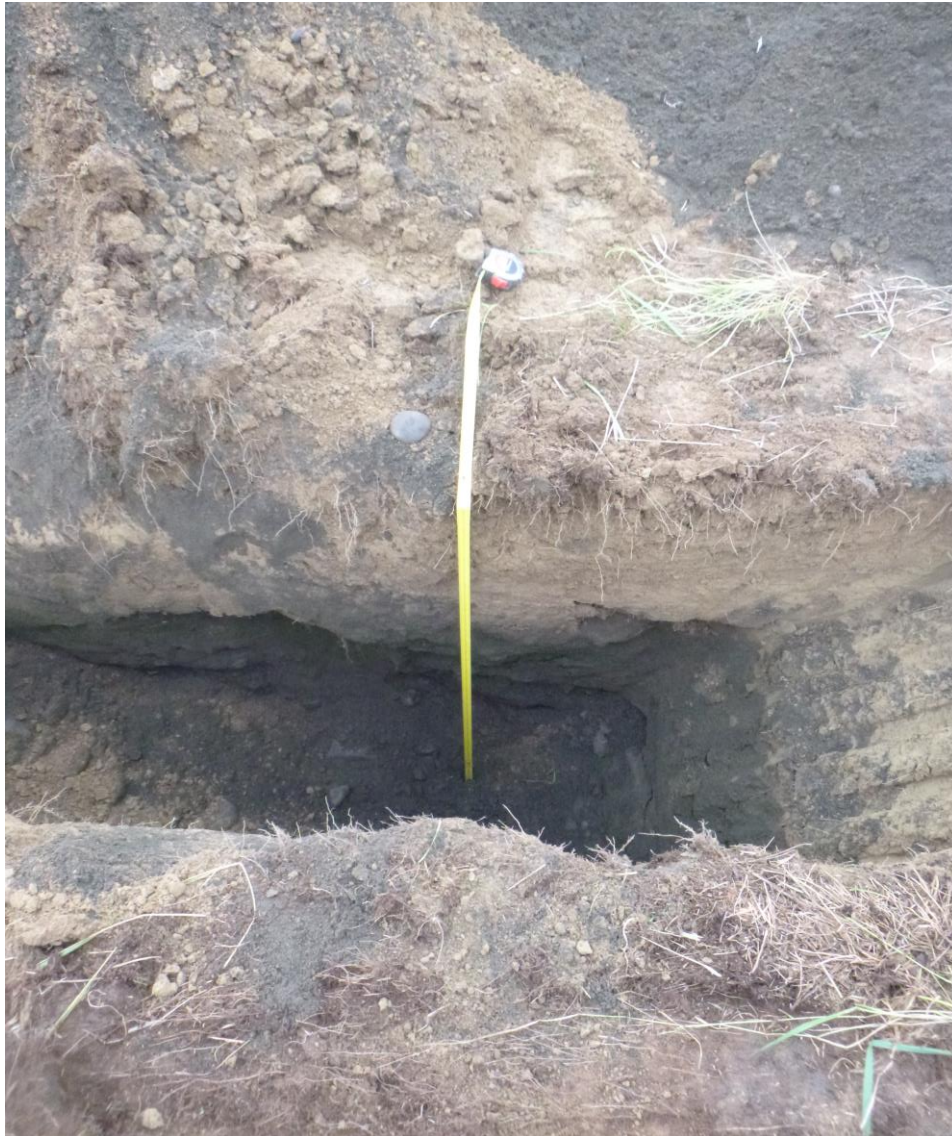
**Date:** 15-Jul-21  
**Logged by:** TH  
**Project No:** 7945  
**Site No:** TP2

- Notes:**
1. Weather Overcast.
  2. Minor collapse of sidewall in horizon D.
  3. No Groundwater Encountered.

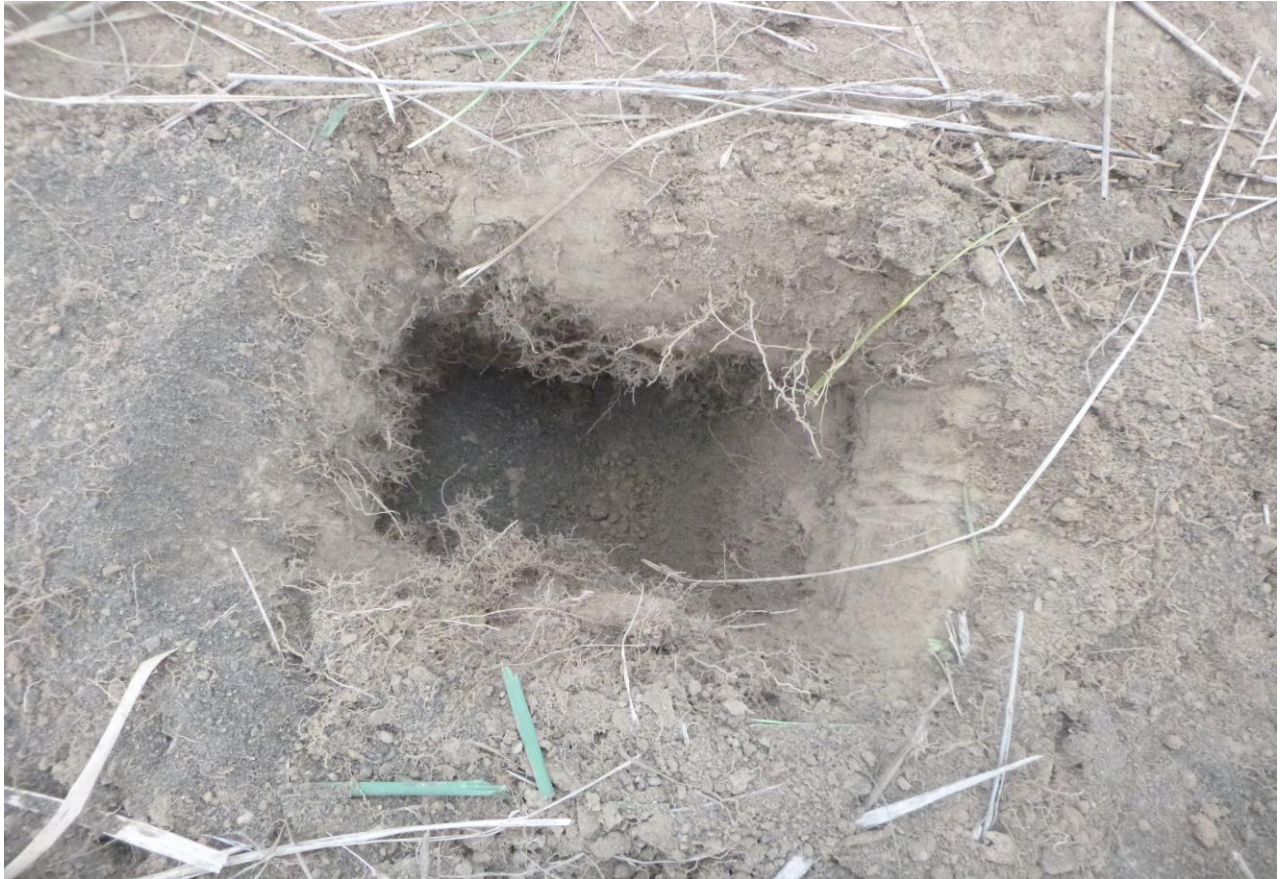
**Date:** 15-Jul-21  
**Logged by:** TH  
**Project No:** 7945  
**Site No:** TP3

- Notes:**
1. Weather overcast.
  2. No groundwater encountered.
