20 December 2018

Reference No. 1773474_7407-001-LR-Rev0-1023_0004

2016 Kaikoura Earthquake Recovery Manager

2021 SH1, RAKAUTARA – DANGEROUS BUILDING RISK ASSESSMENT

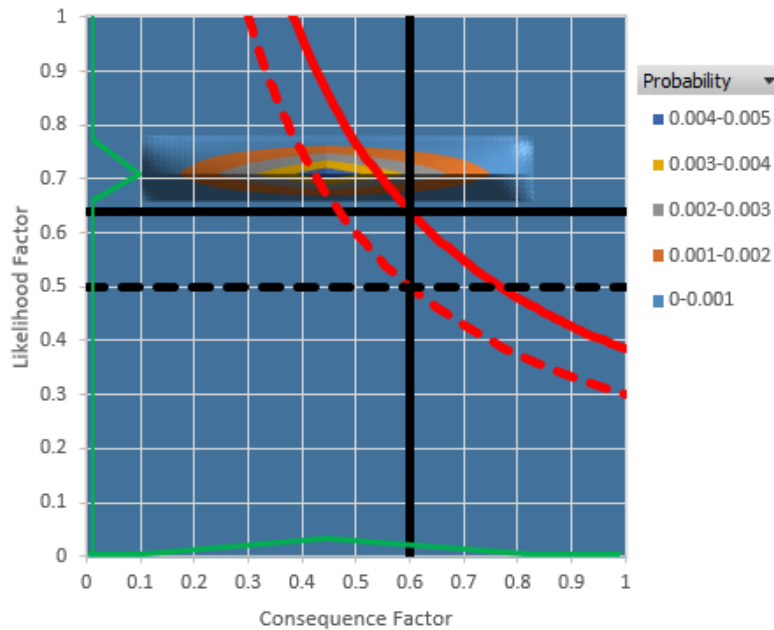
Our estimated likelihood of slope instability impacting on the dwelling could be as low as 1/50 or as high as 1/10, with a most likely probability of 1/20.

The consequences of slope instability impacting on the dwelling could range from noticeable but no property damage (0.11) to significant damage with potential for injuries or a fatality (0.83). We think the most likely consequence of slope instability (rockfall hitting the dwelling) is limited damage but no injuries or fatalities (0.45).

By combining the estimates of likelihood and consequence presented in Section 4.0, we calculated a risk distribution that can be compared to the dangerous building criteria (presented in Section 3.0) as illustrated in Figure 1. Based on this assessment we calculate there is an 20 % probability that the slope instability risk exceeds the dangerous building criteria for 2021 SH1.

Figure 1: Criteria and assessment for dangerous building assessment. Likelihood and consequence factors are defined in Attachment B. Criteria are shown as black and red lines. The assessed range of likelihood- and consequence- factors are shown as green lines on the left and bottom axes, the combined probability of the assessed likelihood and consequence is shown as probability by colour bands.

Given the layout of the dwelling on this property relative to the toe of the slope, we believe that mitigation of the rockfall hazard could be effective and reduce the level of risk for occupants. In this case, the dwelling could be moved sufficiently far from the toe of the slope to be outside the area identified in Golder 2017a as the 'rockfall hazard zone'. In addition, there is sufficient space between the building and the toe of the slope to create a rockfall catch structure to mitigate the rockfall hazard. It is our opinion that if such measures are implemented, the slope instability risk to occupants of the dwelling could be reduced.
