20 December 2018

Reference No. 1773474\_7407-001-LR-Rev0-1023\_0008

**2016 Kaikoura Earthquake Recovery Manager**

**2029 SH1, KAIKOURA – DANGEROUS BUILDING RISK ASSESSMENT**

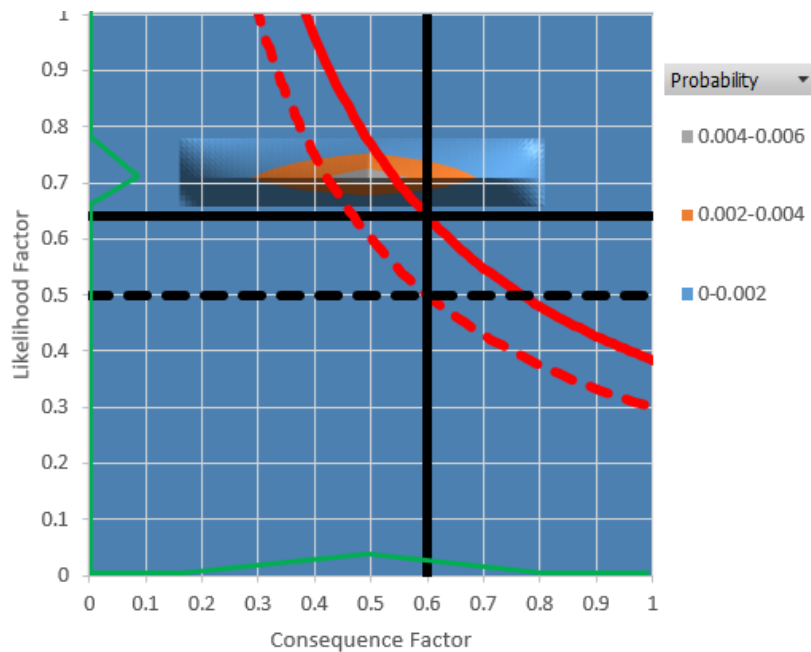
Our estimated likelihood of slope instability impacting on the dwelling could be as low as 1/50 or as high as 1/10, with a most likely probability of 1/20.

The consequences of slope instability impacting on the dwelling could range from noticeable but no property damage (0.17) to significant damage with potential for injuries or a fatality (0.81). We think the most likely consequence of slope instability (rockfall hitting the dwelling) is limited damage but no injuries or fatalities (0.45).

By combining the estimates of likelihood and consequence presented in Section 4.0, we calculated a risk distribution that can be compared to the dangerous building criteria (presented in Section 3.0) as illustrated in Figure 1. Based on this assessment we calculate there is a 23 % probability that the slope instability risk exceeds the dangerous building criteria for 2029 SH1.

**Figure 1: Criteria and assessment for dangerous building assessment. Likelihood and consequence factors are defined in Attachment B. Criteria are shown as black and red lines. The assessed range of likelihood- and consequence- factors are shown as green lines on the left and bottom axes, the combined probability of the assessed likelihood and consequence is shown as probability by colour bands.**

Given the layout of the dwelling on this property relative to the toe of the slope, we believe that mitigation of the rockfall hazard could be effective and result in a reduced level of risk for occupants. In this case, the dwelling could be moved sufficiently far from the toe of the slope to be outside the area identified in Golder 2017a as the 'rockfall hazard zone'. In addition, there is sufficient space between the building and the toe of the slope to create a rockfall catch structure to mitigate the rockfall hazard. It is our opinion that if such measures are implemented, the slope instability risk to occupants of the dwelling could be reduced.
