20 December 2018

Reference No. 1773474_7407-001-LR-Rev0-1023_0009

270-277 ESPLANADE, KAIKOURA – DANGEROUS BUILDING RISK ASSESSMENT

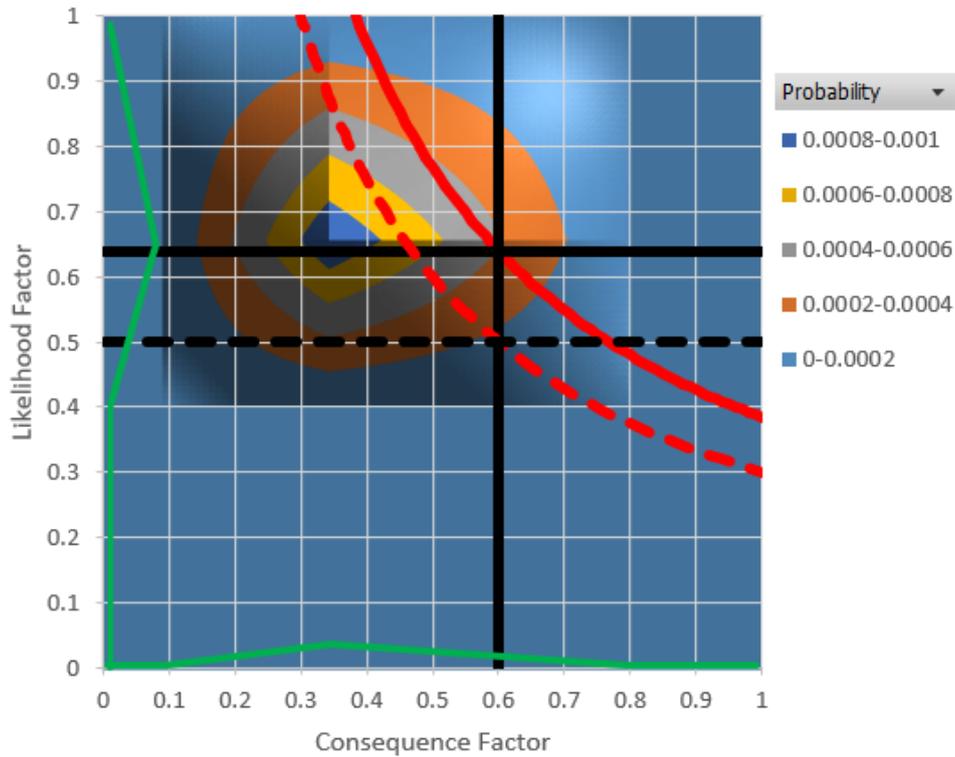
The heavy black vertical line on Figure 1 represents the boundary between where the consequence exceeds a minor injury and where hospitalisation may be required. Therefore, the area to the right of that line can be considered to exceed the consequence criteria.

- The two heavy black horizontal lines represent annual probabilities of 1/475 (dashed line) and 1/73 (solid line) likelihood criteria. The area of the graph above each of these criteria can be considered to exceed each likelihood criteria.
- The dashed and solid red lines are lines of constant slope instability risk derived using the intersection of the two likelihood acceptance criteria and the consequence acceptance criterion.

This assessment is shown on Figure 1 as the coloured map that presents the combined probability distribution of the estimated consequence and likelihood.

- The horizontal axis labelled at the bottom represents the consequences and a green line graph inside that axis shows the assessed distribution of consequence described above.
- The vertical axis labelled on the left represents the likelihood and a green line graph inside that axis shows the assessed distribution of likelihood described above.
- The slope instability risk distribution is defined as the likelihood multiplied by the consequence so at each point in the field presented in Figure 1 the probability is shown as a colour. The risk probability is calculated in a 100x100 bin matrix.

By combining the estimates of likelihood and consequence presented in Section 4.0, we calculated a risk distribution that can be compared to the dangerous building criteria (presented in Section 3.0) as illustrated in Figure 1. Based on this assessment we calculate there is a 11 % to 13 % probability that the slope instability risk exceeds the dangerous building criteria for 270-277 Esplanade. There is an 87 % probability that the slope instability risk will not exceed the dangerous building criteria for 270-277 Esplanade

Figure 1: Criteria and assessment for dangerous building assessment. Likelihood and consequence factors are defined in Attachment B. Criteria are shown as black and red lines. The assessed range of likelihood- and consequence- factors are shown as green lines on the left and bottom axes, the combined probability of the assessed likelihood and consequence is shown as probability by colour bands.

Given the above discussion, we do not believe any mitigation of slope instability hazard is needed at this site. However, maintenance of the existing rockfall protection measures implemented at the site will help to keep the rockfall risk as low as practicable. Mitigation of the rockslide hazard or cliff collapse at this site is not likely to be practicable.
