20 December 2018

Reference No. 1773474_7407-001-LR-Rev0-1023_0002

93 WAITANE ROAD, OARO – DANGEROUS BUILDING RISK ASSESSMENT

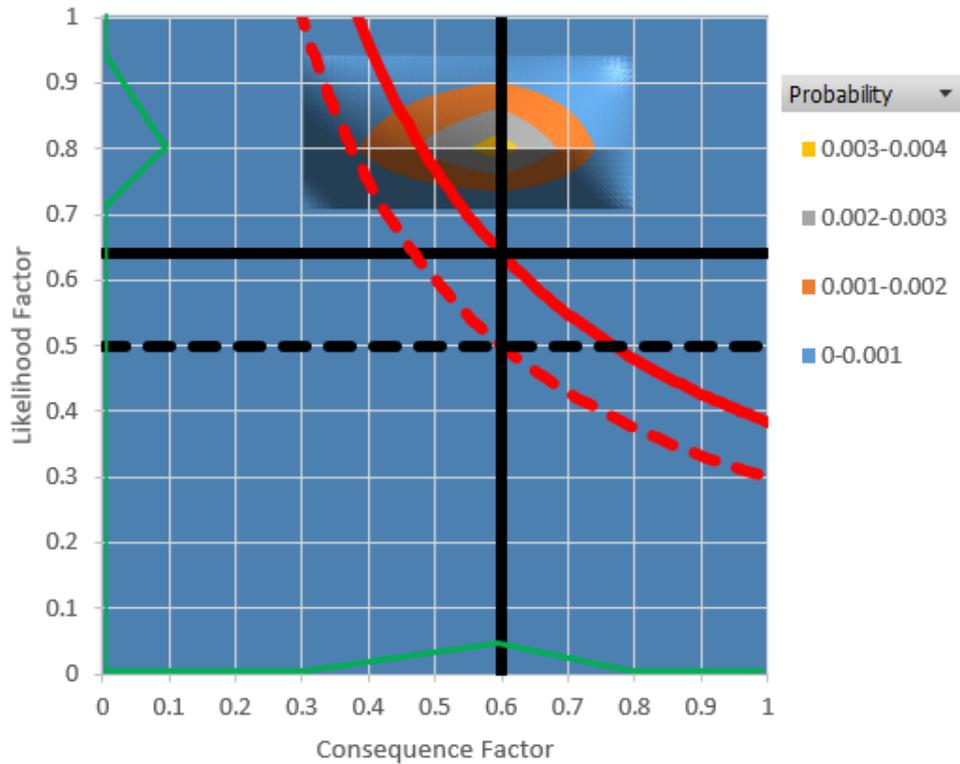
Our estimated likelihood of slope instability impacting on the buildings on the properties could be as low as 1/20 per year or as high as 1/2 per year with a most likely probability of 1/5 per year.

The consequences of very minor rockfall affecting the dwelling could be limited property damage (0.31). A large debris slide affecting the dwelling could result in significant damage and possible fatalities (0.8). We think the most likely consequence of slope instability hitting the dwelling is significant damage with injuries possible but without death occurring (0.6).

By combining the estimates of likelihood and consequence presented in Section 4.0, we calculated a risk distribution that can be compared to the dangerous building criteria (presented in Section 3.0) as illustrated in Figure 1. Based on this assessment we calculate there is a 43 % probability that the slope instability risk exceeds the dangerous building criteria for 93 Waitane Road.

Figure 1: Criteria and assessment for dangerous building assessment. Likelihood and consequence factors are defined in Attachment B. Criteria are shown as black and red lines. The assessed range of likelihood- and consequence- factors are shown as green lines on the left and bottom axes, the combined probability of the assessed likelihood and consequence is shown as probability by colour bands.

Given the layout of the property with the dwelling located on a narrow strip of land between the toe of the slope and the railway lines, we believe that mitigation of the slope instability hazard would be difficult to significantly reduce the risk for occupants. We believe that moving the dwelling to an alternative site is the most effective way to mitigate the hazard.
