20 December 2018

Reference No. 1773474_7407-001-LR-Rev0-1023_0005

2023 SH1, RAKAUTARA – DANGEROUS BUILDING RISK ASSESSMENT

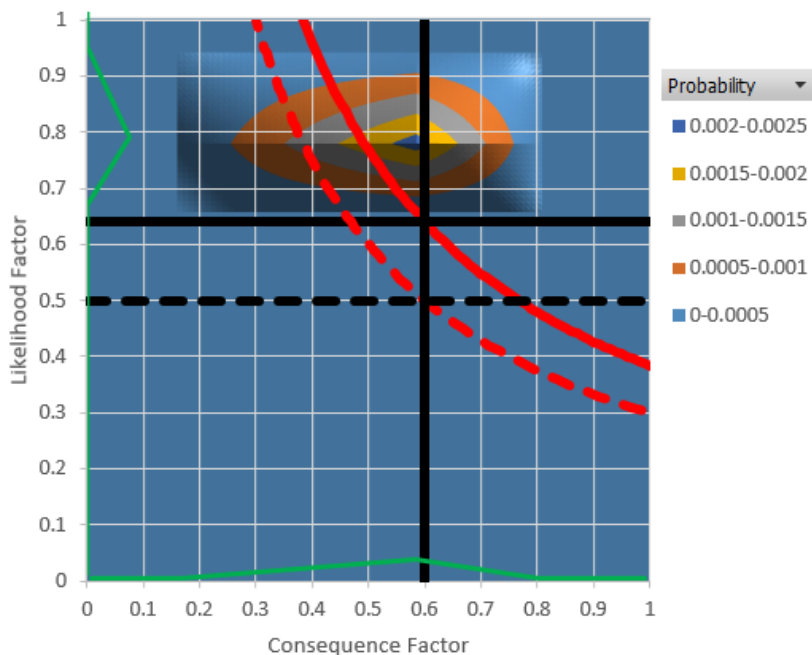
The heavy black vertical line on Figure 1 represents the boundary between where the consequence exceeds a minor injury and where hospitalisation may be required. Therefore, the area to the right of that line can be considered to exceed the consequence criteria.

- The two heavy black horizontal lines represent annual probabilities of 1/475 (dashed line) and 1/73 (solid line) likelihood criteria. The area of the graph above each of these criteria can be considered to exceed each likelihood criteria.
- The dashed and solid red lines are lines of constant slope instability risk derived using the intersection of the two likelihood acceptance criteria and the consequence acceptance criterion.

This assessment is shown on Figure 1 as the coloured map that presents the combined probability distribution of the estimated consequence and likelihood.

By combining the estimates of likelihood and consequence presented in Section 4.0, we calculated a risk distribution that can be compared to the dangerous building criteria (presented in Section 3.0) as illustrated in Figure 1. Based on this assessment we calculate there is a 33 % probability that the slope instability risk exceeds the dangerous building criteria for 2023 SH1.

Figure 1: Criteria and assessment for dangerous building assessment. Likelihood and consequence factors are defined in Attachment B. Criteria are shown as black and red lines. The assessed range of likelihood- and consequence- factors are shown as green lines on the left and bottom axes, the combined probability of the assessed likelihood and consequence is shown as probability by colour bands.
