20 December 2018

Reference No. 1773474_7407-001-LR-Rev0-1025_0006

2025 SH1, RAKAUTARA – DANGEROUS BUILDING RISK ASSESSMENT

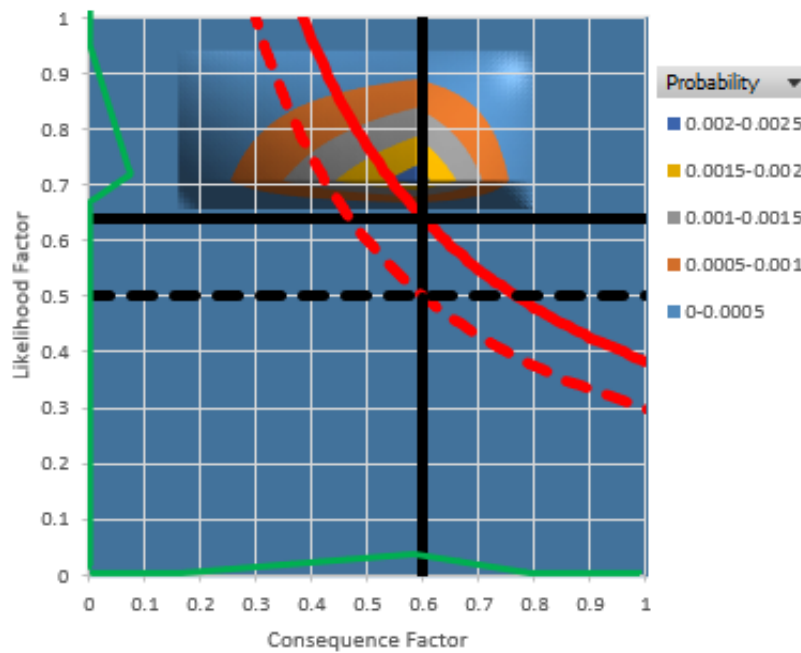
The heavy black vertical line on Figure 1 represents the boundary between where the consequence exceeds a minor injury and where hospitalisation may be required. Therefore, the area to the right of that line can be considered to exceed the consequence criteria.

- The two heavy black horizontal lines represent annual probabilities of 1/475 (dashed line) and 1/73 (solid line) likelihood criteria. The area of the graph above each of these criteria can be considered to exceed each likelihood criteria.
- The dashed and solid red lines are lines of constant slope instability risk derived using the intersection of the two likelihood acceptance criteria and the consequence acceptance criterion.

- The horizontal axis labelled at the bottom represents the consequences and a green line graph inside that axis shows the assessed distribution of consequence described above.
- The vertical axis labelled on the left represents the likelihood and a green line graph inside that axis shows the assessed distribution of consequences described above.
- The slope instability risk distribution is defined as the likelihood multiplied by the consequence so at each point in the field presented in Figure 1 the probability is shown as a colour. The risk probability is calculated in a 100x100 bin matrix.

By combining the estimates of likelihood and consequence presented in Section 4.0, we calculated a risk distribution that can be compared to the dangerous building criteria (presented in Section 3.0) as illustrated in Figure 1. Based on this assessment we calculate there is a 32 % probability that the slope instability risk exceeds the dangerous building criteria for 2023 SH1.

Figure 1: Criteria and assessment for dangerous building assessment. Likelihood and consequence factors are defined in Attachment B. Criteria are shown as black and red lines. The assessed range of likelihood- and consequence- factors are shown as green lines on the left and bottom axes, the combined probability of the assessed likelihood and consequence is shown as probability by colour bands.

Given the layout of the dwelling on this property relative to the toe of the slope, we believe that mitigation of the rockfall hazard could be effective and reduce the level of risk. In this case, the dwelling could be moved sufficiently far from the toe of the slope to be outside the area identified in Golder 2017a as the 'rockfall hazard zone'. In addition, there is sufficient space between the building and the toe of the slope to create a rockfall catch structure to mitigate the rockfall hazard. It is our opinion that if such measures are implemented, the slope instability risk to occupants of the dwelling could be reduced.
