20 December 2018

Reference No. 1773474_7407-001-LR-Rev0-1023_0007

2016 Kaikoura Earthquake Recovery Manager

2027 SH1, RAKAUTARA – DANGEROUS BUILDING RISK ASSESSMENT

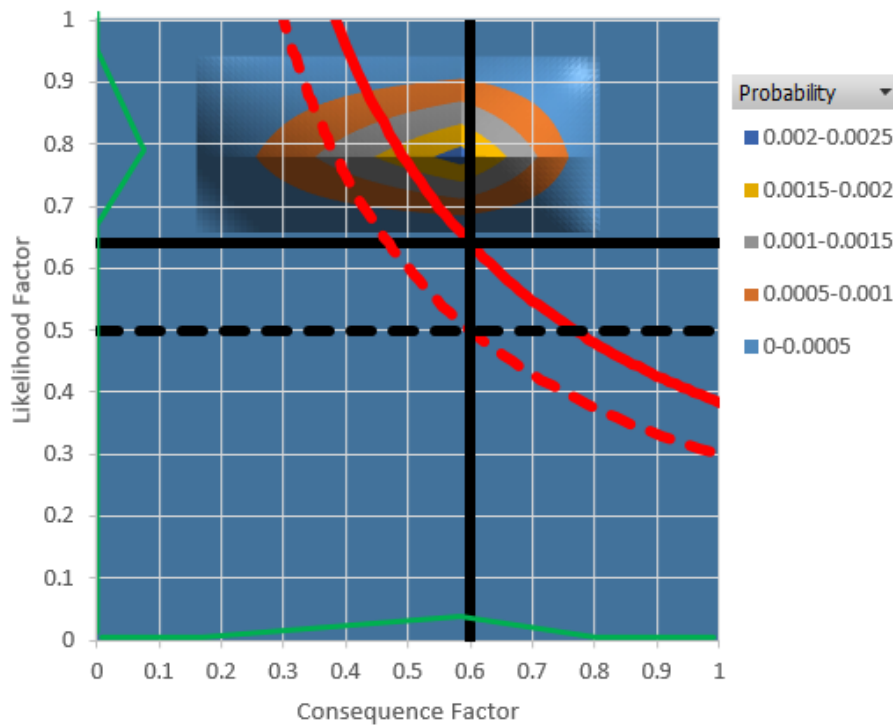
The heavy black vertical line on Figure 1 represents the boundary between where the consequence exceeds a minor injury and where hospitalisation may be required. Therefore, the area to the right of that line can be considered to exceed the consequence criteria.

- The two heavy black horizontal lines represent annual probabilities of 1/475 (dashed line) and 1/73 (solid line) likelihood criteria. The area of the graph above each of these criteria can be considered to exceed each likelihood criteria.

- The dashed and solid red lines are lines of constant slope instability risk derived using the intersection of the two likelihood acceptance criteria and the consequence acceptance criterion.

This assessment is shown on Figure 1 as the coloured map that presents the combined probability distribution of the estimated consequence and likelihood.

By combining the estimates of likelihood and consequence presented in Section 4.0, we calculated a risk distribution that can be compared to the dangerous building criteria (presented in Section 3.0) as illustrated in Figure 1. Based on this assessment we calculate there is a 33 % probability that the slope instability risk exceeds the dangerous building criteria for 2027 SH1.

Figure 1: Criteria and assessment for dangerous building assessment. Likelihood and consequence factors are defined in Attachment B. Criteria are shown as black and red lines. The assessed range of likelihood- and consequence- factors are shown as green lines on the left and bottom axes, the combined probability of the assessed likelihood and consequence is shown as probability by colour bands.
