20 December 2018

Reference No. 1773474_7407-001-LR-Rev0-1023_0001

2016 Kaikoura Earthquake Recovery Manager

335 EAST LANE, KEKERENGU – DANGEROUS BUILDING RISK ASSESSMENT

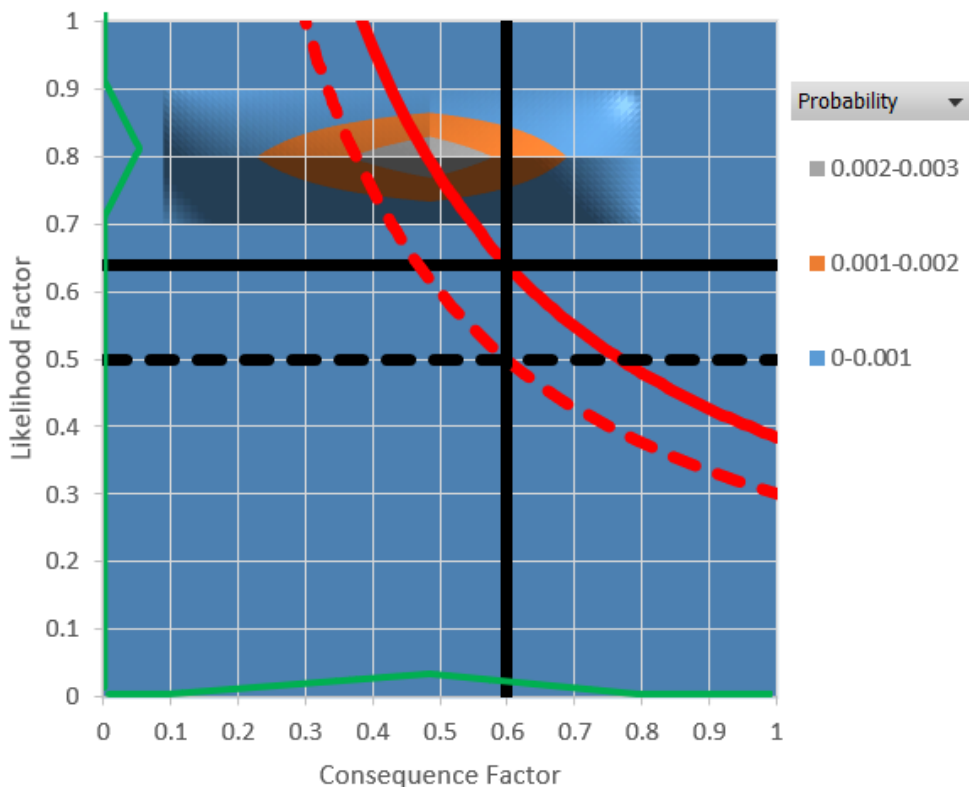
The heavy black vertical line on Figure 1 represents the boundary between where the consequence exceeds a minor injury and where hospitalisation may be required. Therefore, the area to the right of that line can be considered to exceed the consequence criteria.

- The two heavy black horizontal lines represent annual probabilities of 1/475 (dashed line) and 1/73 (solid line) likelihood criteria. The area of the graph above each of these criteria can be considered to exceed each likelihood criteria.
- The dashed and solid red lines are lines of constant slope instability risk derived using the intersection of the two likelihood acceptance criteria and the consequence acceptance criterion.

This assessment is shown on Figure 1 as the coloured map that presents the combined probability distribution of the estimated consequence and likelihood.

- The horizontal axis labelled at the bottom represents the consequences and a green line graph inside that axis shows the assessed distribution of consequence described above.
- The vertical axis labelled on the left represents the likelihood and a green line graph inside that axis shows the assessed distribution of likelihood described above.
- The slope instability risk distribution is defined as the likelihood multiplied by the consequence so at each point in the field presented in Figure 1 the probability is shown as a colour. The risk probability is calculated in a 100x100 bin matrix.

By combining the estimates of likelihood and consequence presented in Section 4.0, we calculated a risk distribution that can be compared to the dangerous building criteria (presented in Section 3.0) as illustrated in Figure 1. Based on this assessment we calculate there is a 19 % probability that the slope instability risk exceeds the dangerous building criteria for 335 East Lane, Kaikoura.

Figure 1: Criteria and assessment for dangerous building assessment. Likelihood and consequence factors are defined in Attachment B. Criteria are shown as black and red lines. The assessed range of likelihood- and consequence- factors are shown as green lines on the left and bottom axes, the combined probability of the assessed likelihood and consequence is shown as probability by colour bands.

Given the layout of the dwelling on the existing building platform and the evidence for earthquake induced landslide deformation, we believe that effective mitigation of the slope instability hazard could be difficult. We believe it is likely that a suitable building platform could be identified on the property where the effects of slope instability are reduced.
