20 December 2018

Reference No. 1773474_7407-001-LR-Rev0-1023_0003

2016 Kaikoura Earthquake Recovery Manager

1800, 1802 SH1, BOAT HARBOUR, KAIKOURA – DANGEROUS BUILDING RISK ASSESSMENT

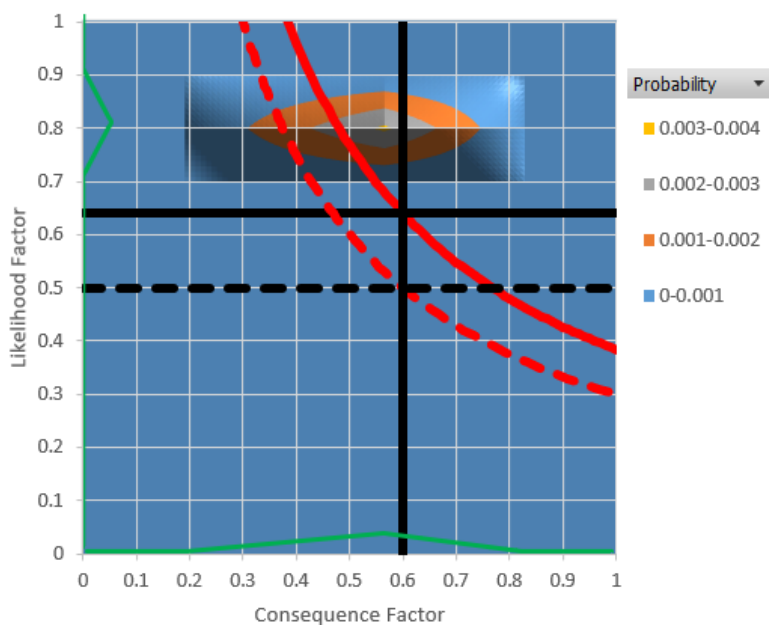
The heavy black vertical line on Figure 1 represents the boundary between where the consequence exceeds a minor injury and where hospitalisation may be required. Therefore, the area to the right of that line can be considered to exceed the consequence criteria.

- The two heavy black horizontal lines represent annual probabilities of 1/475 (dashed line) and 1/73 (solid line) likelihood criteria. The area of the graph above each of these criteria can be considered to exceed each likelihood criteria.
- The dashed and solid red lines are lines of constant slope instability risk derived using the intersection of the two likelihood acceptance criteria and the consequence acceptance criterion.

This assessment is shown on Figure 1 as the coloured map that presents the combined probability distribution of the estimated consequence and likelihood.

Figure 1. Based on this assessment we calculate there is a 34 % probability that the slope instability risk exceeds the dangerous building criteria for 1800 and 1802 SH1.

Figure 1: Criteria and assessment for dangerous building assessment. Likelihood and consequence factors are defined in Attachment B. Criteria are shown as black and red lines. The assessed range of likelihood- and consequence- factors are shown as green lines on the left and bottom axes, the combined probability of the assessed likelihood and consequence is shown as probability by colour bands.
