69 Inland Kaikoura Road, Proposed Lot 14. Site Validation Report

Kaikoura Business Park 2021

Reference: J2021031

7 September 2022

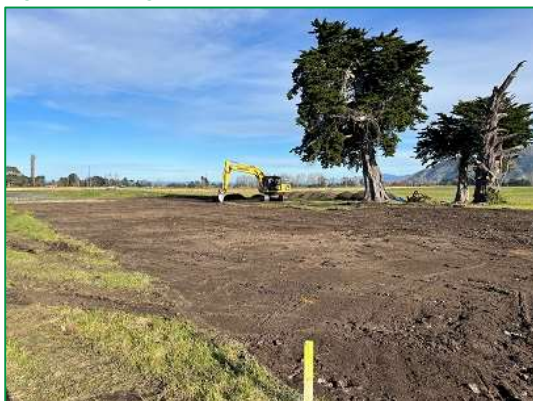
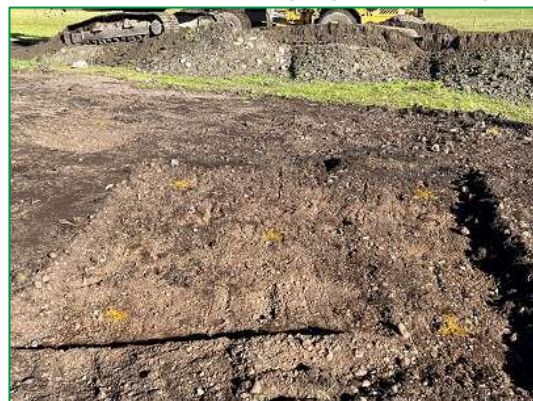
Figure 3. Images from the Remedial Work (Including Additional Excavation of Areas Returning High XRF Readings)

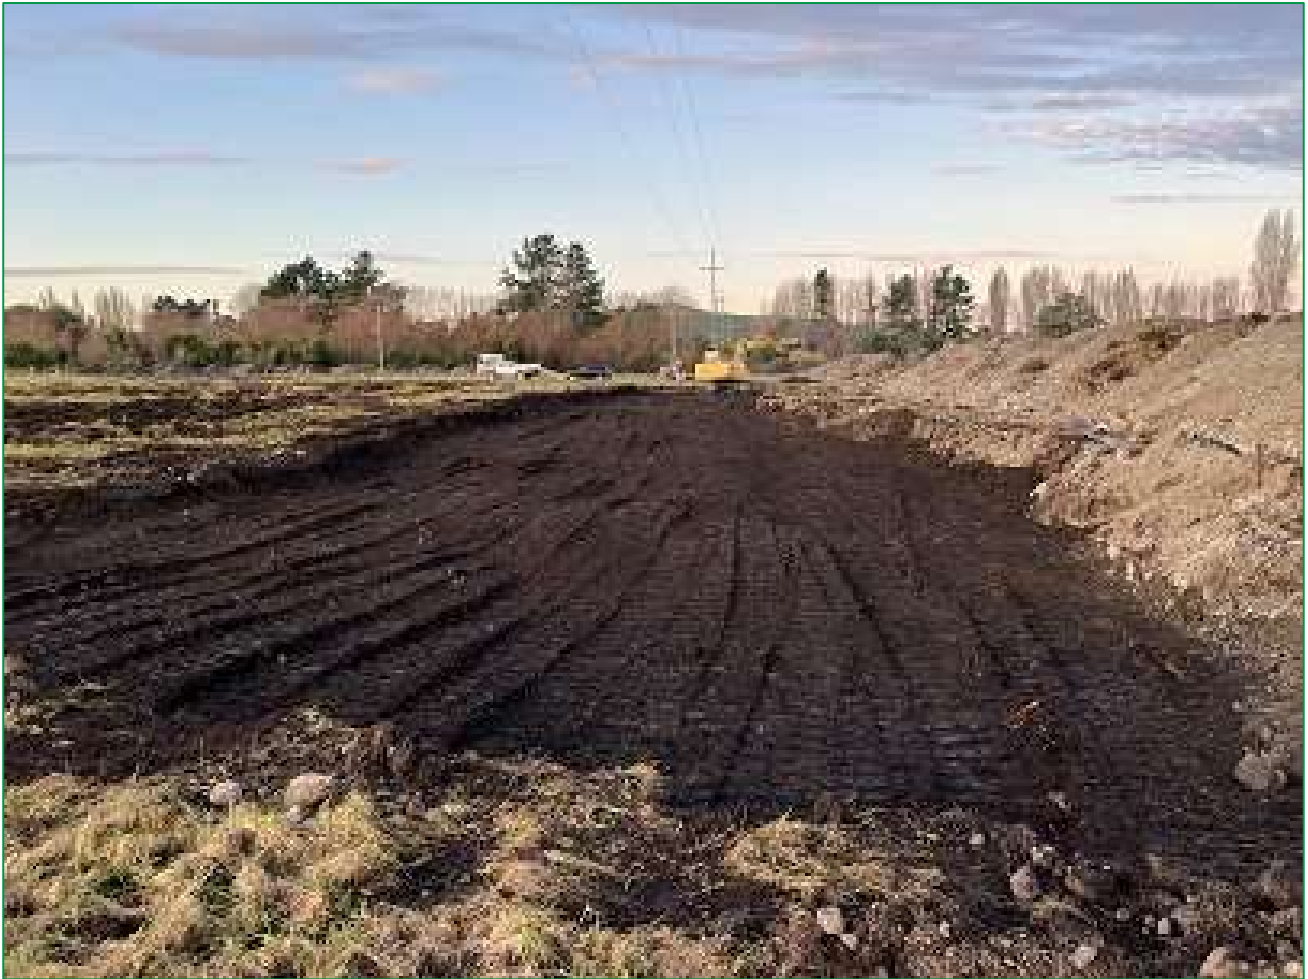
Figure 5. Containment Cell View to the East

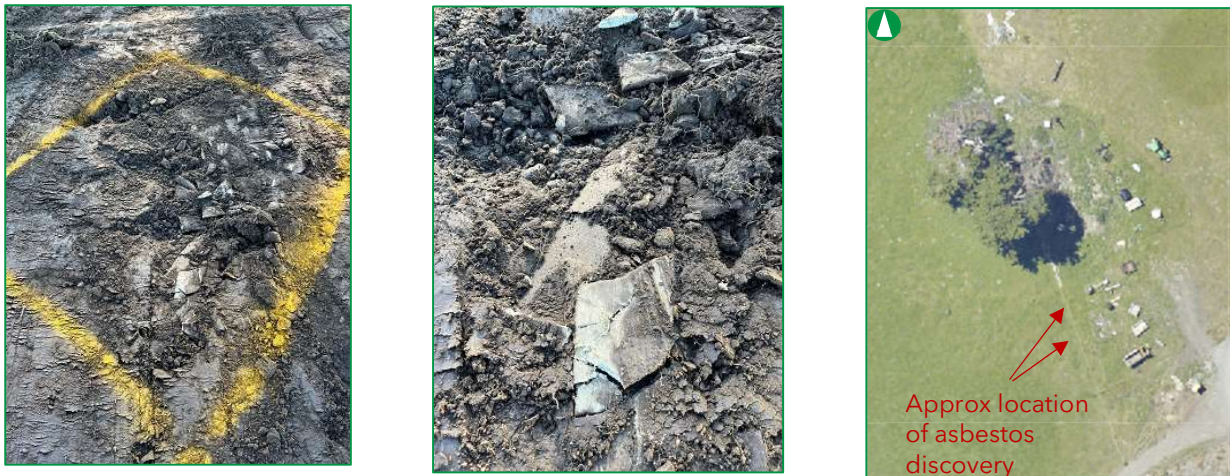
During the excavation and removal of surface soil in area HM1, previously sub-surface asbestos was exposed (see **Figure 6**). The discovery was in the approximate location of the previous asbestos removal works conducted by Agon Solutions Ltd (mentioned in Section 3.1). CLS assessed the health and safety associated with the discovery, donned additional PPE/RPE and hand-picked visible ACM, which was placed in a labelled asbestos disposal bag. Underlying soil was scraped and placed in a 20L bucket. Two validation soil samples were collected from the base of the impacted area. Soil in the 20L bucket was transferred to part of the site shown in **Figure 7** which is known to already be impacted with asbestos and is earmarked for future asbestos remediation.

Figure 6. Asbestos Discovery

The temporary stockpile requires appropriate removal and disposal as its current storage is not acceptable in the long-term.

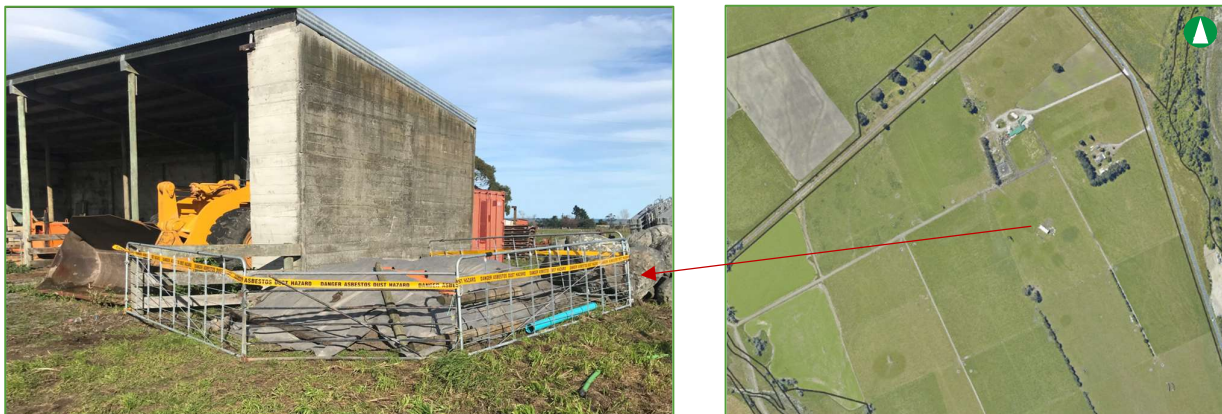
Figure 7. Temporary Disposal Location of 20L Bucket of Asbestos Contaminated Soil Next to Hay Barn (Covered and Marked)

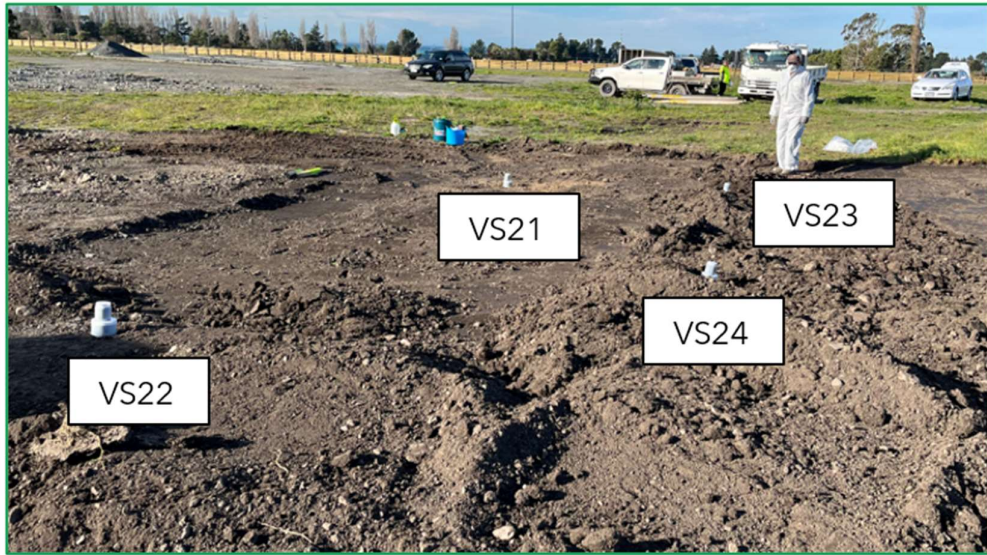
Figure 9. Validation Sample Locations (Asbestos)
Photograph Taken Looking South i.e., At the Southern End of Area HM1

Following the failure of validation samples VS11 and VS12 to meet the remediation goals for asbestos, further remedial work has been conducted and validation samples VS21 - VS24 collected. These samples returned results below the remediation goals.

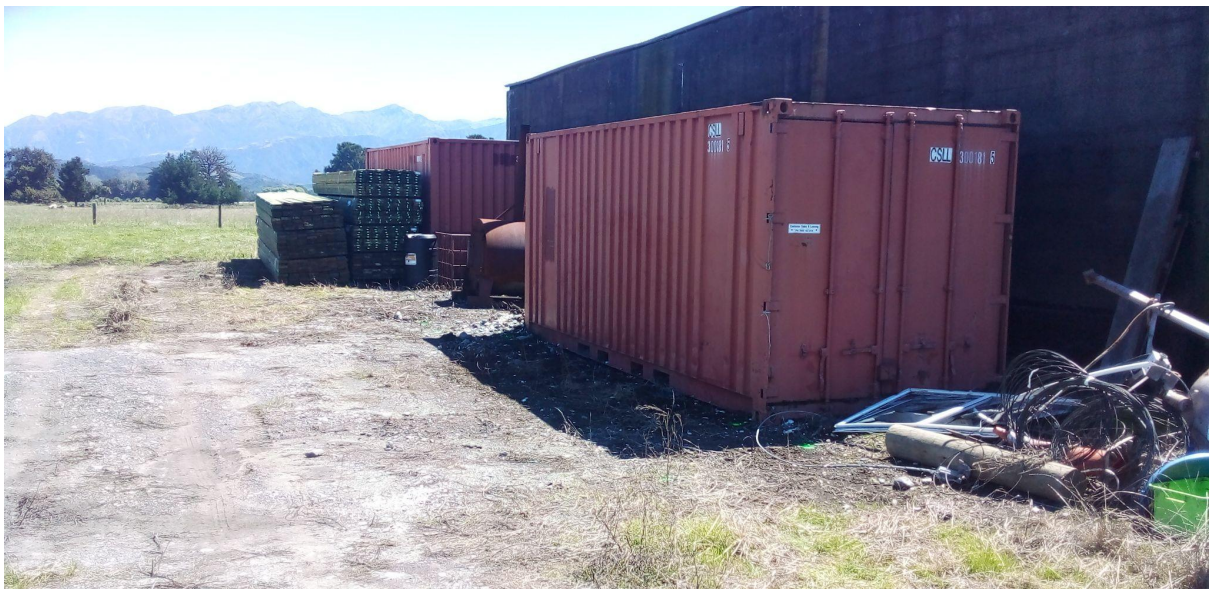
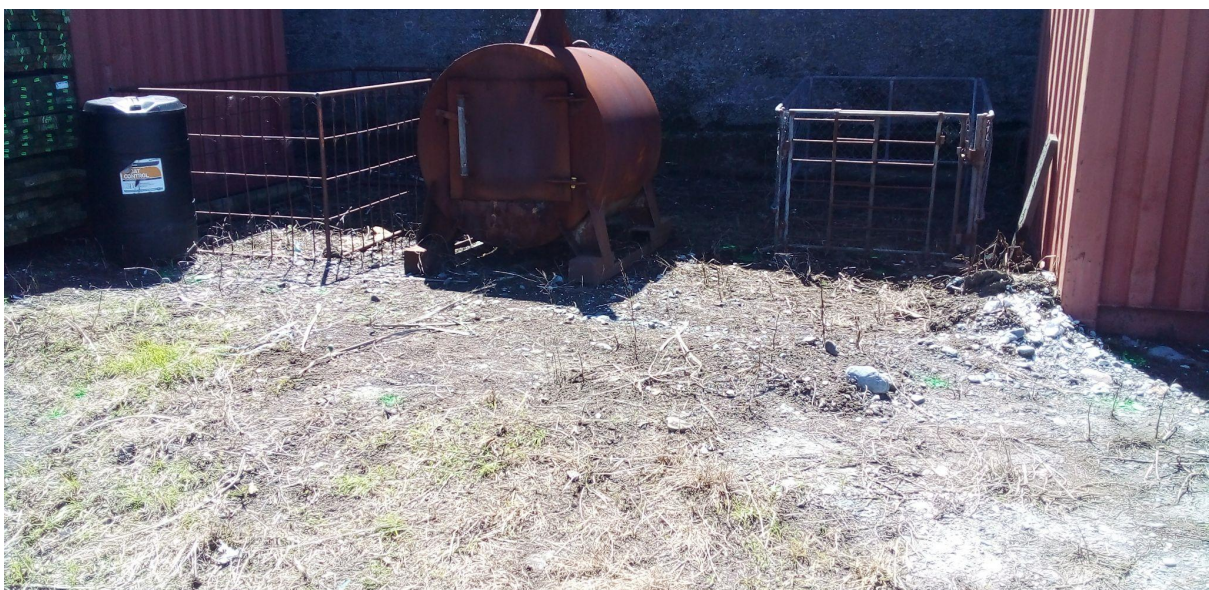
The incinerator sits behind a concrete barn and the historic piggery area is a clear site.

Figures 1 and 2. Incinerator and environs

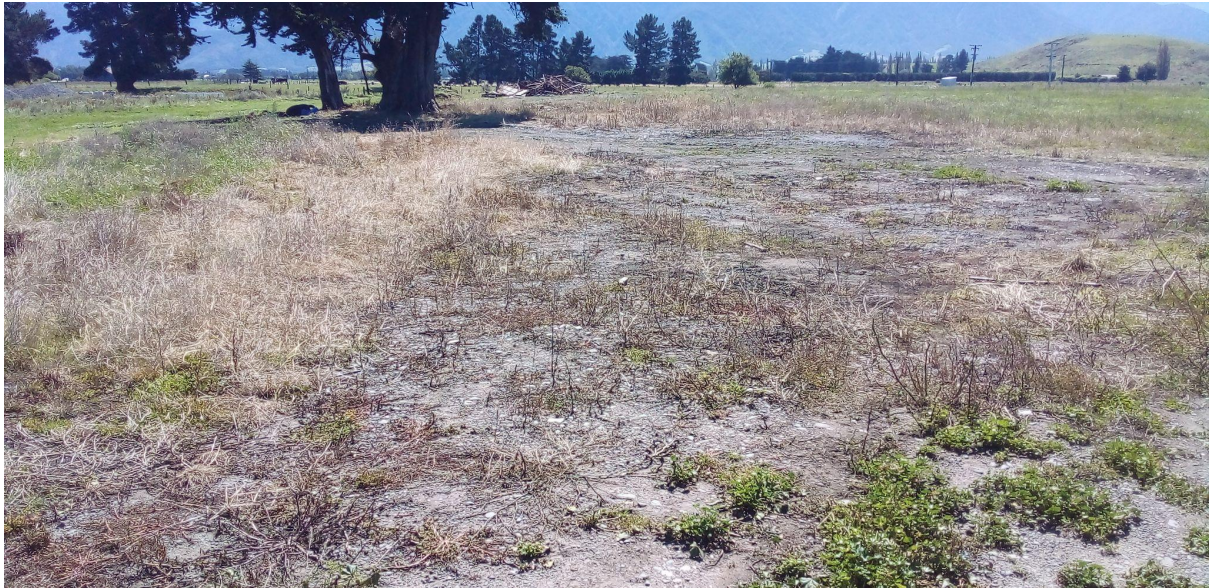
Figure 3. Piggery

The piggery area revealed only a small amount of ACM, mainly in a line at the southern boundary suggesting the existence of an historic structure.

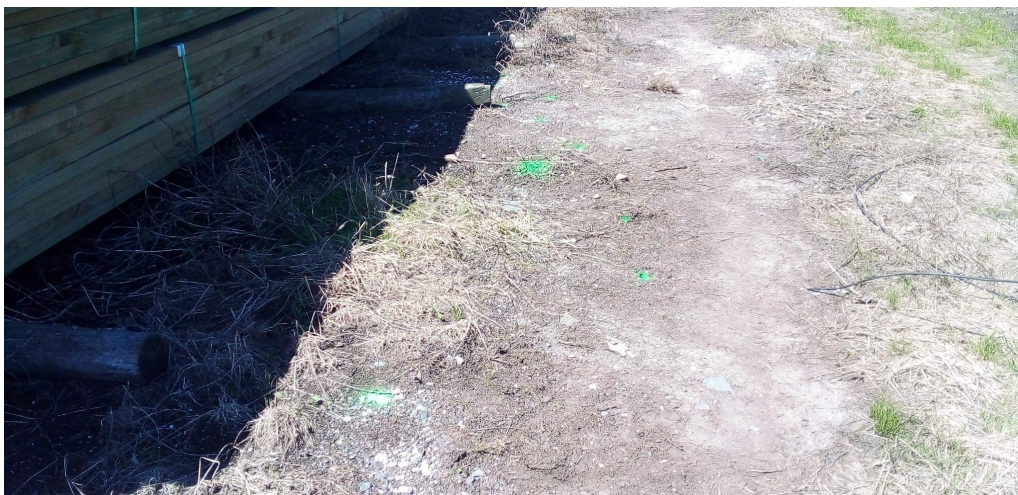
ACM (cement sheet and super six) was found around the containers, barn, timber pile, incinerator and the used farm equipment.

Figure 4. Incinerator area

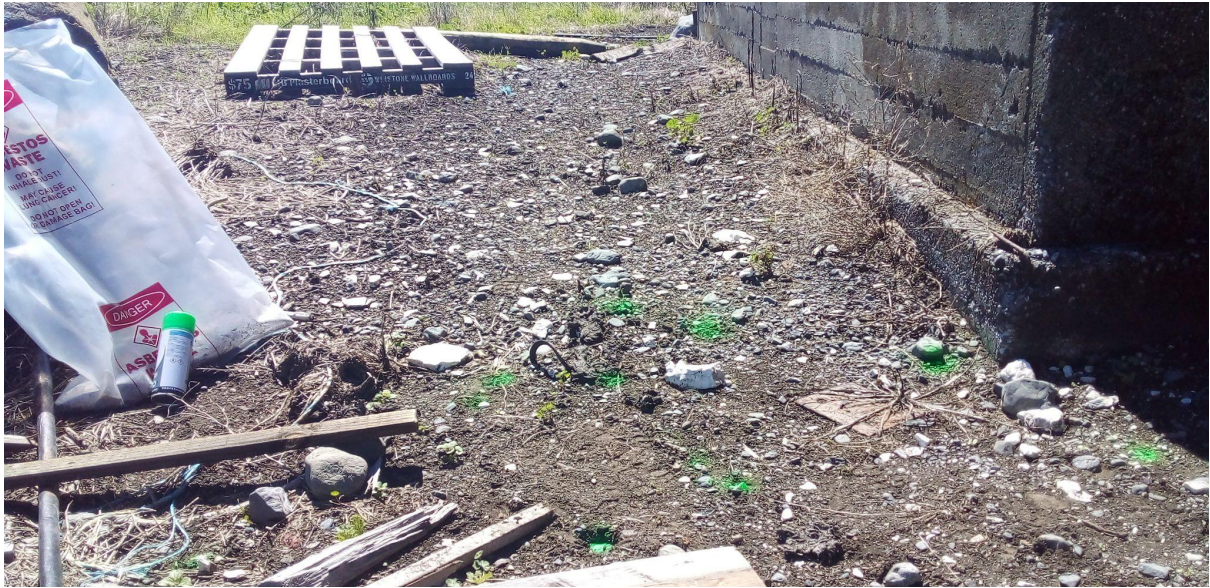
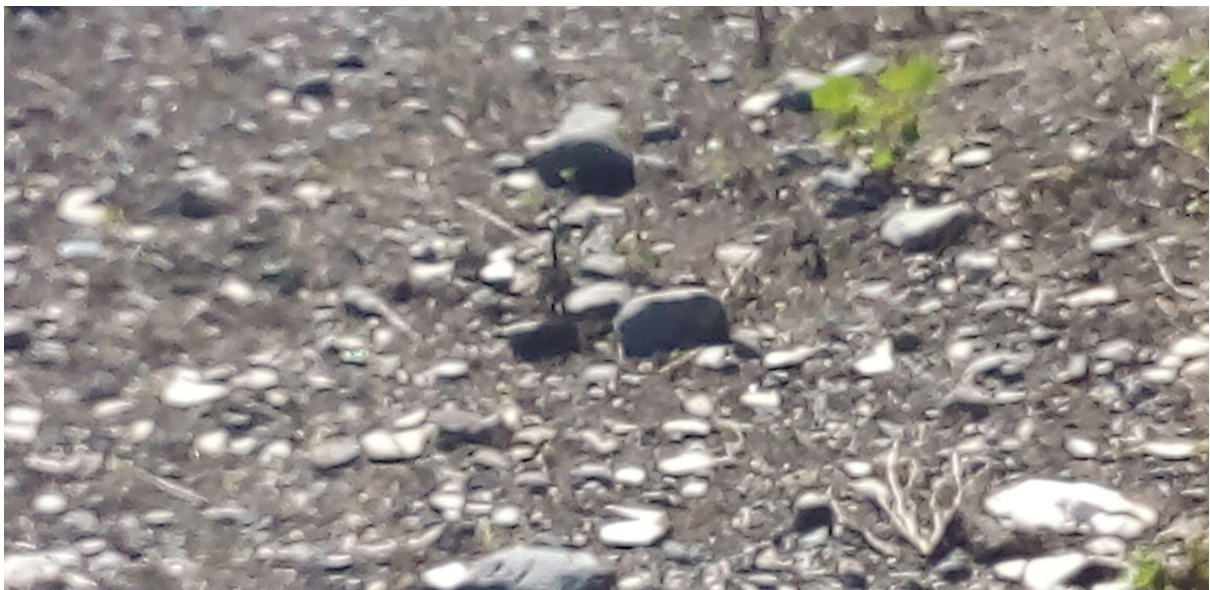
There was a notable increase in the concentration of ACM on the west side of the barn.

Figures 4 and 5 west side of barn

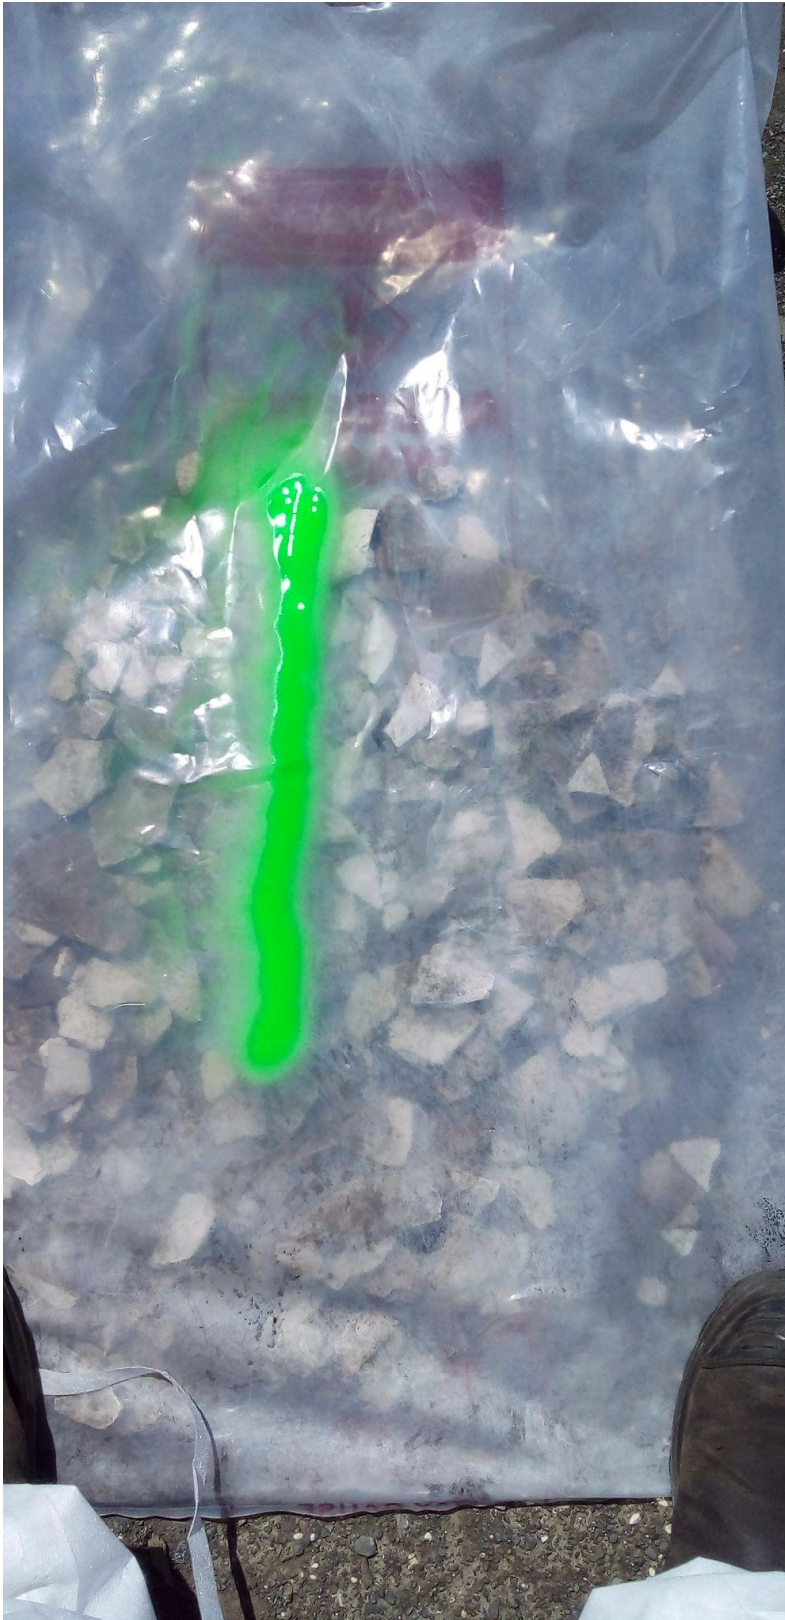
Figure 6. ACM from incinerator area

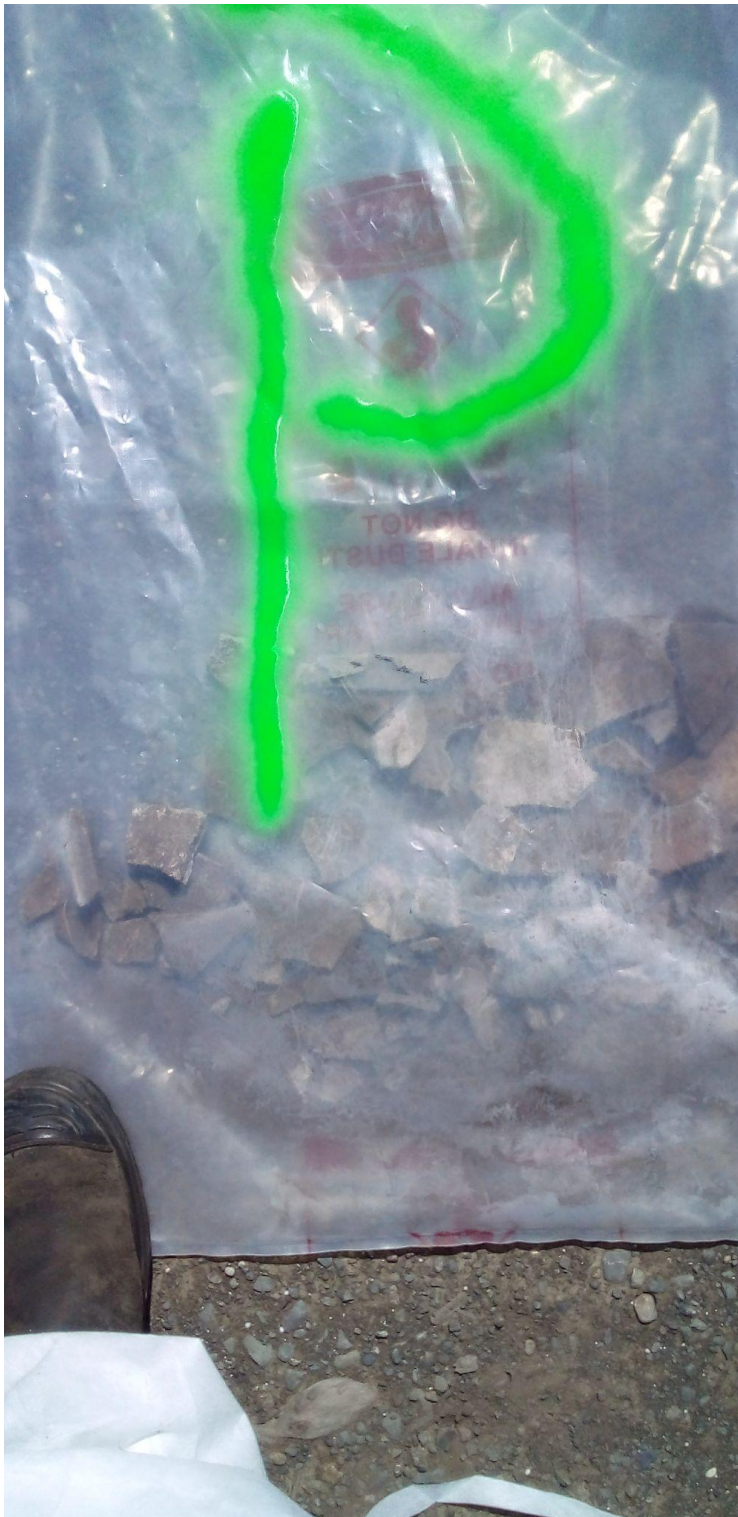
Figure 7. ACM from piggery area.

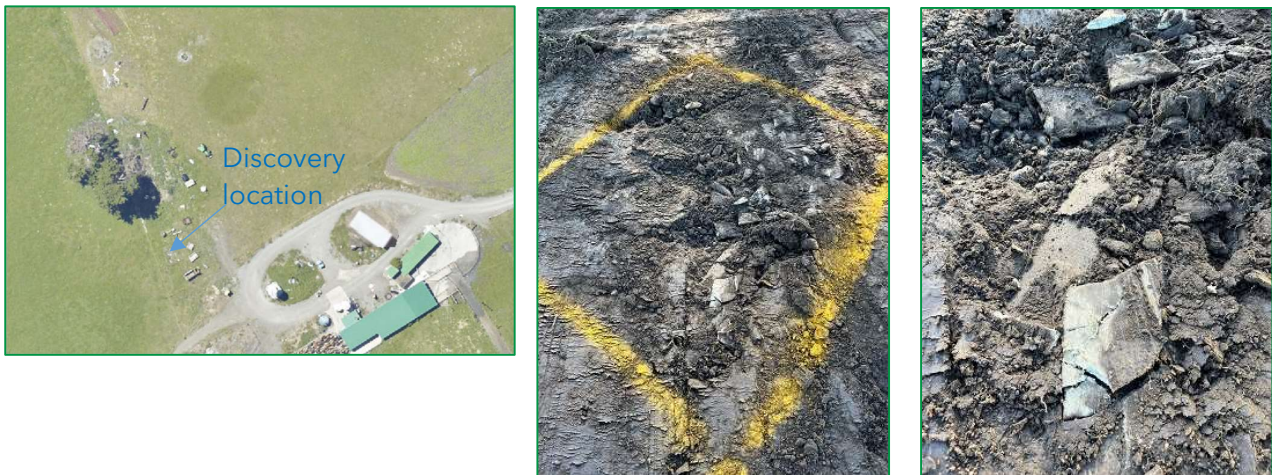
During the excavation, asbestos cement sheeting (ACM) was encountered as shown below.

As the quantity was below that requiring an asbestos removalist, and PPE was available, visible ACM was handpicked by Helen Davies of CLS and transferred into an asbestos waste bag. Underlying soil was removed into a bucket which was transferred to the known ACM contaminated area on the site, located near the incinerator (approx. total of 15 litres soil transferred).

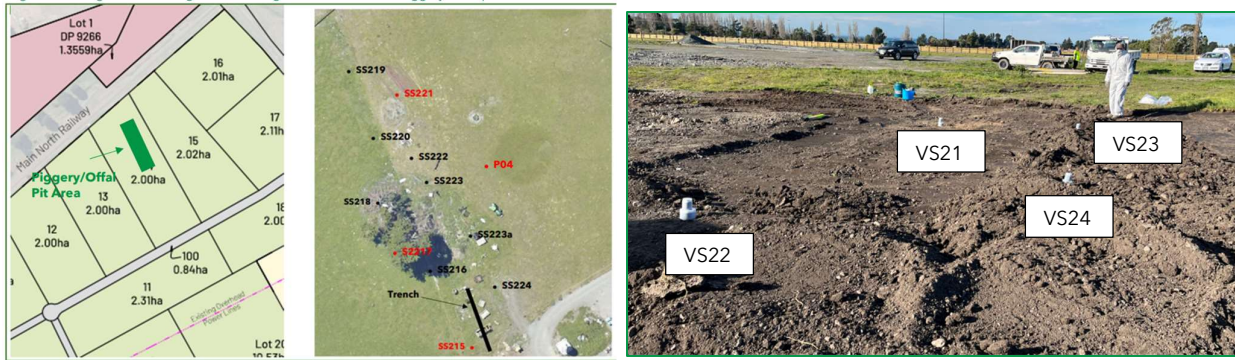
Per the Clearance Certificate, the remediation area shown in **Figure 1** was visually inspected by 1 metre spaced passes looking for ACM. In addition to the visual clearance, four soil samples (samples VS21 - VS24) were collected from the base of the remediation area for analysis for the presence of asbestos. Asbestos was detected in two of the four validation samples (see **Table 1**). The w/w percentages were all below the soil guideline values in the *New Zealand Guidelines for Assessing and Managing Asbestos in Soil* (BRANZ, 2017), and the soil is therefore considered to have been successfully remediated with respect to asbestos.

Figure 1. Remediation Area Looking East (Sample Containers Located at Sampling Points)

On 18 July 2022, Agon Solutions (Matt Garrett, Licensed Asbestos Removalist) and CLS (Helen Davies, 'Competent Person' per WorkSafe 2016) attended site for removal of asbestos impacted soil from the area shown in **Figure 1** using procedures described in an Asbestos Removal Control Plan (Agon 2022) and in the Contaminated Site Management Plan (CLS 2022). The removal was classified as Asbestos-Related Work. Conditions were calm and dry throughout the removal, and soil was moist following recent heavy rainfall. Work commenced at 8.00am using a mechanical excavator to scrape approximately 100mm soil from a 12m x 6m remediation area. Soil was directly placed into a truck used for its transferral across the site for temporary stockpiling in an area of the site already known to be contaminated with asbestos (see **Figure 2**). The works were completed by 10.40am and Clearance Inspection commenced at that time and included inspection of the remediation area. In addition, 'raking' and inspection of soil surrounding the remediation area was conducted to identify any further undiscovered visual ACM in the surrounding area (none was found).

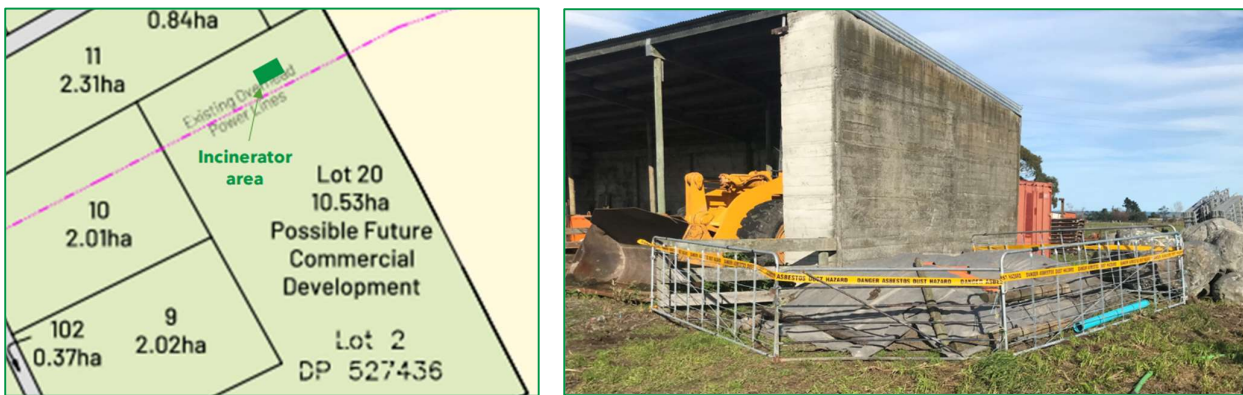
Figure 2. Temporary Stockpiling of Asbestos Contaminated Soil in the Incinerator Area
