Arboricultural Assessment of Norfolk Island Pines Kaikoura Esplanade.

Arboricultural Assessment

Site Address: Kaikoura Memorial Gardens and Esplanade

Date of Report: 6th May 2021

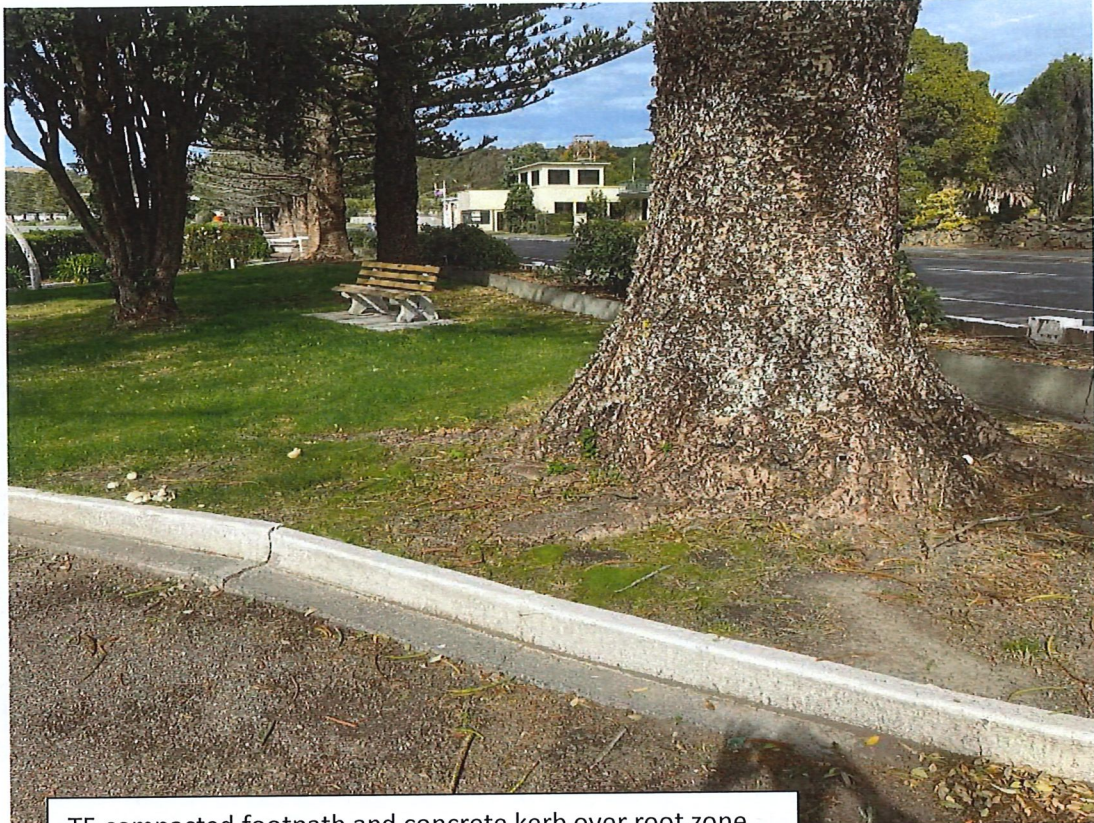
T5 compacted footpath and concrete kerb over root zone.

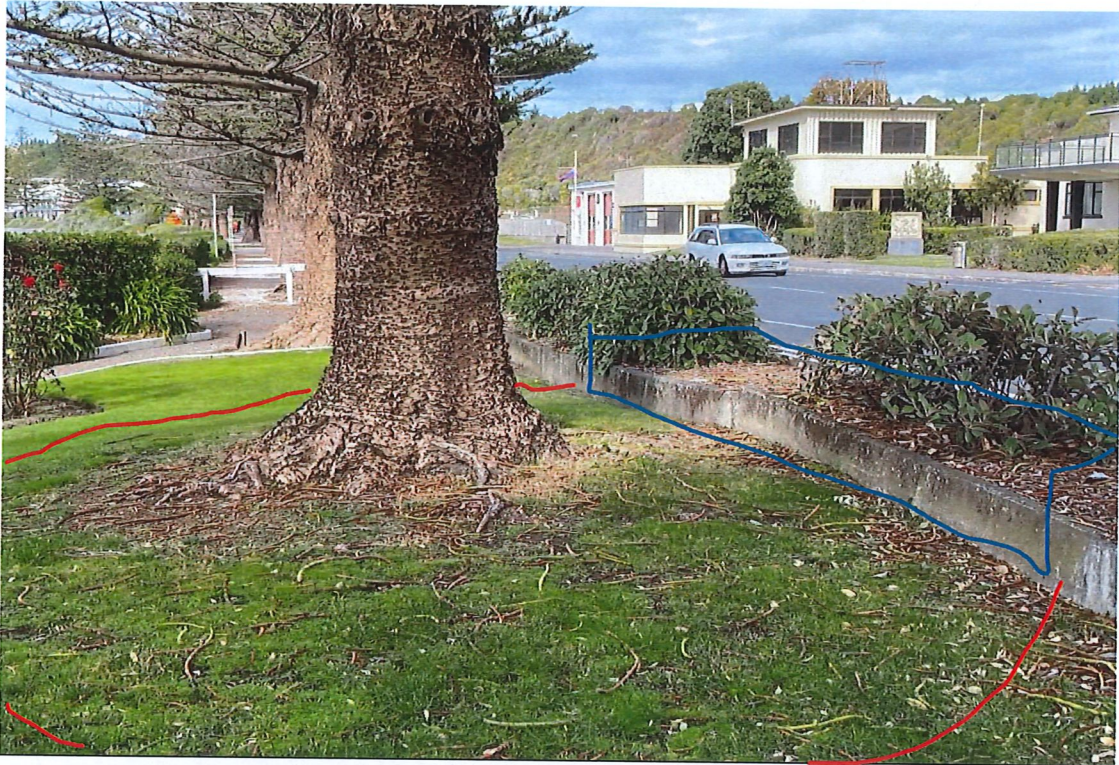
T8 Approximate area required for radial trenching and soil amendments to remedy compaction and section of planter to be removed.

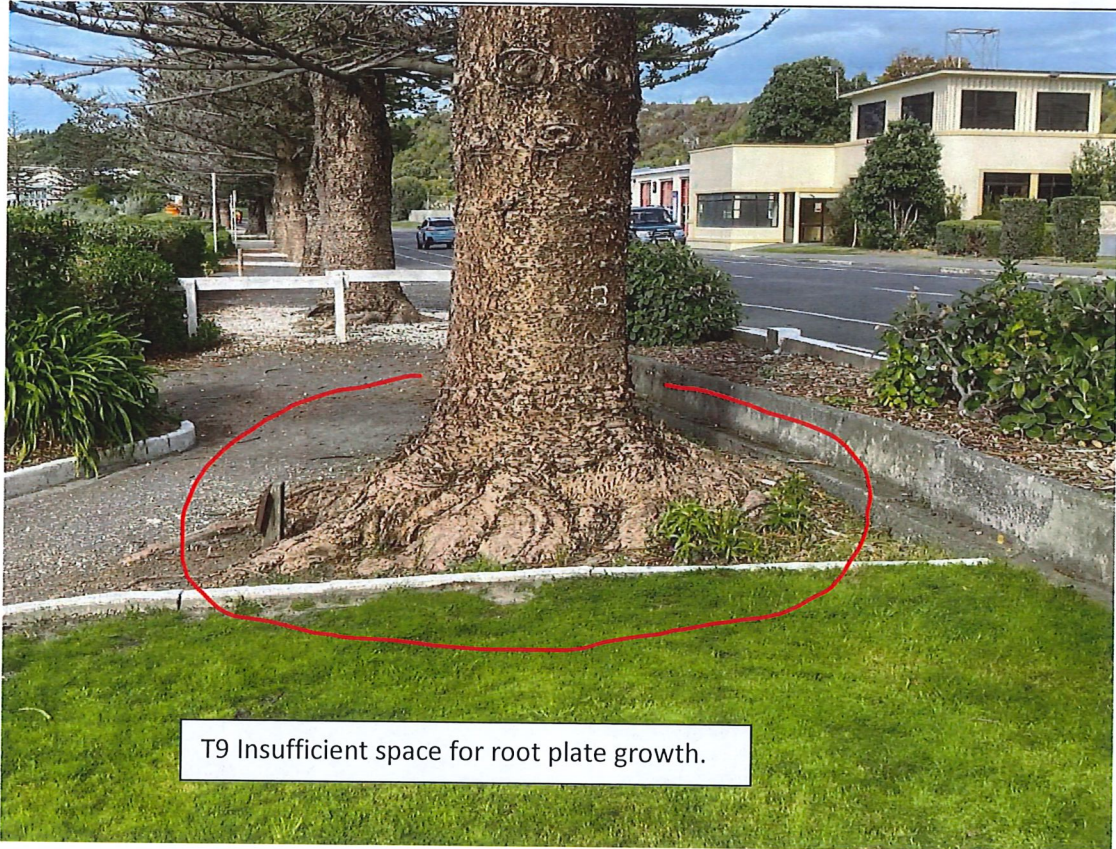
T9 Insufficient space for root plate growth.

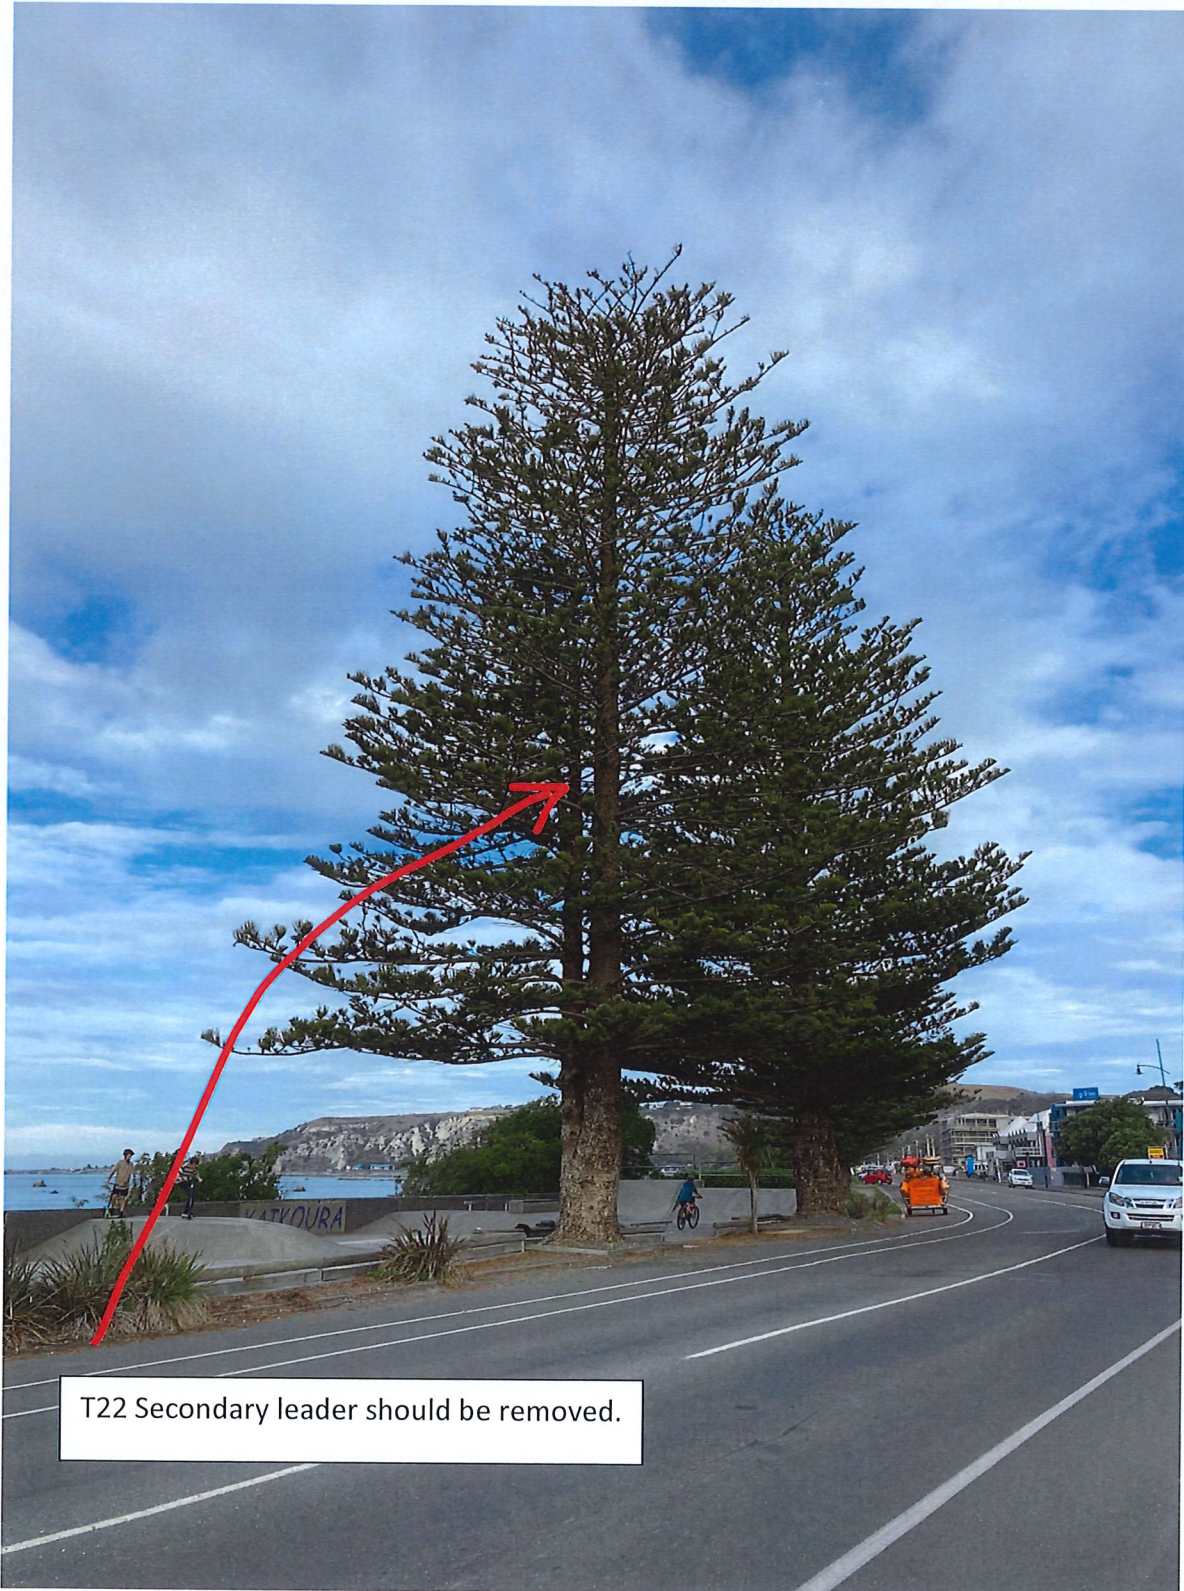
T22 Secondary leader should be removed.

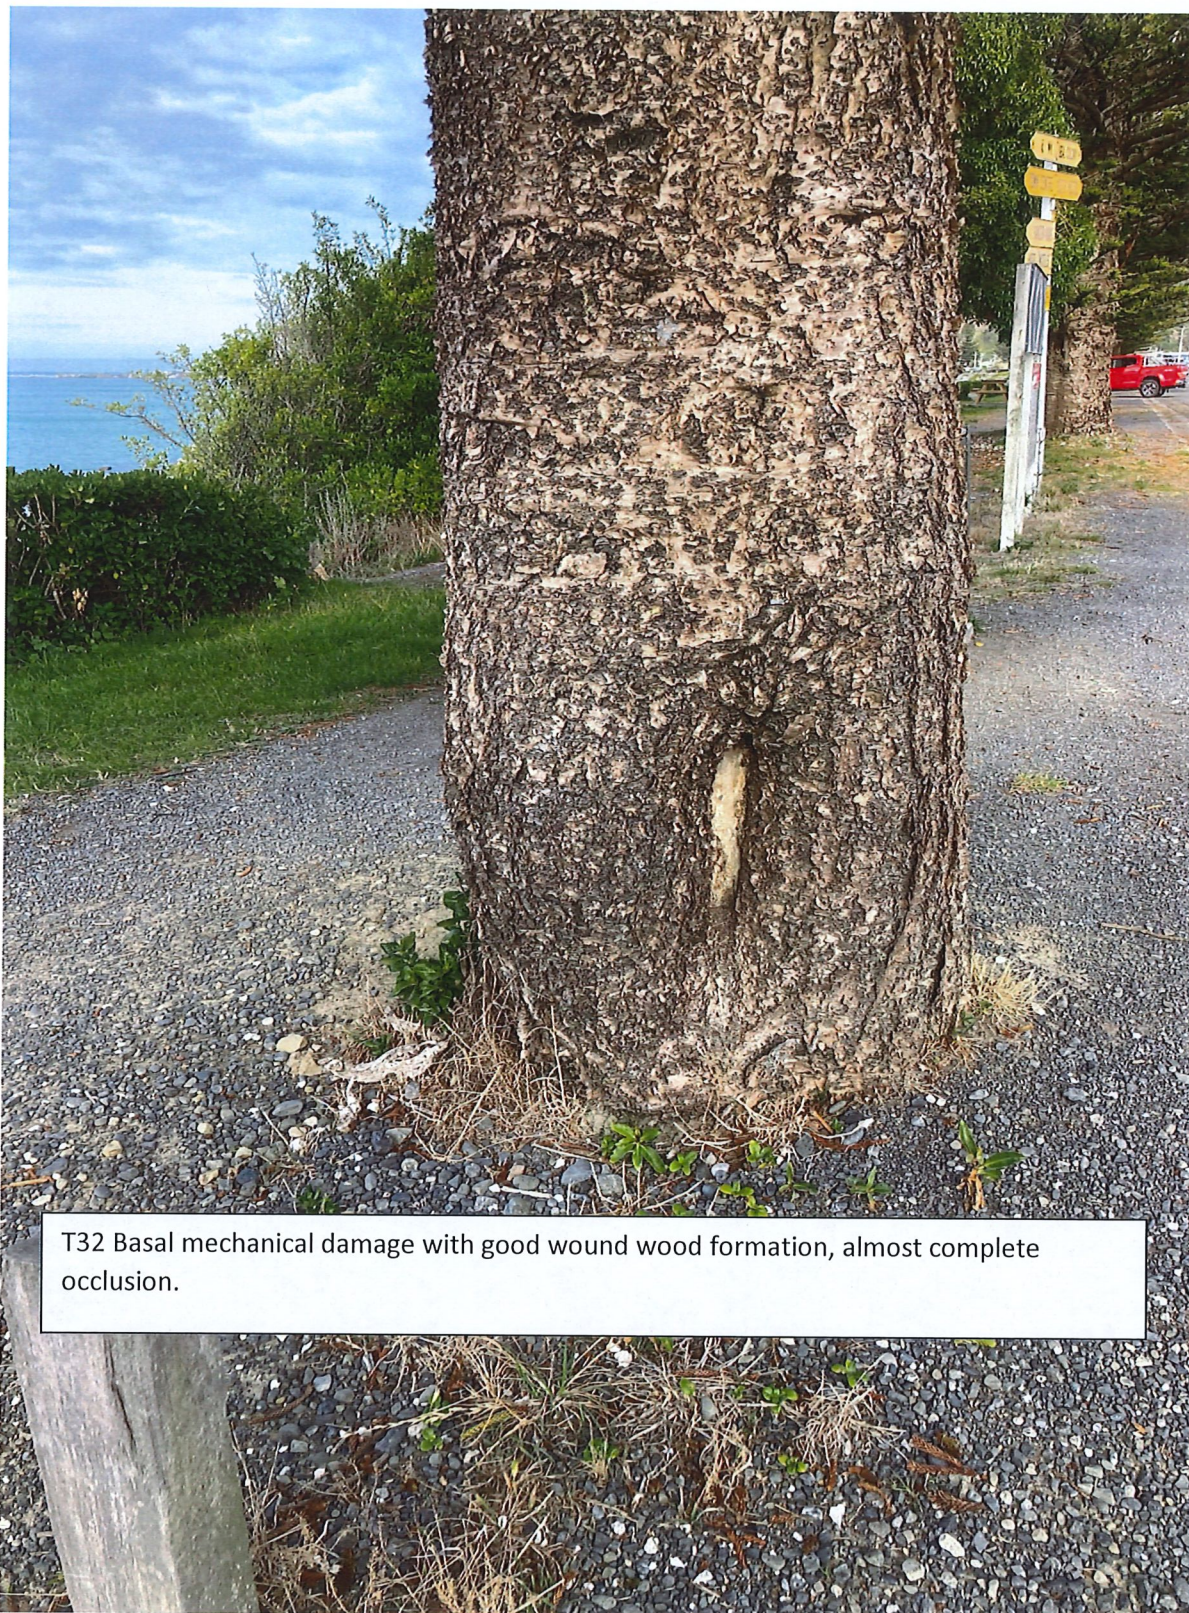
T32 Basal mechanical damage with good wound wood formation, almost complete occlusion.

TREE #	HT (m)	DBH* (cm)	Health	Group 2 trees Form	Issues of concern/comments
24	19	95	Good	OK	Small mechanical damage basal wound almost completely occluded
25	19	70	Fair/Poor	OK	None
26	20	95	Good (better than average)	OK	None
27	22	100	Good	OK	None
28	20	100	Good	OK	None
29	18	130	Good	OK	Basal damage
30	22	95	Good	OK	None
31	17	95	Fair	OK	None
32	22	95	Fair/Poor	OK	Basal damage

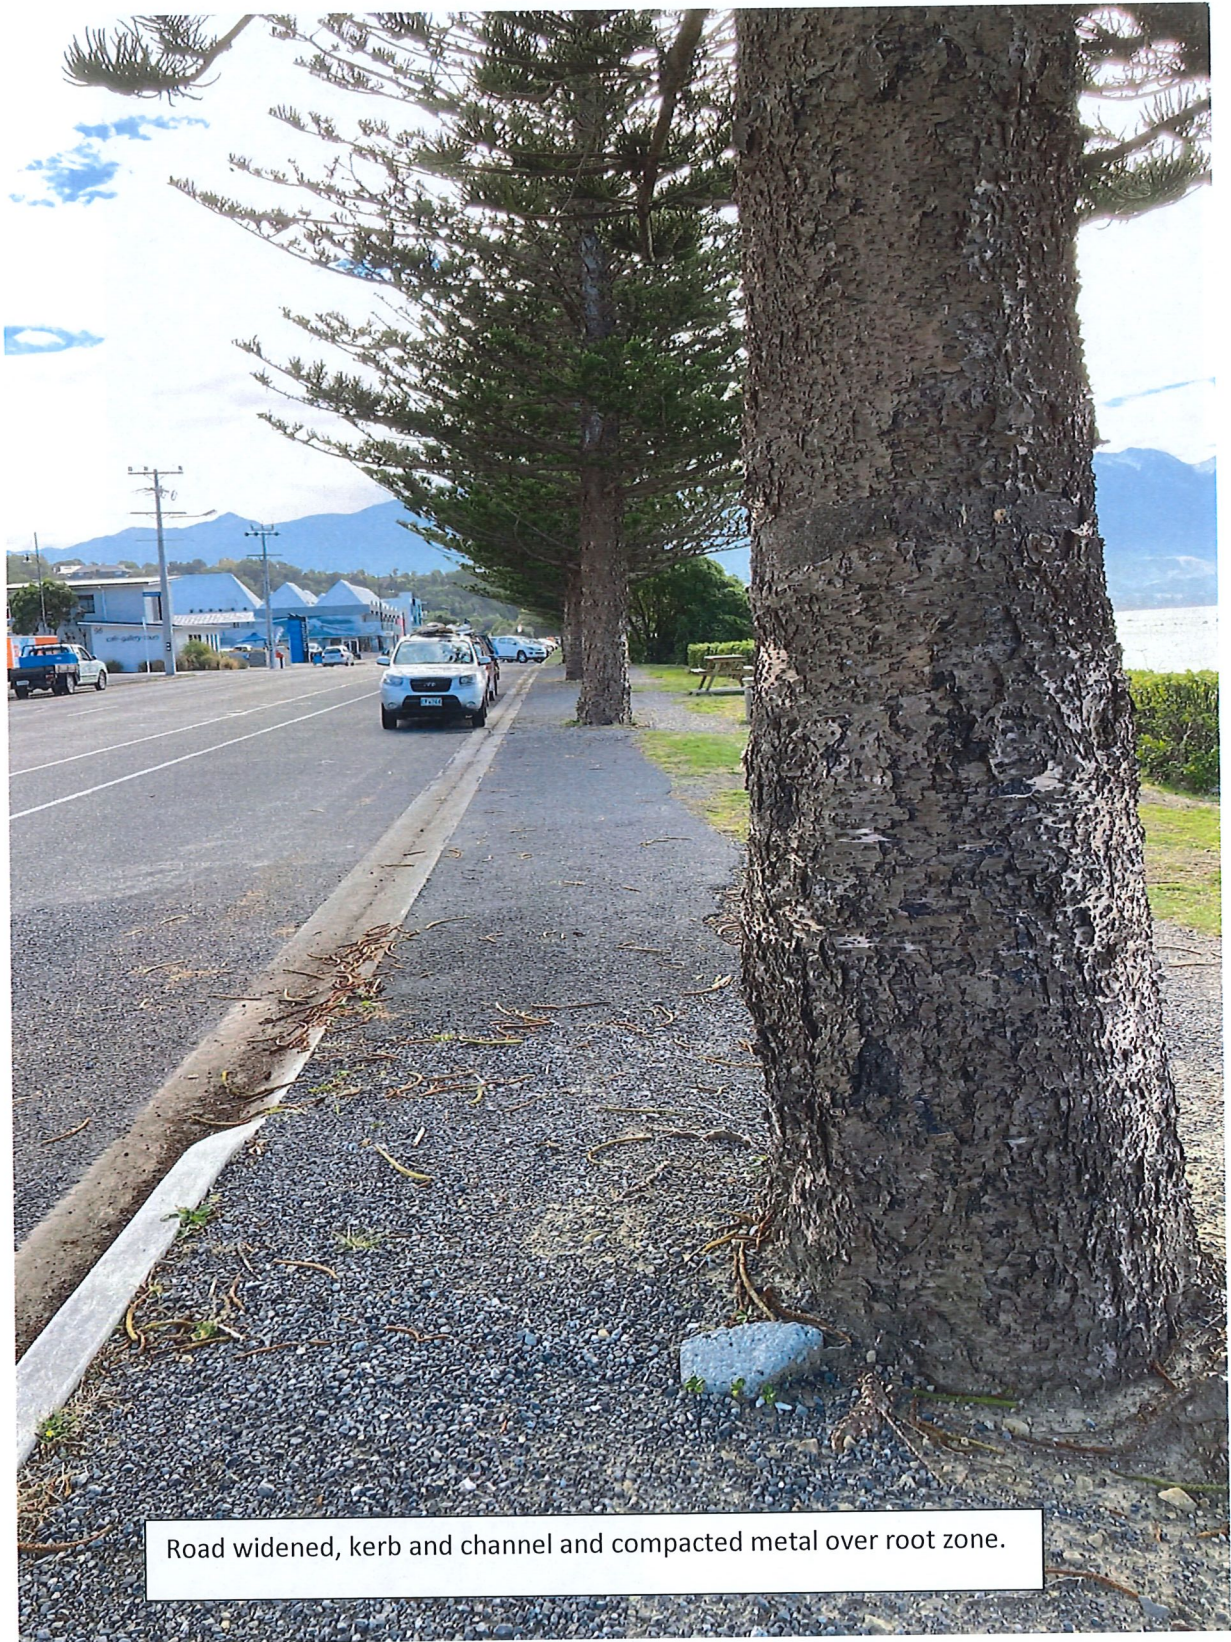
Road widened, kerb and channel and compacted metal over root zone.

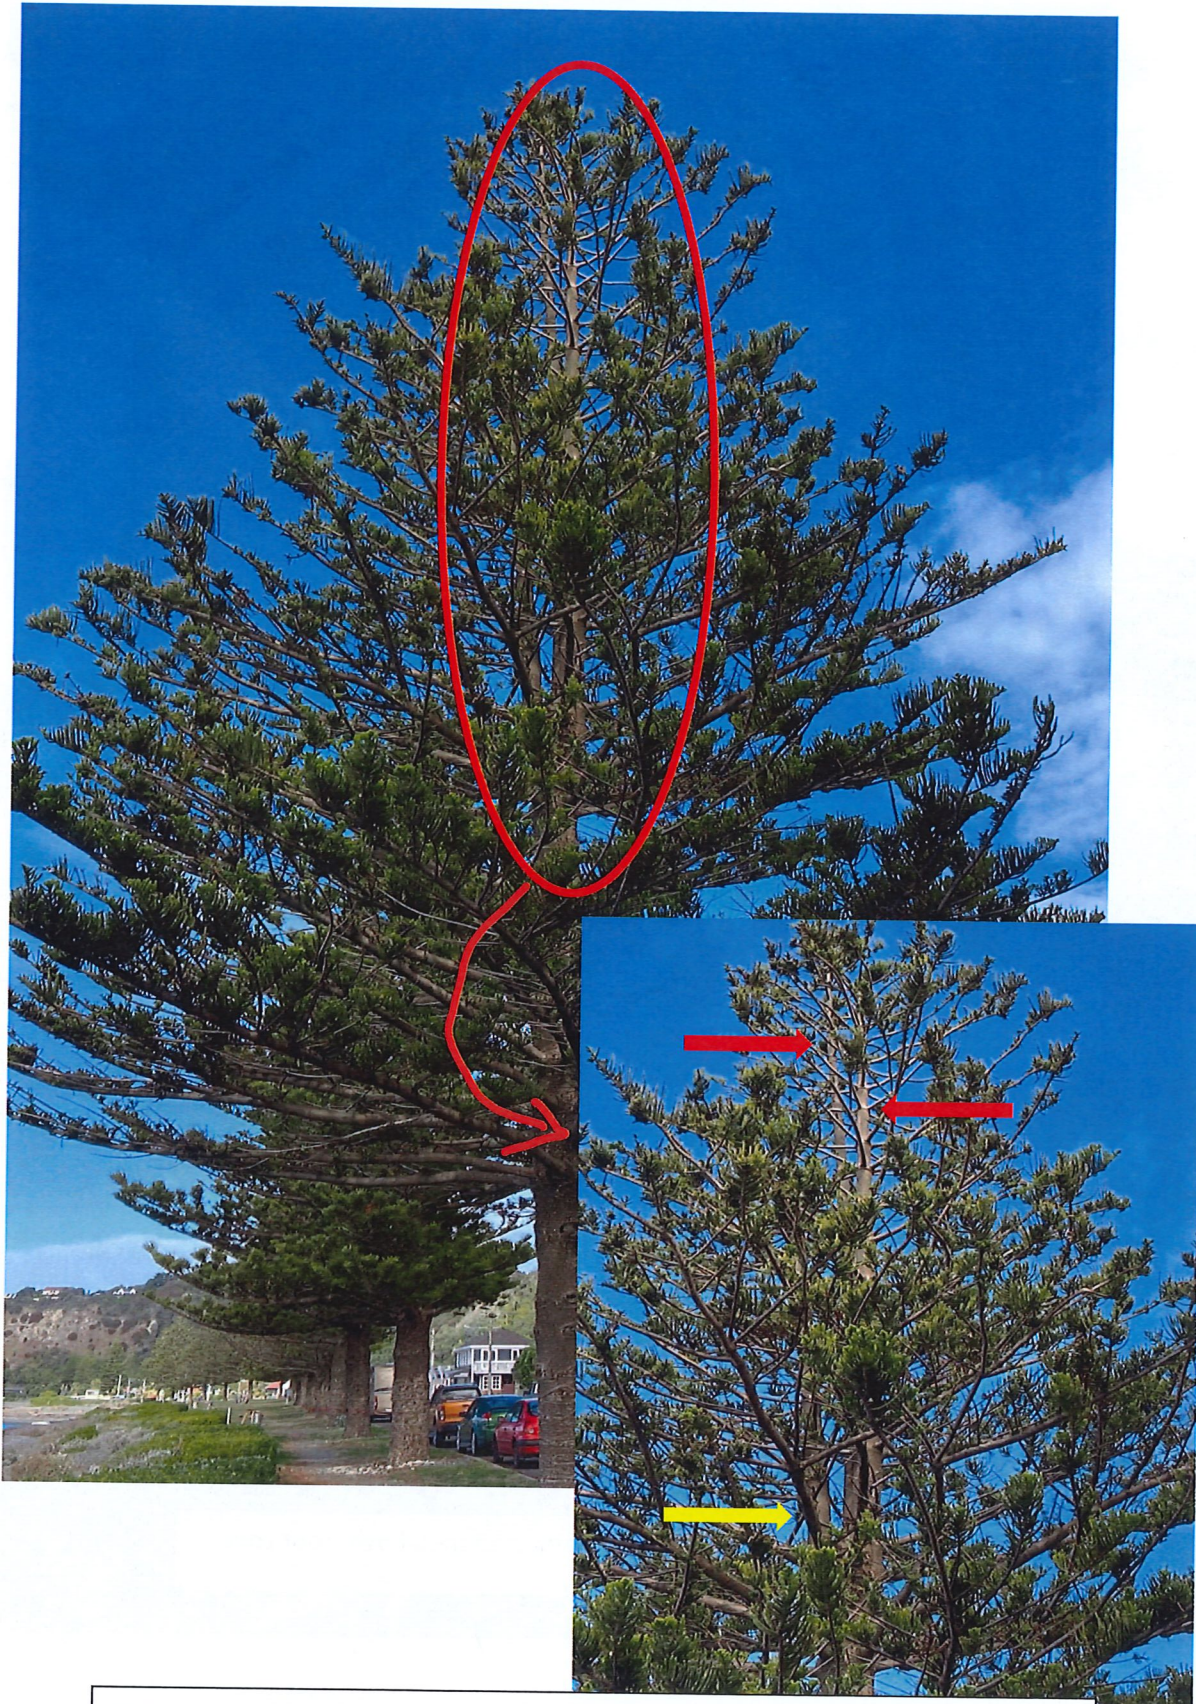
T37 two competing leaders (red arrows) and a secondary stem (yellow arrow).

TREE #	HT (m)	DBH* (cm)	Health	Form	Issues of concern/comments
33	25	120	Good	OK	Prune large epicormic shoot @1m
34	19	95	Poor/Fair	OK	None
35	18	80	Fair/Good	OK	None
36	24	95	Good	Secondary leader @ 16m	Prune to single top
37	23	90	Good	Multi-leaders (3)	Prune to single top
38	20	90	Good	Small secondary leader	Prune to single top
39	24	90	Good	Double leader	Prune to single top
40	21	90	Poor/Fair	OK	Basal wound nearly occluded
41	19	95	Fair/Poor	OK	None
42	23	95	Good	Lean to seaward, recurve from 15m	None
43	16	80	Fair/Poor	OK	None
44	21	100	Fair	OK	None
45	21	80	Fair	OK	None
46	19	70	Fair	OK	Old wound @ 1m seaward side, occluded

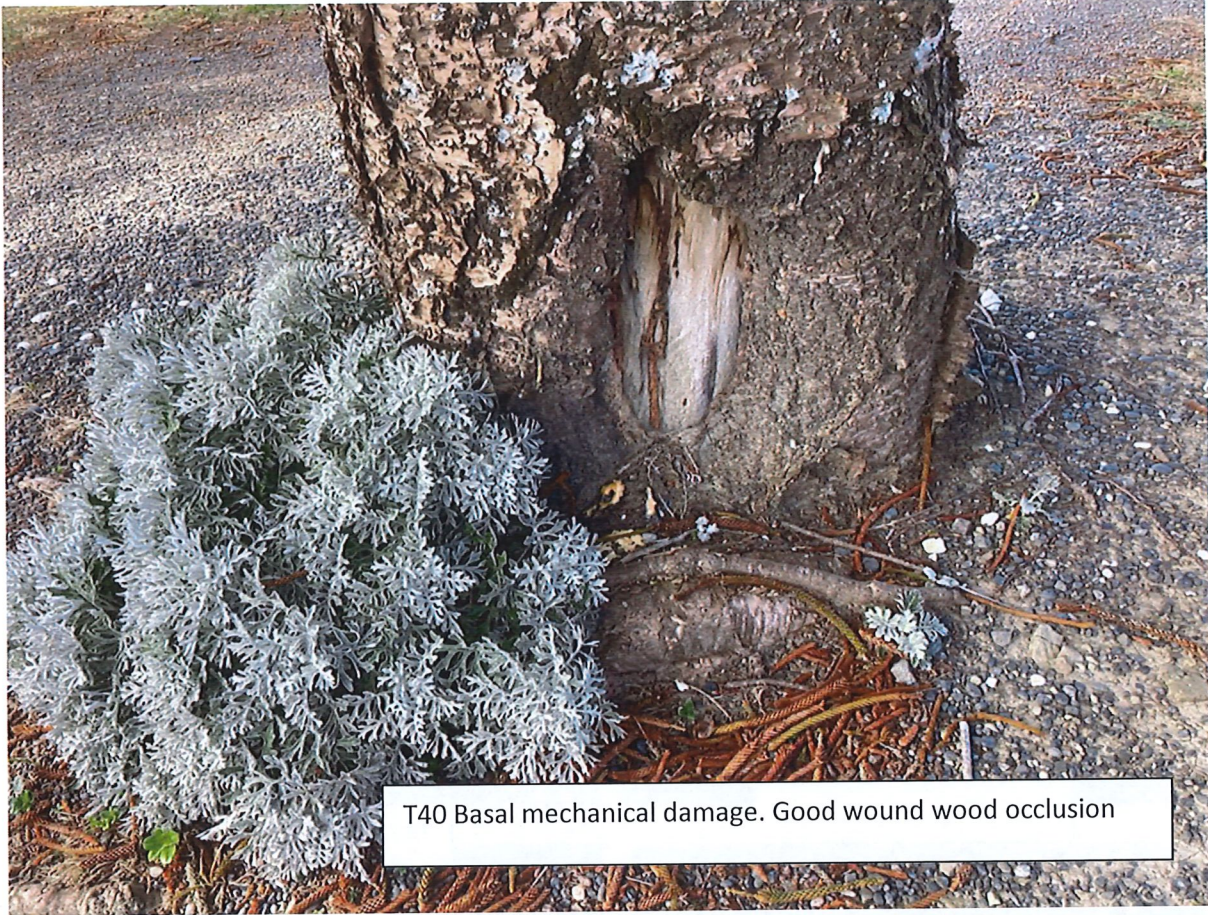
T40 Basal mechanical damage. Good wound wood occlusion

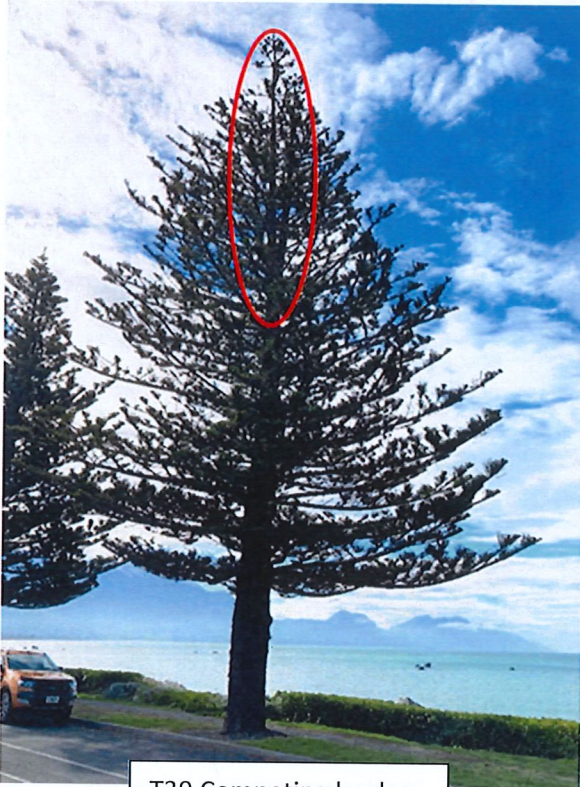
T39 Competing leaders

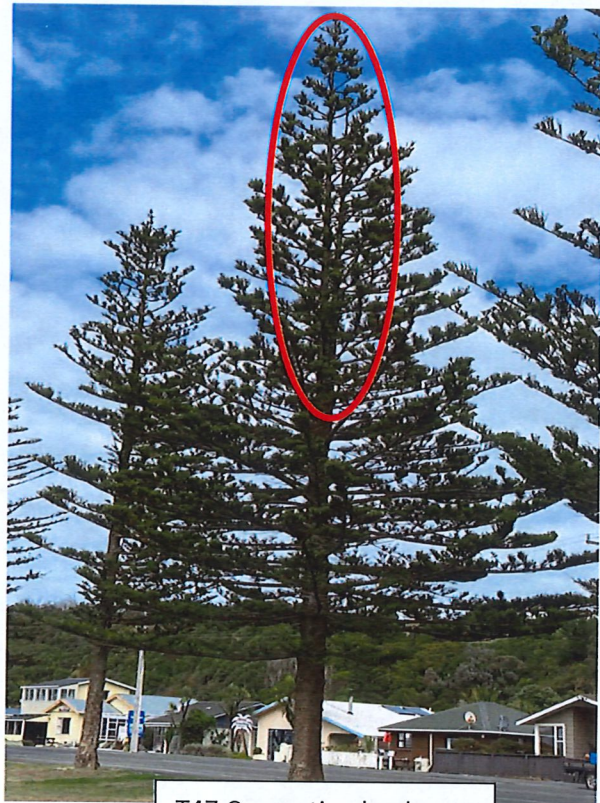
T47 Competing leaders

TREE #	HT (m)	DBH* (cm)	Health	Form	Issues of concern/comments
47	22	90	Good	Secondary leader	Prune to single top
48	22	80	Fair	Secondary leader	Prune to single top
49	22	65	Fair	OK	Branches absent E. side to 15m, basal wound W. side
50	23	60	Poor	OK	Sparse canopy, malformed leaves, new growth OK.
51	19	80	Fair	OK	Minor girdling root
52	20	80	Fair/Poor	OK	None
53	22	90	Fair/Poor	OK	None
54	14	60	Fair/Poor	OK	None
55	24	100	Fair/Good	OK	None
56	20	90	Fair/Good	OK	Mechanical damage to surface root N side

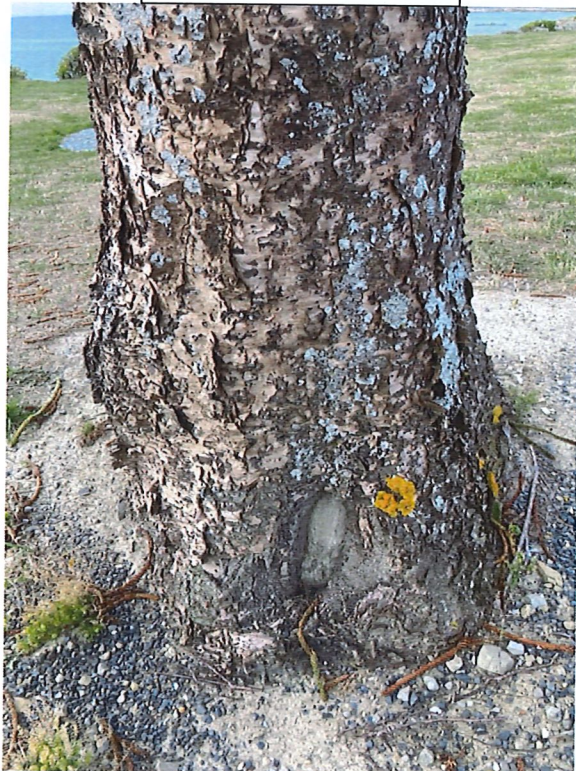
T49 Small basal mechanical damage, east side branches absent to approximately 15m

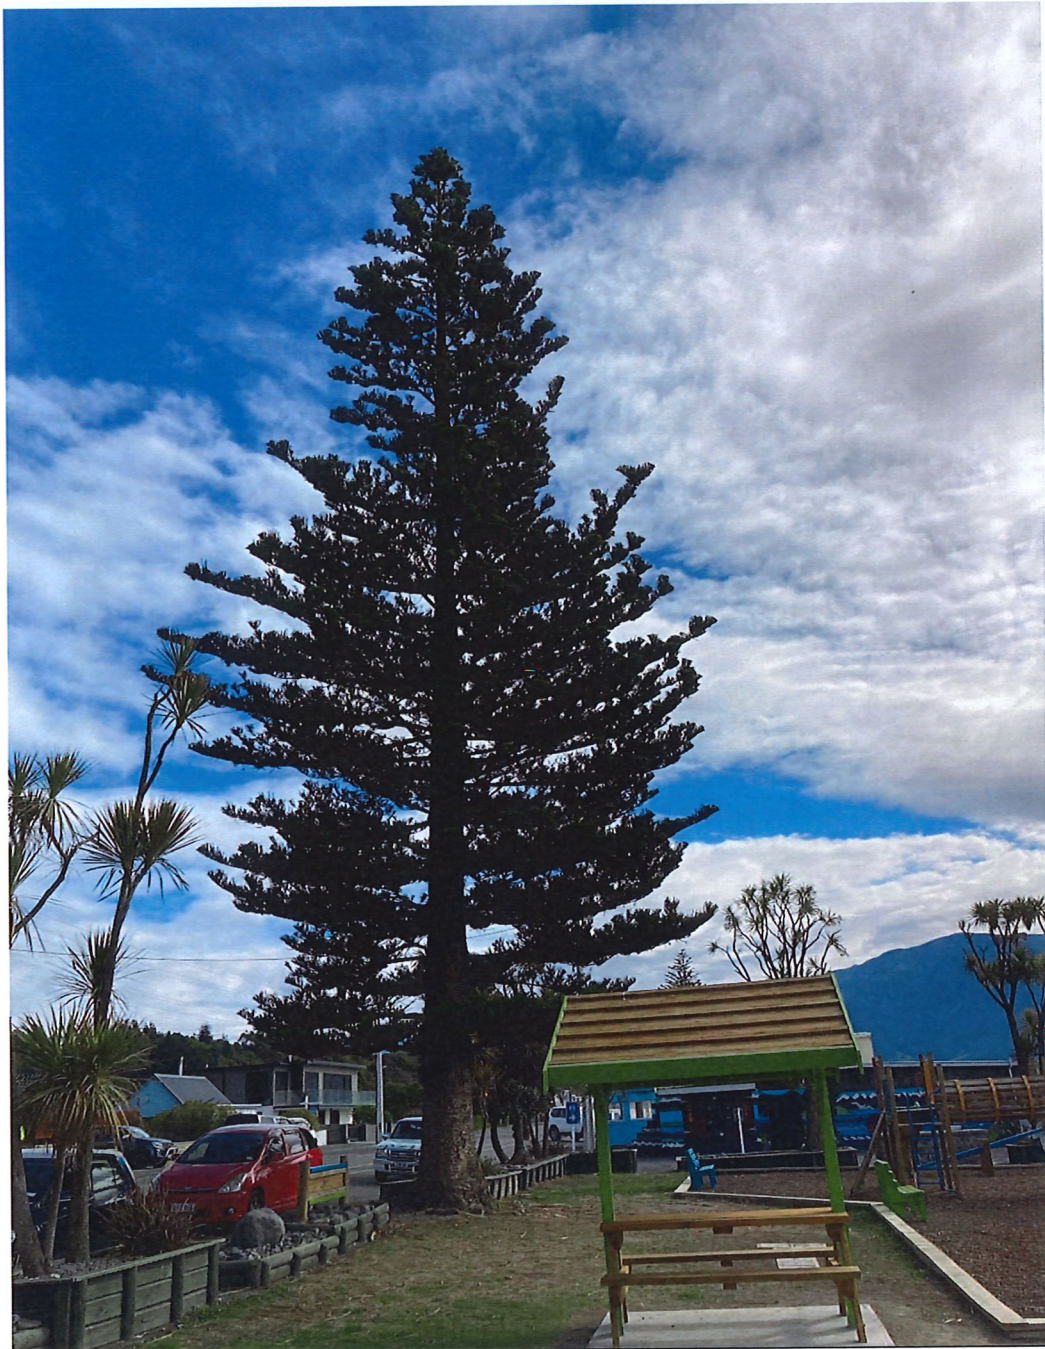
T57 is the healthiest of all the trees inspected and is an example of the potential appearance of the trees if remediation/improved growing conditions is successful.

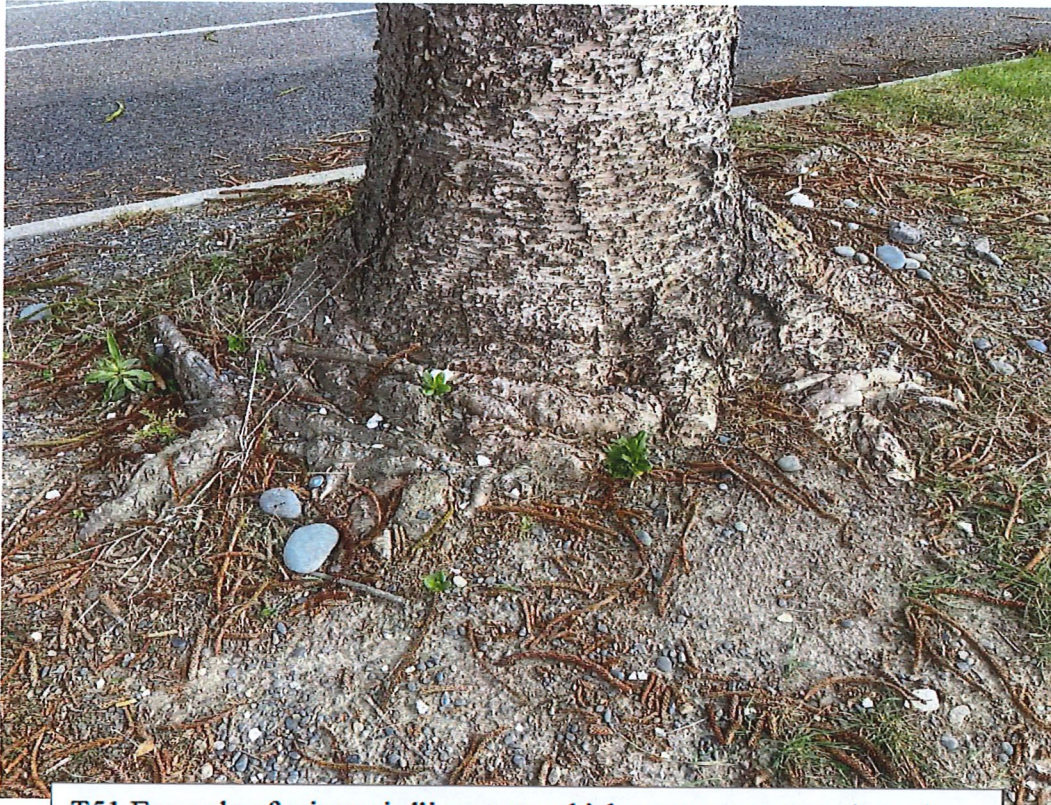
T51 Example of minor girdling roots which seems common along the avenue

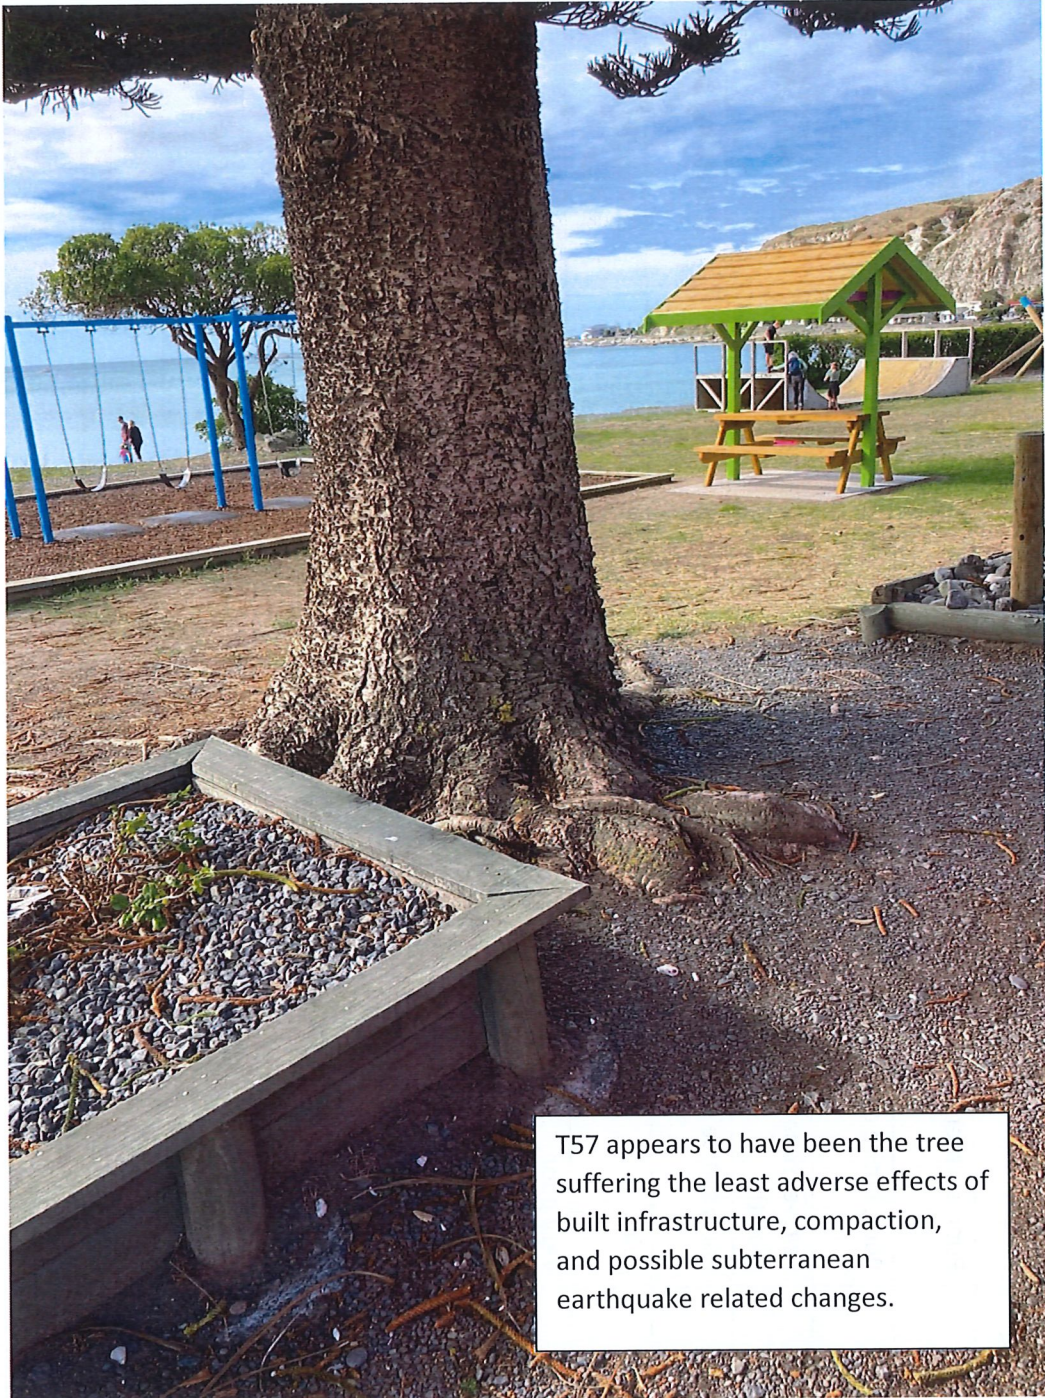
T57 appears to have been the tree suffering the least adverse effects of built infrastructure, compaction, and possible subterranean earthquake related changes.
