**KAIKOURA DISTRICT COUNCIL WORKS AND SERVICES
COMMITTEE MEETING HELD ON WEDNESDAY 16
MARCH 2011 IN MEMORIAL HALL SUPPER ROOM,
ESPLANADE, KAIKOURA.**

WORKS AND SERVICES REPORT

ROADING REPORT

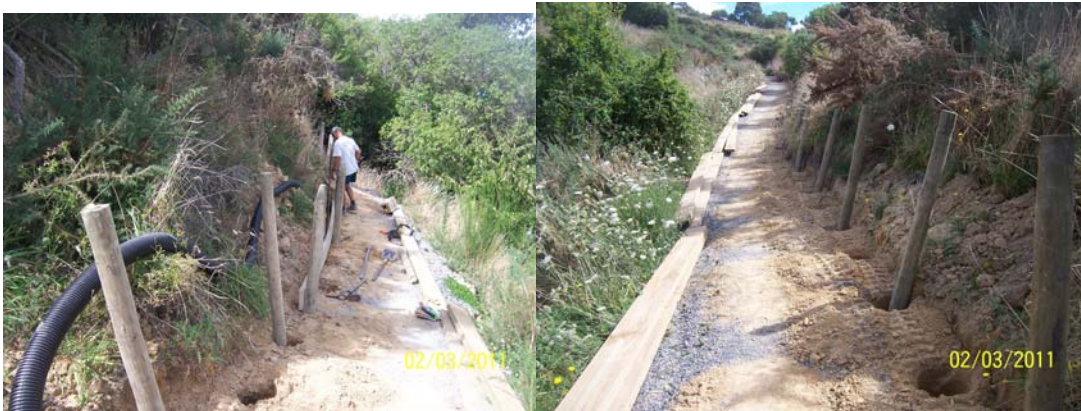
The contractor commenced work on Tom's Track on February 28th, 2011. The work being carried out is to retain the area of significant slip as identified in a Geotechnical report prepared by Smart Alliances for Kaikoura District Council. The works involves:

1. Retaining wall 400mm high (90 linear meter approx) including polythene to base and novaflow drainage with solid discharge pipes etc, concreted posts, back filled with aggregate.
2. 90m length of 100mm x25mm pegged track boundary to bottom side of track.

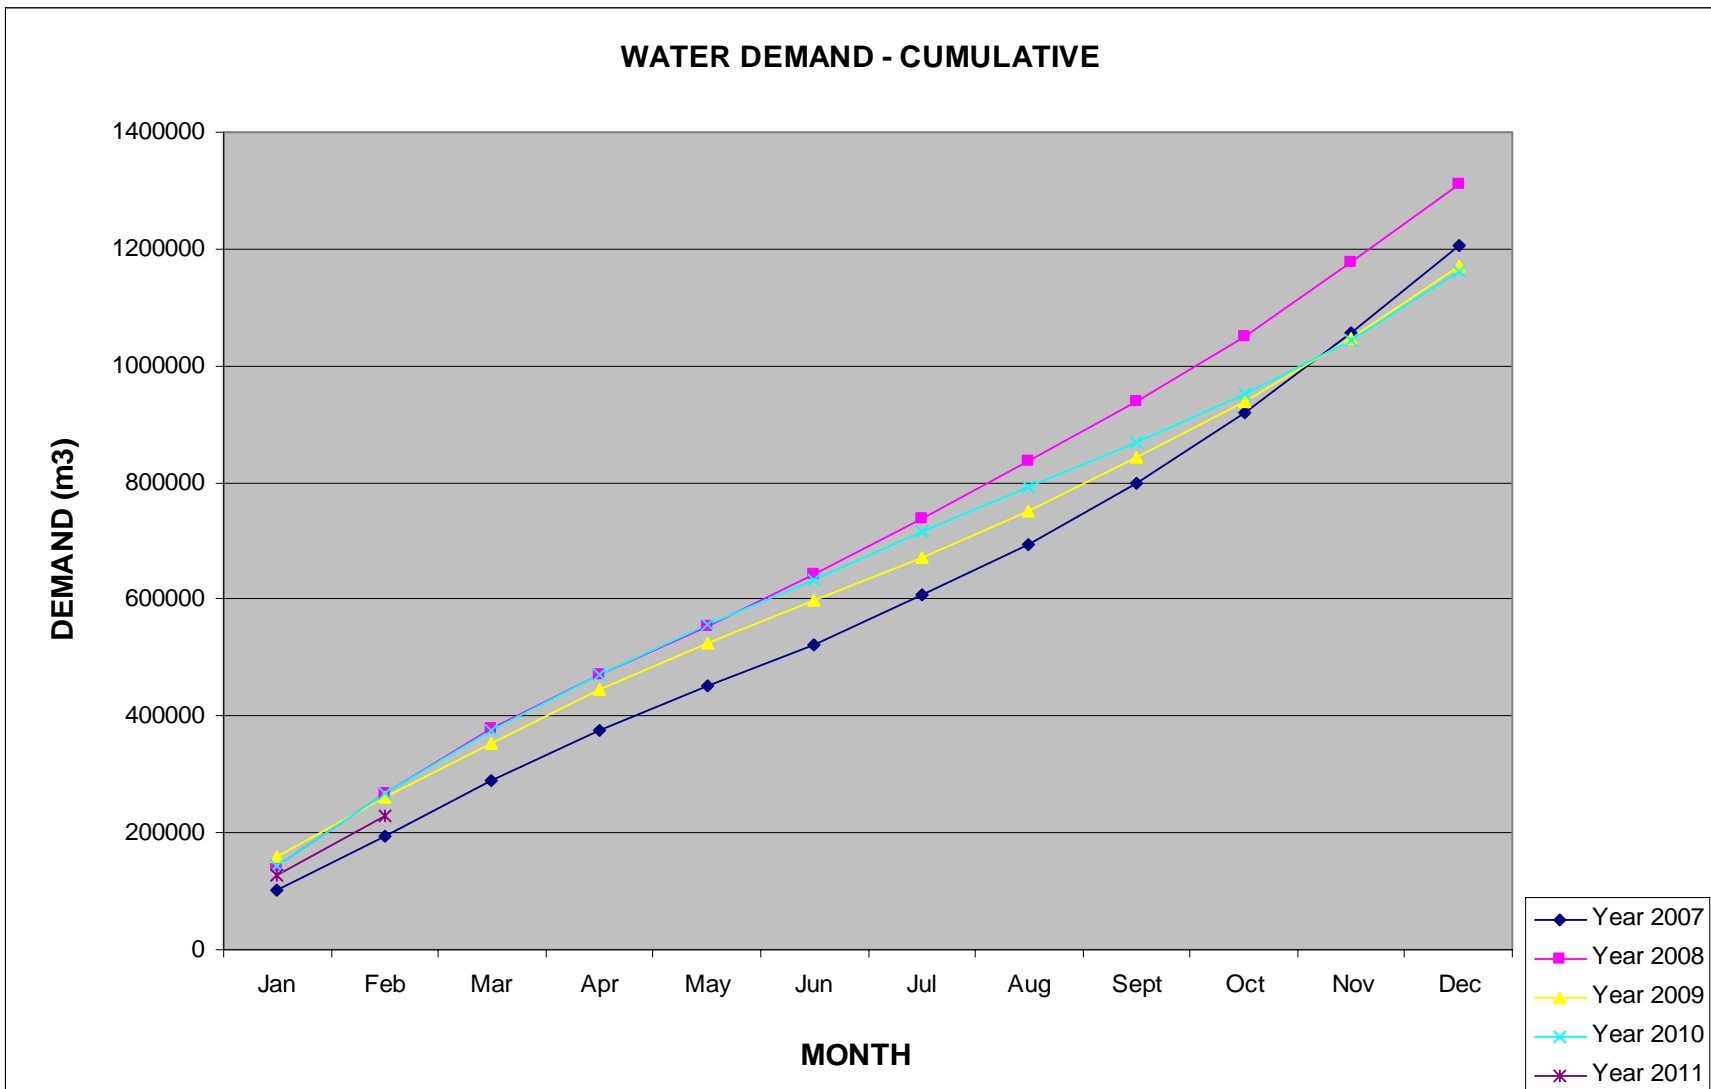
Figure 1: Yearly Cumulative Water demand

Table 1 below shows the water demand for the reporting month measured from the Mackle's bore while figure 1 on page 5 shows the yearly cumulative water demand since 2007.

Based on the financial year calendar, the cumulative water usage (demand) to date is shown in figure 1 below.

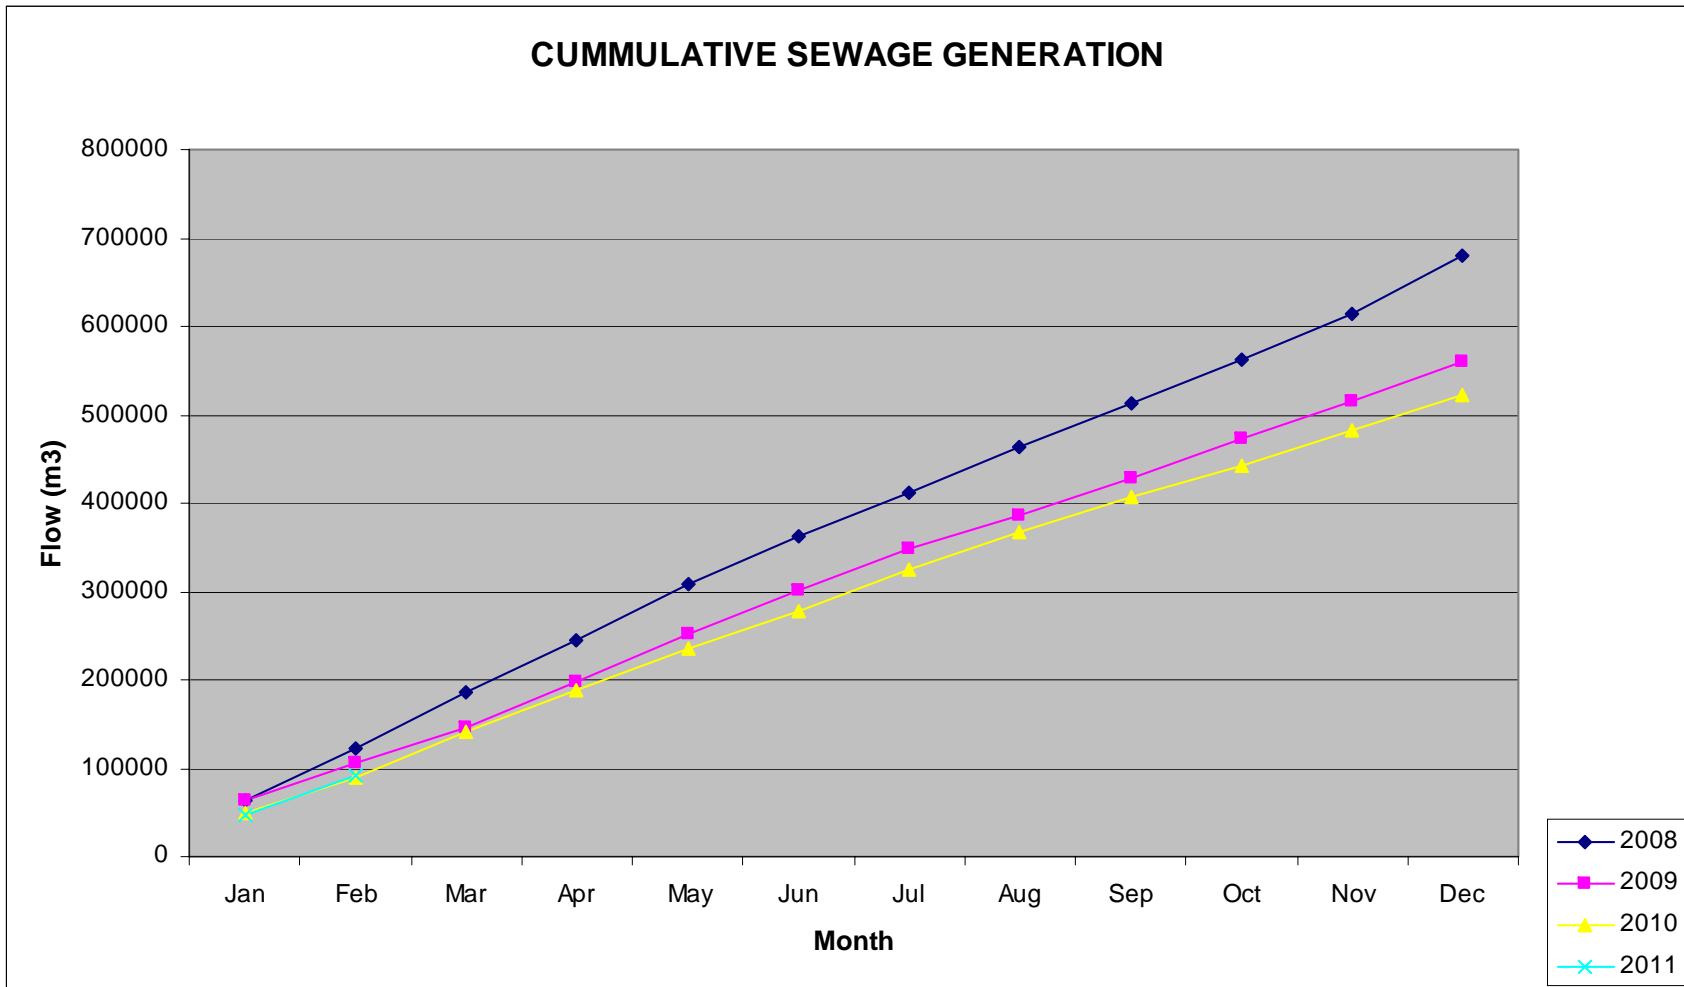
Figure 2: Yearly Sewage Generation

Table 2 below shows the average sewage flows for the reporting month as measured at the Mill Road pumping station while figure 2 on page 6 shows the sewage generation to date in comparison to previous years.

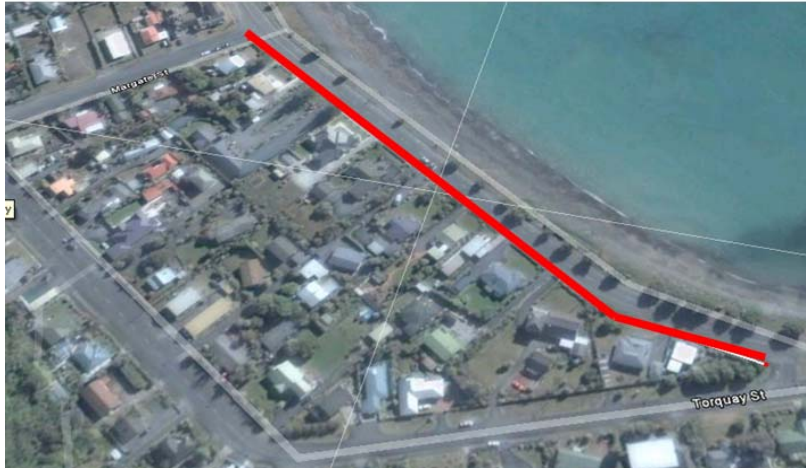
The streetlights along the Esplanade between Margate Street and Torquay Street are being replaced with six new lights and the overhead cables are being removed. The works within this section will be completed by the end of April 2011. Below is an image showing the section where the new streetlights are being installed.

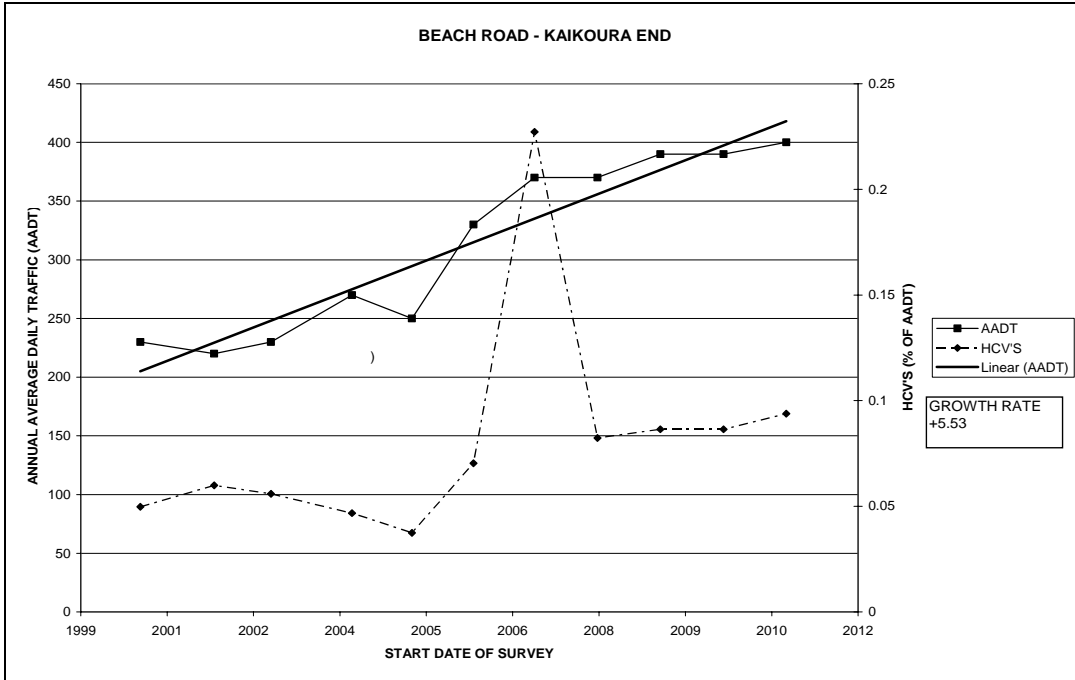
Old Beach Road (Mill Road) – 420 vehicles per Day (vpd)

The average annual daily count from 2001 to 2011 is 400 and the overall AADT growth rate since 2001 is 5.53%. 89.7% of the vehicles were travelling above the posted speed limit of 50kph with 51% of these doing between 50kph and 80kph.

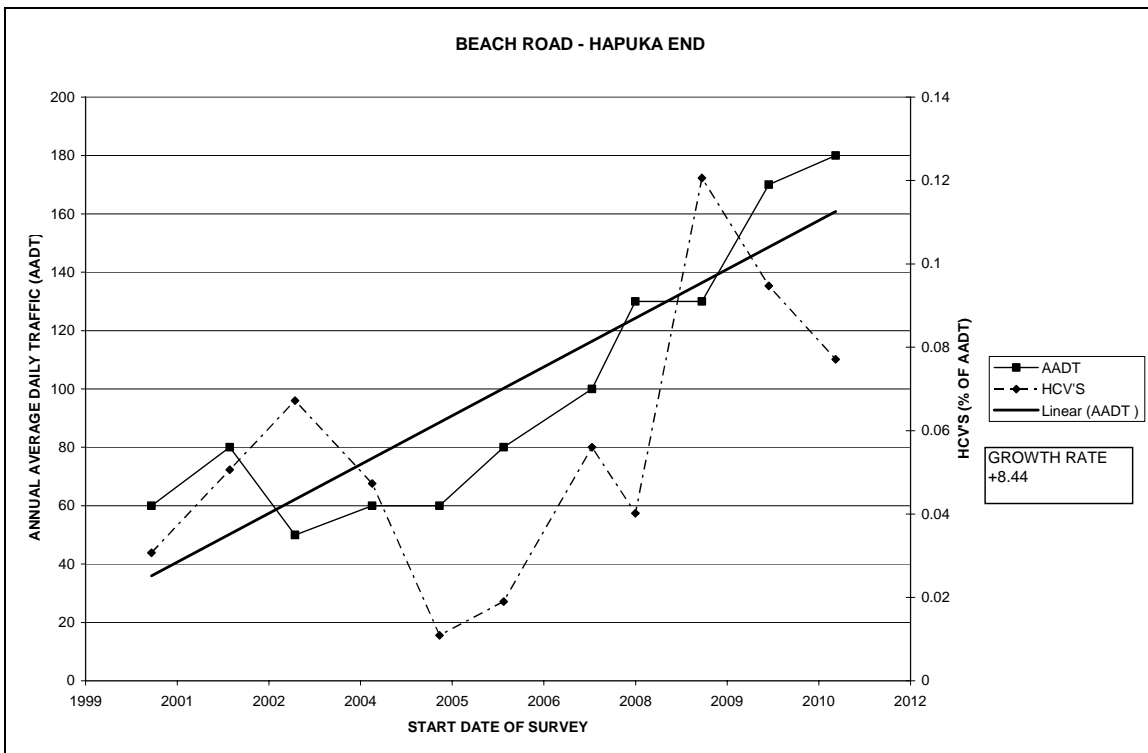
Old Beach Road (Hapuku) – 174 vehicles per Day (vpd)

The average annual daily count from 2001 to 2011 is 180 and the overall AADT growth rate since 2001 is 8.44%. Only 1.9% of the vehicles were travelling above the posted speed limit of 50kph.
