**KAIKOURA DISTRICT COUNCIL WORKS AND SERVICES
COMMITTEE MEETING HELD ON WEDNESDAY 20 APRIL
2011 IN MEMORIAL HALL SUPPER ROOM, ESPLANADE,
KAIKOURA.**

WORKS AND SERVICES REPORT

ROADING REPORT

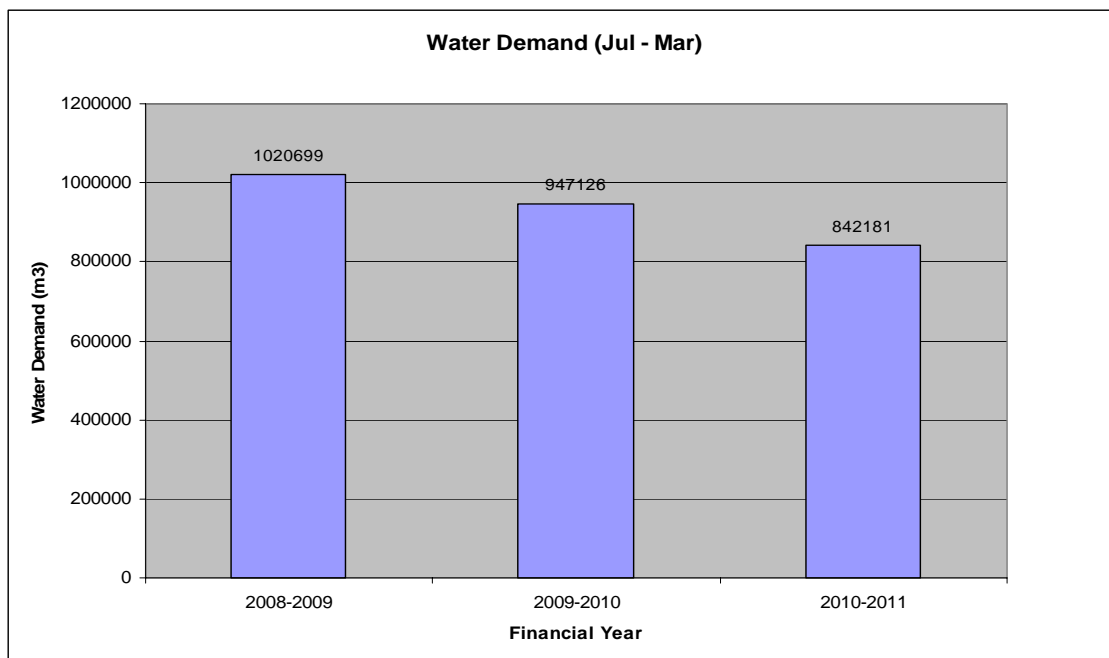
Based on the financial year calendar, the cumulative water usage (demand) to date is shown below.

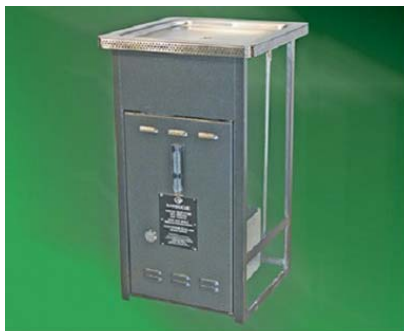
Figure 1: Option 1A - BI

As a result of these extra works, the cost to install the barbeque in this area is shown in the table below as option 1 with the different prices for varying types of barbeques - Barbeque to be bricked in (figures 1 -4) and barbeque that does not require to be bricked in (figures 5 -8)

Item	Description	Approximate cost			
		Option 1A -BI	Option 1B -BI	Option 1C -BI	Option 1D -BI
1	supply of approximately 200m of upsize cable	\$8,000.00	\$8,000.00	\$8,000.00	\$8,000.00
2	To install cable inclusive of cutting across Moa Road, reinstatement of trench and re-instatement of roadway	\$5,000.00	\$5,000.00	\$5,000.00	\$5,000.00
3	To install barbeque inclusive of electrical wiring etc	\$3,010.00	\$3,010.00	\$3,010.00	\$3,010.00
4	To prepare archaeological assessment	\$600.00	\$600.00	\$600.00	\$600.00
5	to monitor site during trenching (\$140/hr and \$1/km)	\$1,500.00	\$1,500.00	\$1,500.00	\$1,500.00
		\$18,110.00	\$18,110.00	\$18,110.00	\$18,110.00
6	Supply barbeque	\$3,939.00	\$5,660.00	\$9,605.00	\$6,195.00
	Brick in barbeque	\$2,000.00	\$2,500.00	\$3,500.00	\$2,000.00
	Total	\$24,049.00	\$26,270.00	\$31,215.00	\$26,305.00

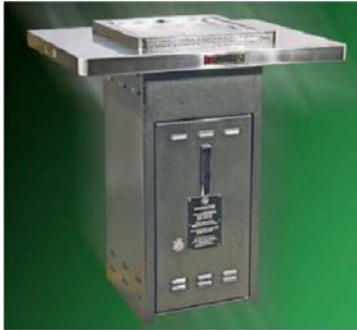
The cost for this would be approximately \$8995.00, \$2,000.00 of which includes cost to brick in the barbecue.

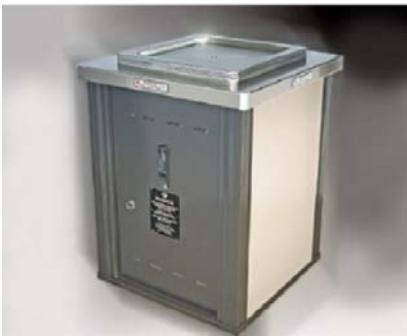
The cost for this would be approximately \$6,895.00, and does not require to be bricked in

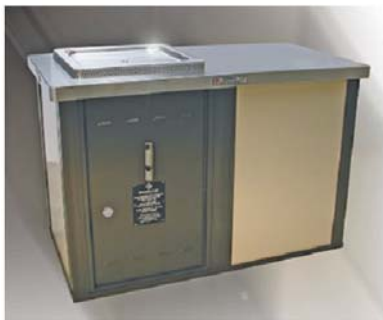
The cost for this would be either \$8070.00 or \$8795.00 depending on whether there is a gas compartment door. This unit would not need to be bricked in.

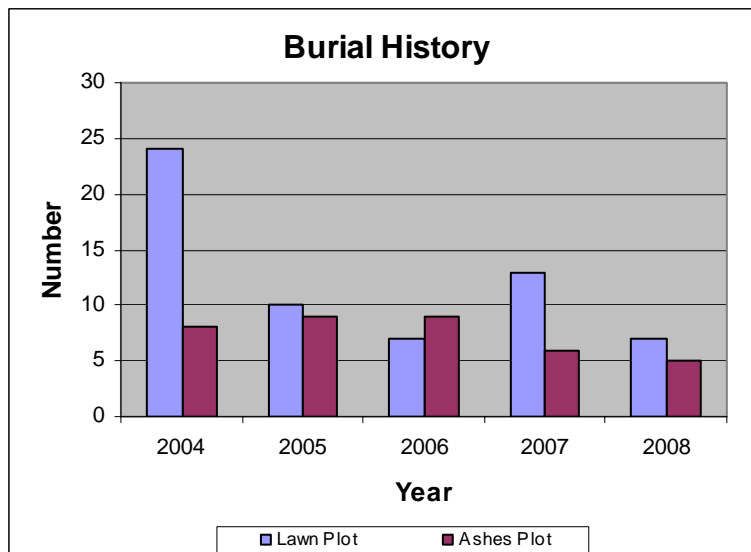
In 2008 when the Sanitary services assessments were carried out it was established that there were approximately 7 years of formed plots remaining to be used (this was done based on uptake rates) as shown in figure 1 below.

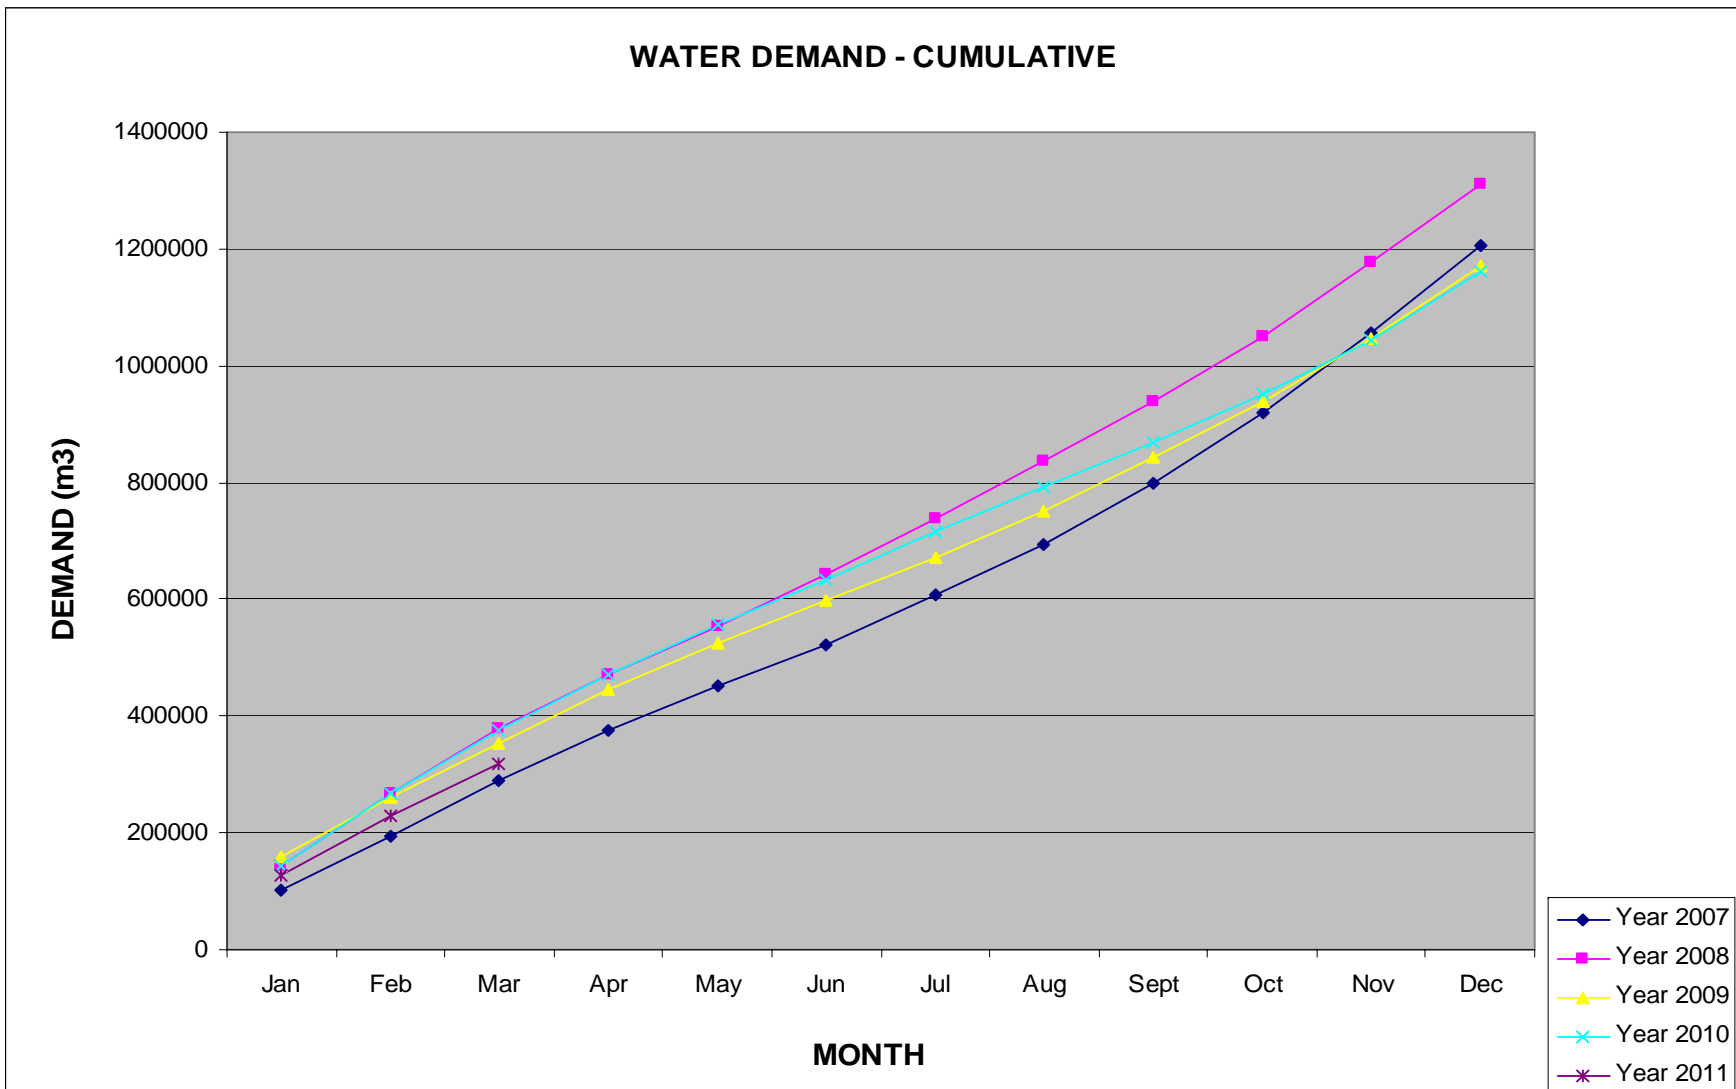
Figure 1: Yearly Cumulative Water demand

Table 1 below shows the water demand for the reporting month measured from the Mackle’s bore while figure 1 on page 12 shows the yearly cumulative water demand since 2007.

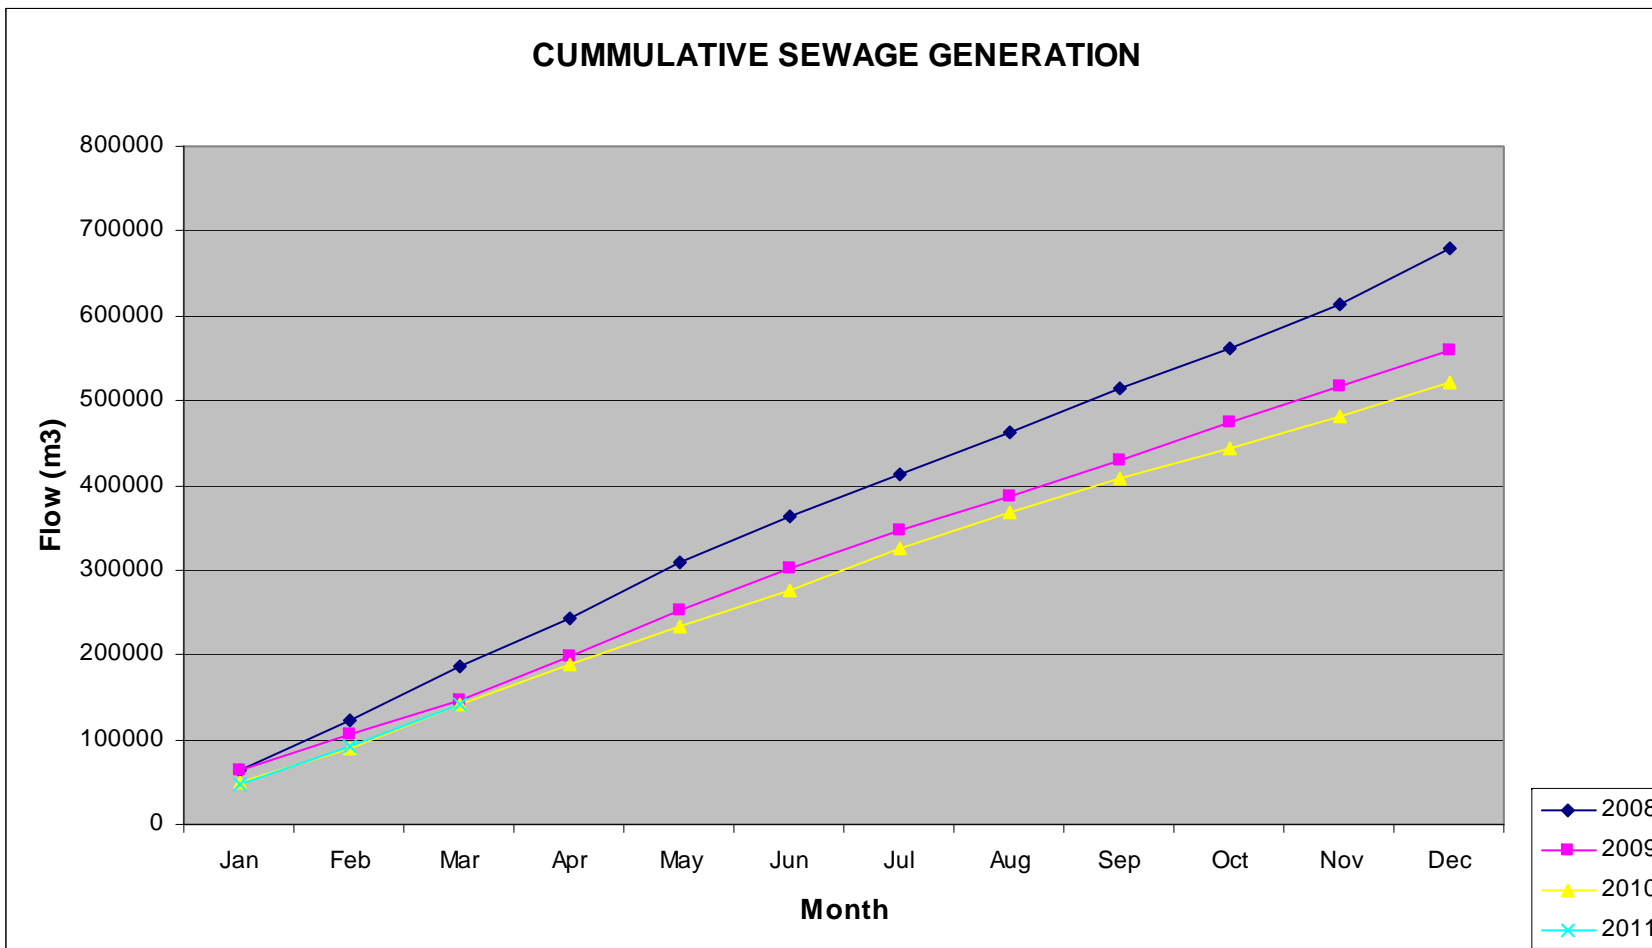
Figure 2: Yearly Sewage Generation

Table 3 below shows the average sewage flows for the reporting month as measured at the Mill Road pumping station while figure 2 on page 13 shows the sewage generation to date in comparison to previous years.

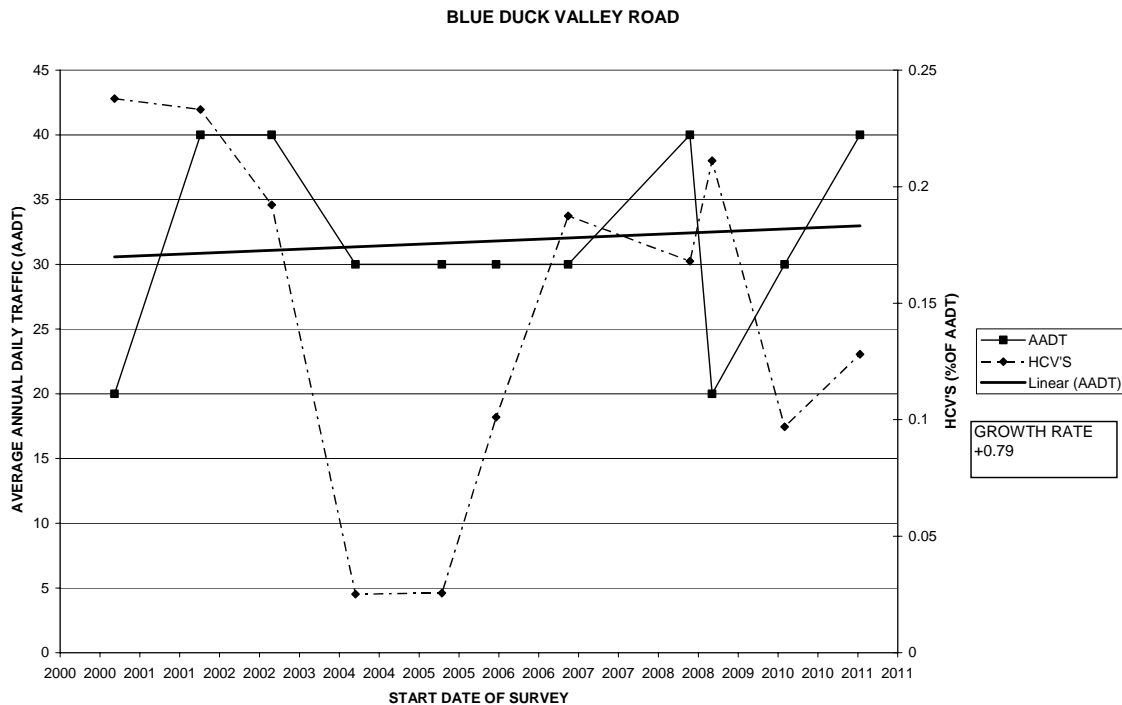
Blue Duck Valley Road– 40 Vehicles per day (vpd)

The average annual daily count from 2001 to 2011 is 39 and the overall AADT growth rate since 2001 is 0.79%. Only 1.5% of the vehicles were travelling above the posted speed limit of 50kph doing between 50kph and 60kph.

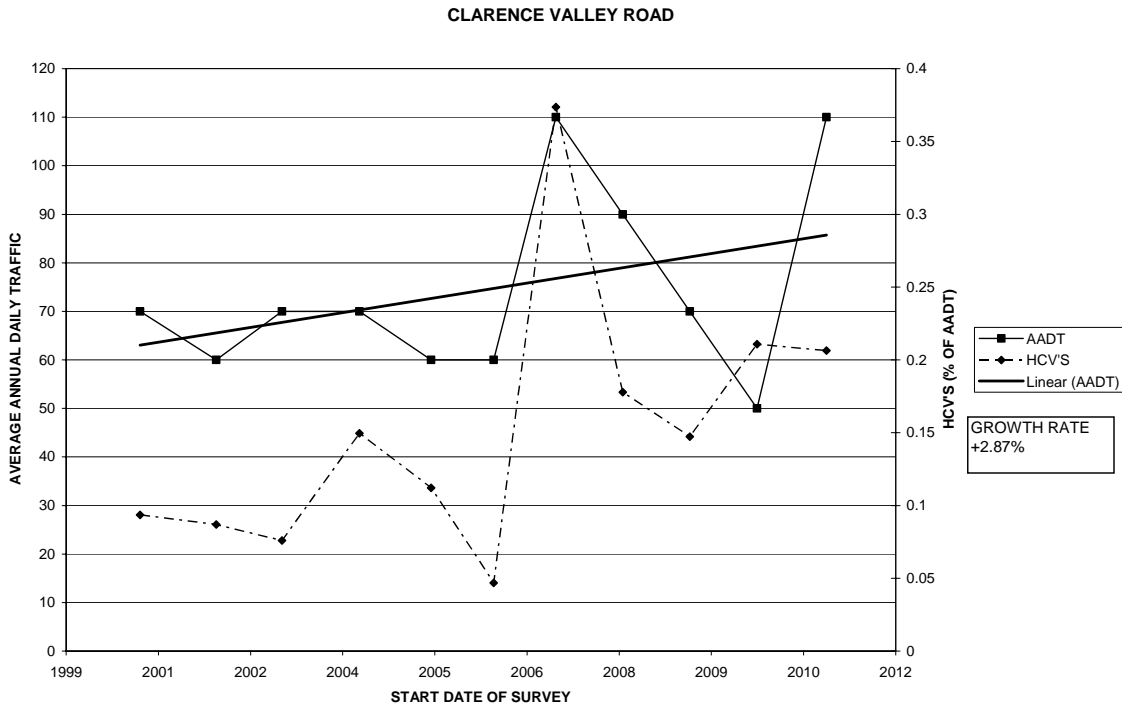
Clarence Valley Road– 108 Vehicles per day (vpd)

The average annual daily count from 2001 to 2011 is 75 and the overall AADT growth rate since 2001 is 2.87%. 64% of the vehicles were travelling above the posted speed limit of 50kph. 35% of these were travelling between 50 and 60kph and 21% were travelling between 60 and 70kph.
