**KAIKOURA DISTRICT COUNCIL WORKS AND SERVICES
COMMITTEE MEETING HELD ON WEDNESDAY 17
AUGUST 2011 IN MEMORIAL HALL SUPPER ROOM,
ESPLANADE, KAIKOURA.**

WORKS AND SERVICES REPORT

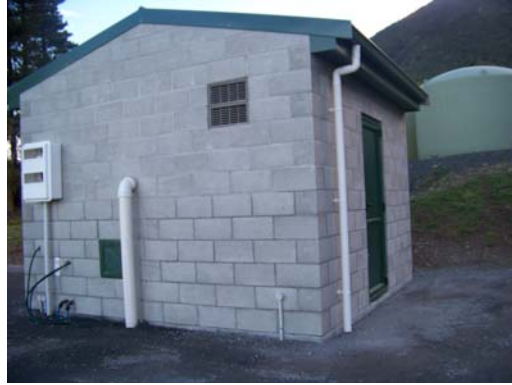
Figure 2: Newly build treatment Shed - Kincaid Supply

The installation of the Kincaid treatment system has been completed. The system operated fairly well however due to the required fittings on the filter the flow into the tank has dropped resulting to slow filling of the concrete tank. We are currently sourcing a booster pump to install parallel to the gravity system to compensate for the low flows reaching the final tank. In addition the integration of the new system into the telemetry is currently being worked on.

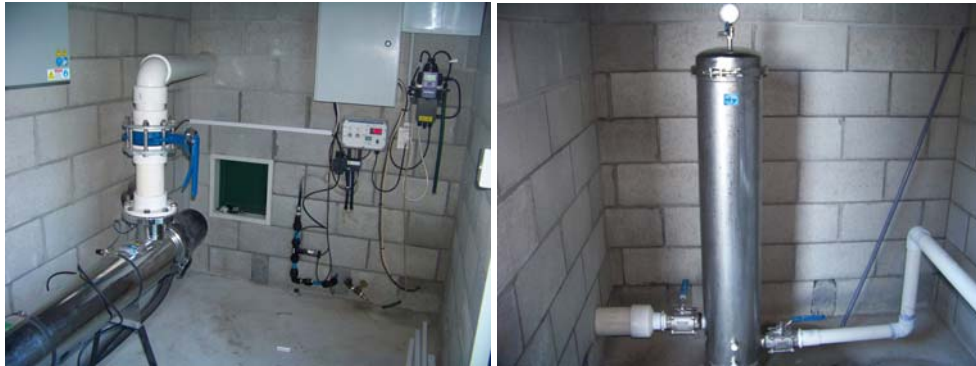
Figure 3: New UV and Cartridge Filtration System

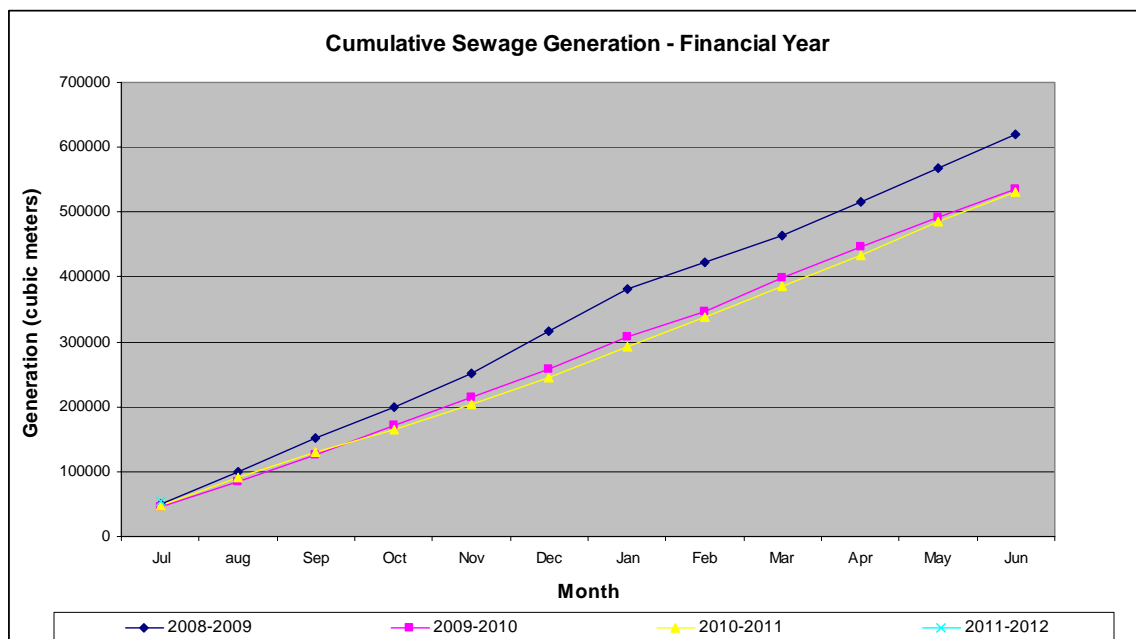
Figure 4: Financial Year cumulative Sewage Generation

The total flow for the month of July 2011 was approximately 55,196m³. From the 8th of July up to and including the 27th of July the flows into the sewer system were very high for this time of the year.

The measured Dissolved Oxygen (DO) averaged 9.4mg/l for the reporting month.

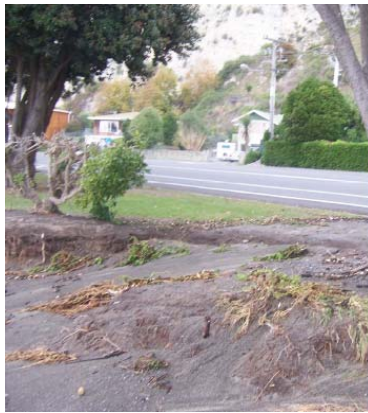
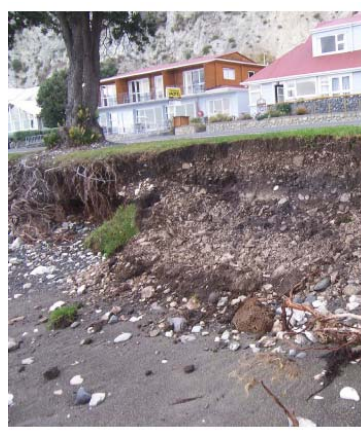
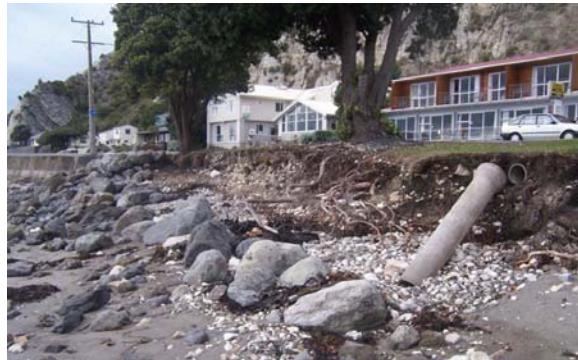
During the reporting month significant erosion took place along the Esplanade foreshore. To mitigate further erosion a rock wall was constructed for approximately 125m as shown in the pictures below. The works were carried out in agreement with Environment Canterbury under Kaikoura District Council's beach re-nourishment consent.

Figure 5: Esplanade Erosion

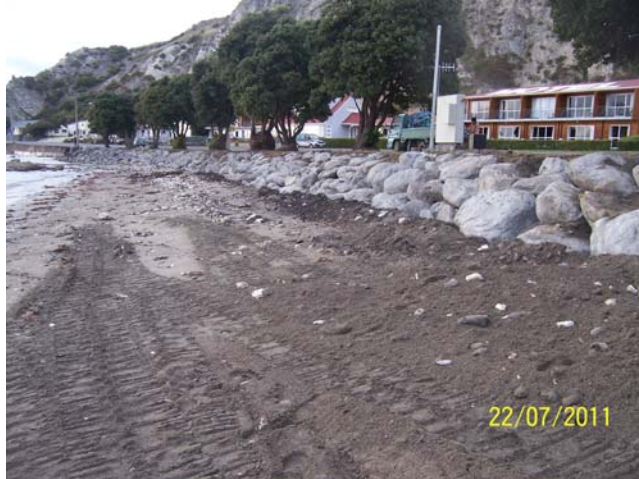
Figure 6: Rock Wall to reduce the impact of erosion along Esplanade

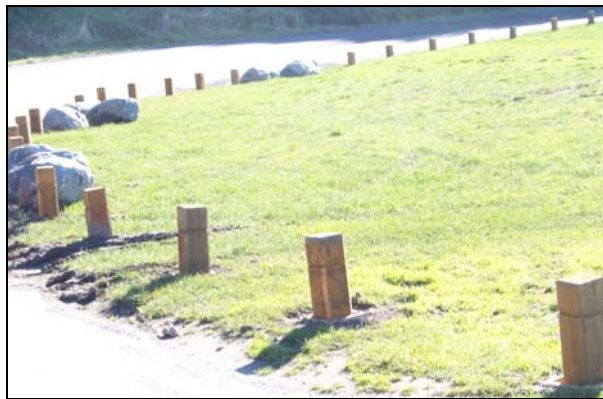
The cordon has been placed around the grassed area at Jimmy Armers as shown in figure 7 below.

Figure 7: Cordon around Jimmy Armers grassed area

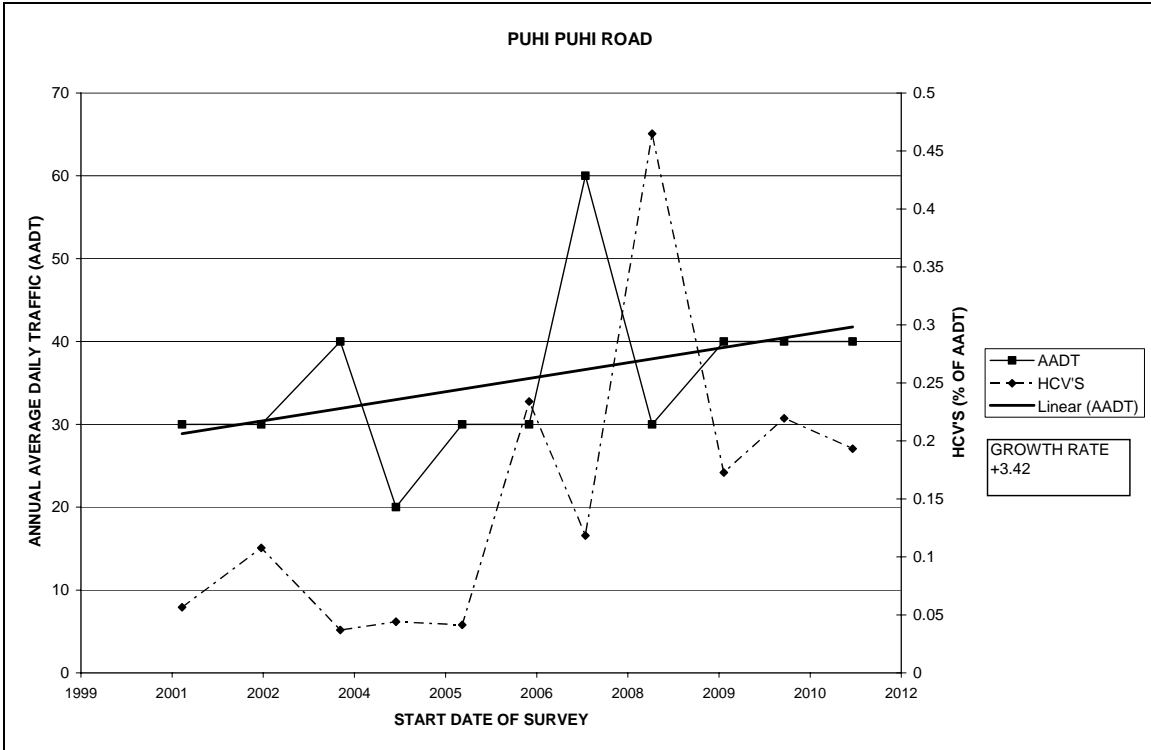
Puhi Puhi Road– 34 Vehicles per Day (vpd)

The average annual daily count 40 and the overall AADT growth rate since 2001 is 3.42%. 10.5% of the vehicles were travelling above the posted speed limit of 50kph. 10.1% were travelling between 50 and 60kph.

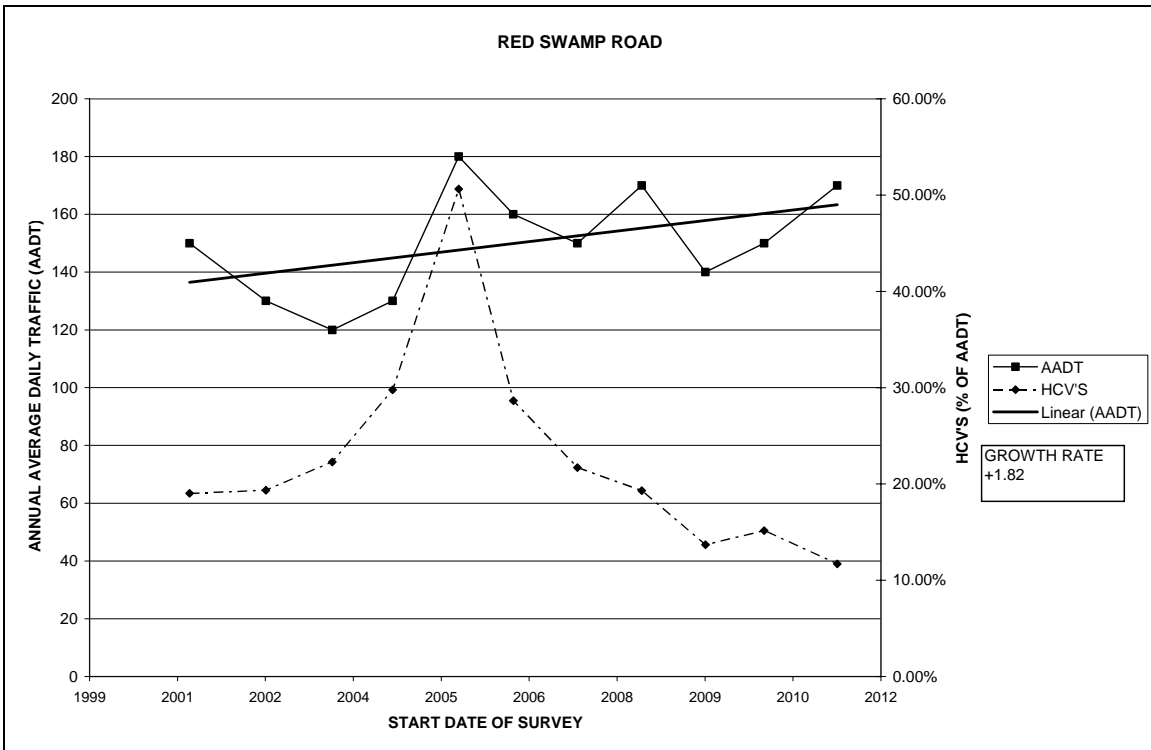
Red Swamp Road – 171 Vehicles per Day (vpd)

The average annual daily count from 2011 is 170 and the overall AADT growth rate since 2001 is 1.82%. 9% of the vehicles were travelling above the posted speed limit of 100kph. 6.5% were travelling between 100 and 110kPh.
