**WORKS AND SERVICES COMMITTEE MEETING HELD AT  
9.00AM ON WEDNESDAY 16 NOVEMBER 2011 IN  
MEMORIAL HALL SUPPER ROOM, ESPLANADE,  
KAIKOURA.**

# Works & Services Report

# Roading Report

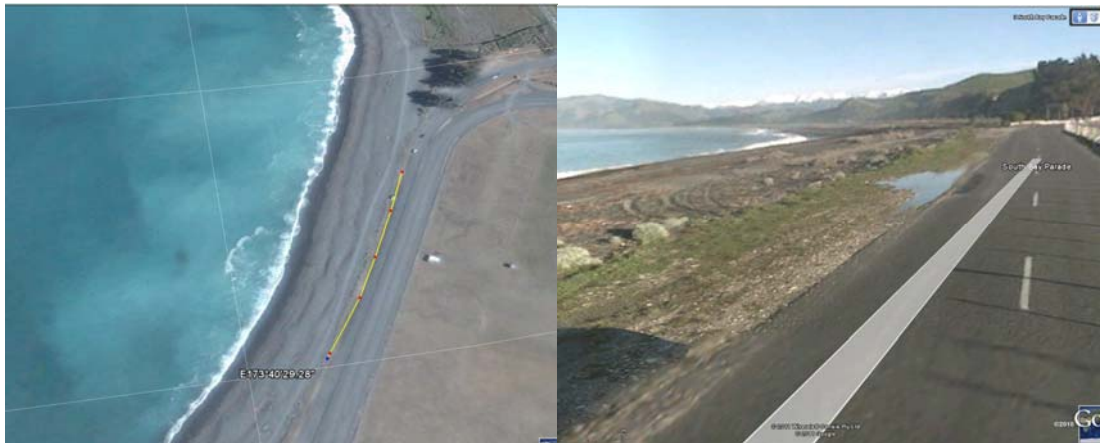
We are having problems with water ponding on the section of road highlighted in the map below. This has been an issue for many years and is very bad for the road and also unsightly. We are looking at installing 285 metres of kerb and channel along the affected edge with 3 sumps and soak pits to address the issue. Other options were considered but deemed to be inappropriate given the nature of the area.

If Council is happy for the works to be completed as proposed this will be completed under minor improvement works.
