OCEAN RIDGE, KAIKOURA  
PROPOSED PLAN CHANGE

STORMWATER MODELLING

**CARGILL STATION LTD**  
**OCEAN RIDGE, KAIKOURA - PROPOSED PLAN CHANGE**

**STORMWATER MODELLING STUDY**

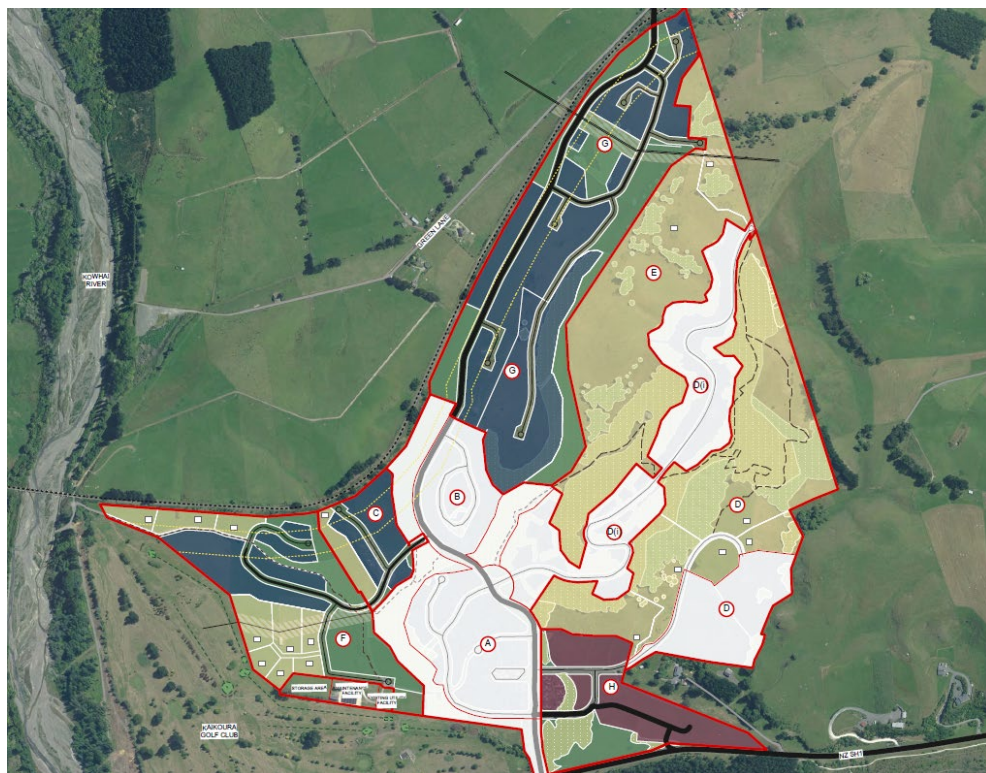
**Figure 1: Proposed Master Plan**

We understand that Cargill Station Ltd. intends to develop the northern and western parts of the site into residential areas and to add a commercial area at the southern end, as illustrated in the proposed Master Plan in Figure 1 below, referred to as the 'post-development condition'.

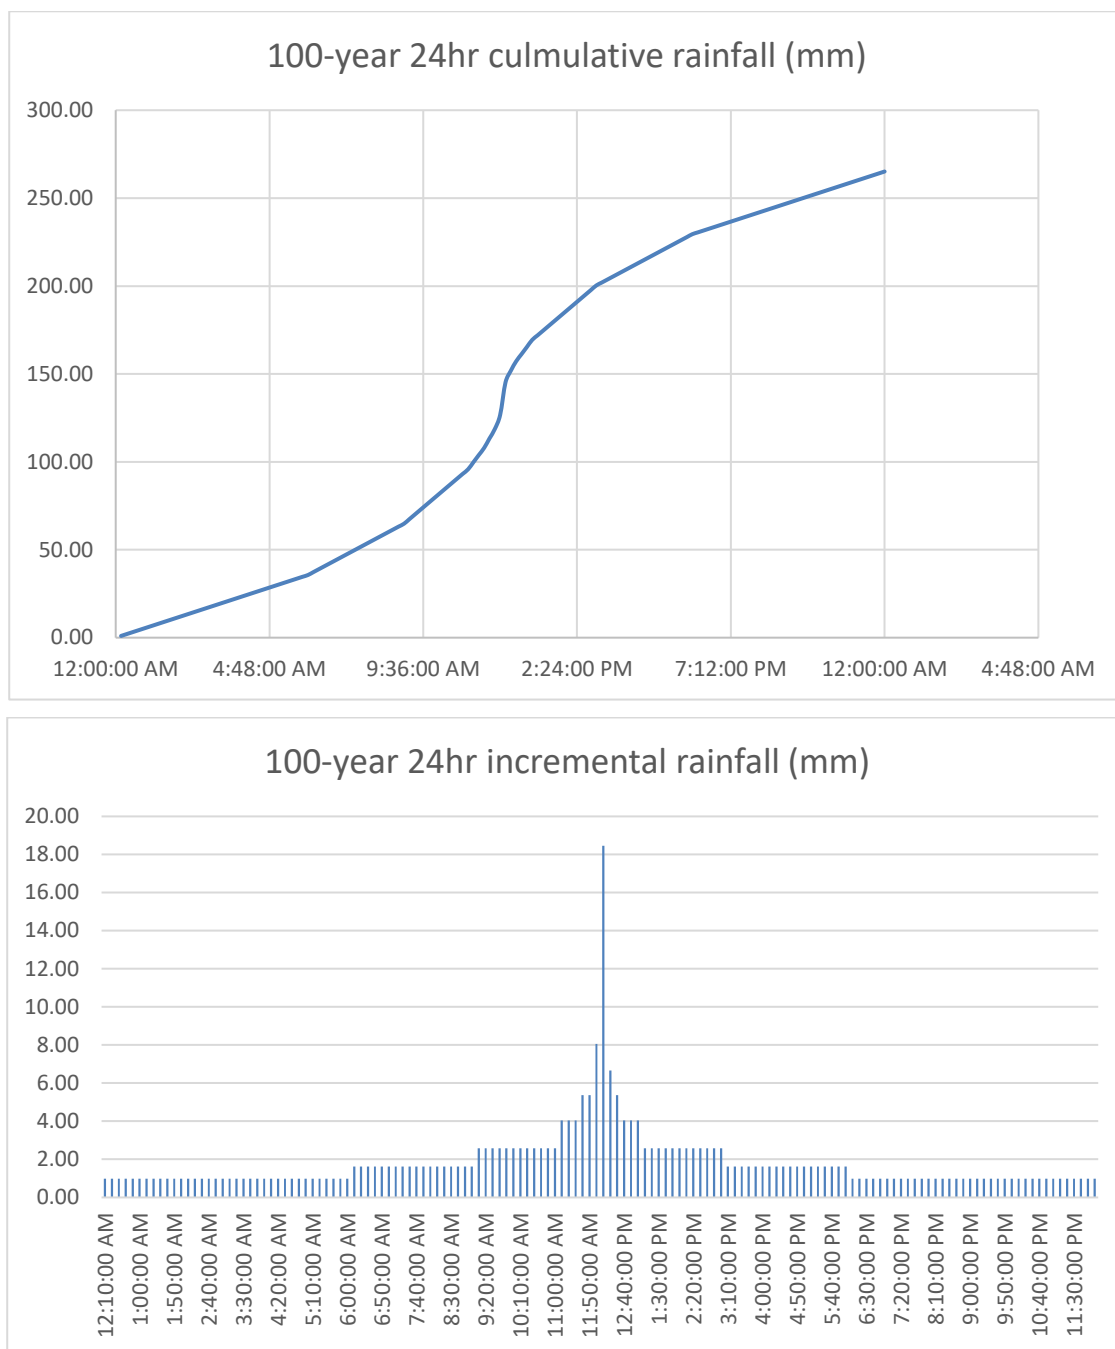
**Figure 3: Synthetic temporal rainfall pattern**

A synthetic temporal rainfall distribution was adopted for the site. The 100-year cumulative and incremental rainfall patterns are shown in Figure 3. Other rainfall events follow a similar pattern.

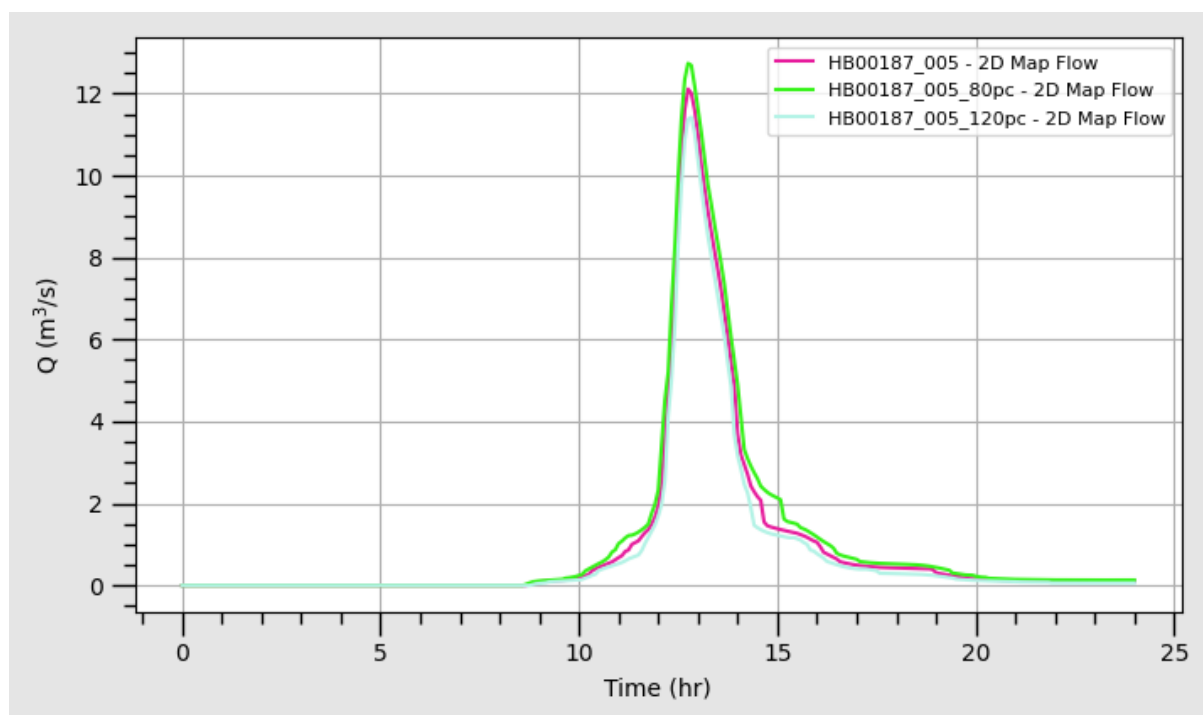
**Figure 4: Sensitivity Test with +/- 20% Infiltration Rates**

The infiltration test results vary significantly across the site. A sensitivity test was conducted by altering the infiltration rates by +/- 20%, resulting in only a +/- 5% change in the flow rate. Therefore, the infiltration rates adopted for the model are deemed appropriate.

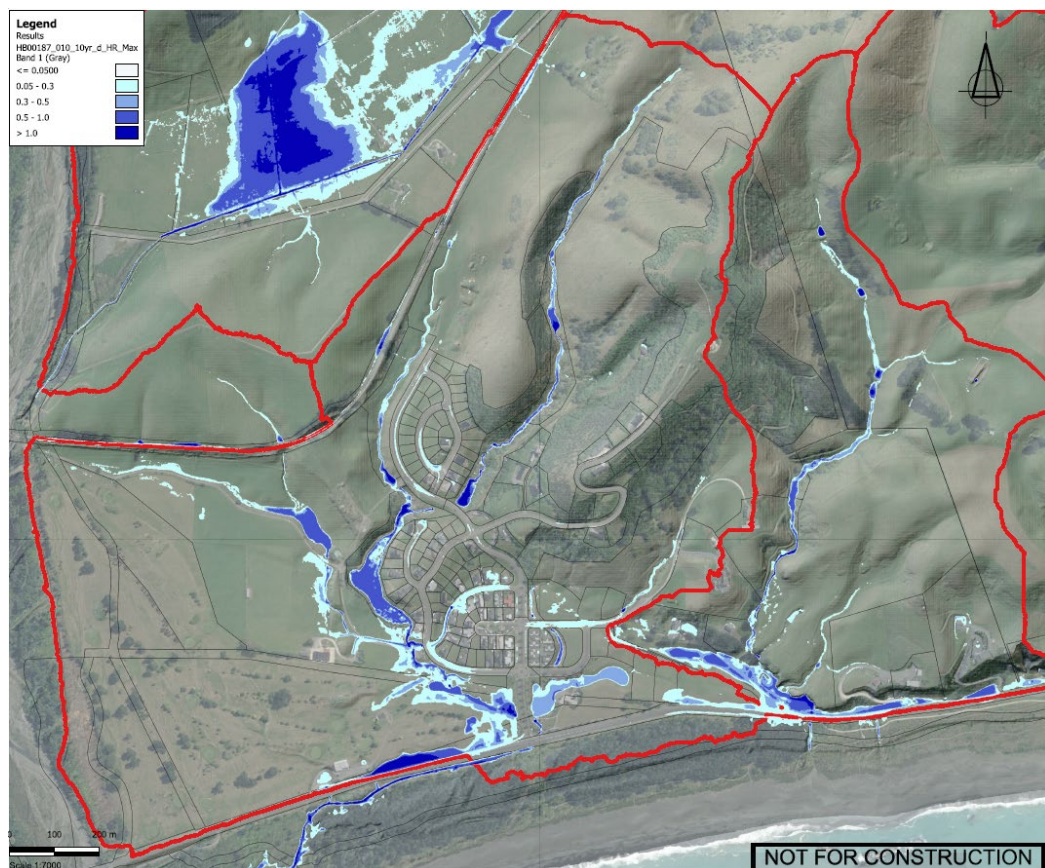
**Figure 5: 10-year Pre-development Flood Extent**

The current stormwater system within the site performs satisfactorily during 10-year and 100-year events. Most of the flooding occurs in the existing gullies and stormwater detention areas, with minor flooding on the roads. However, due to downstream constraints, water backs up in the system and floods the area immediately north of the state highway, as shown in Figures 5 and 6.

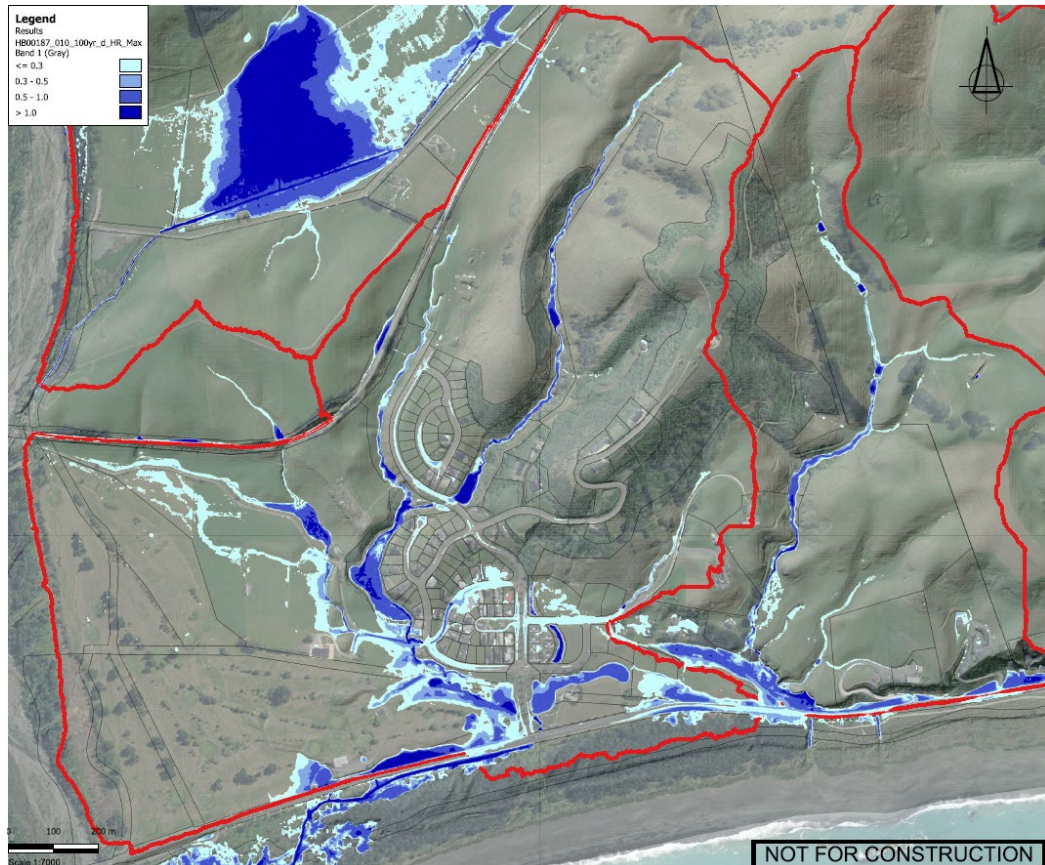
**Figure 6: 100-year Pre-development Flood Extent**

During a 100-year event, it is predicted that flooding will occur on the state highway. Any future intensification should be managed to avoid worsening the current flooding condition.

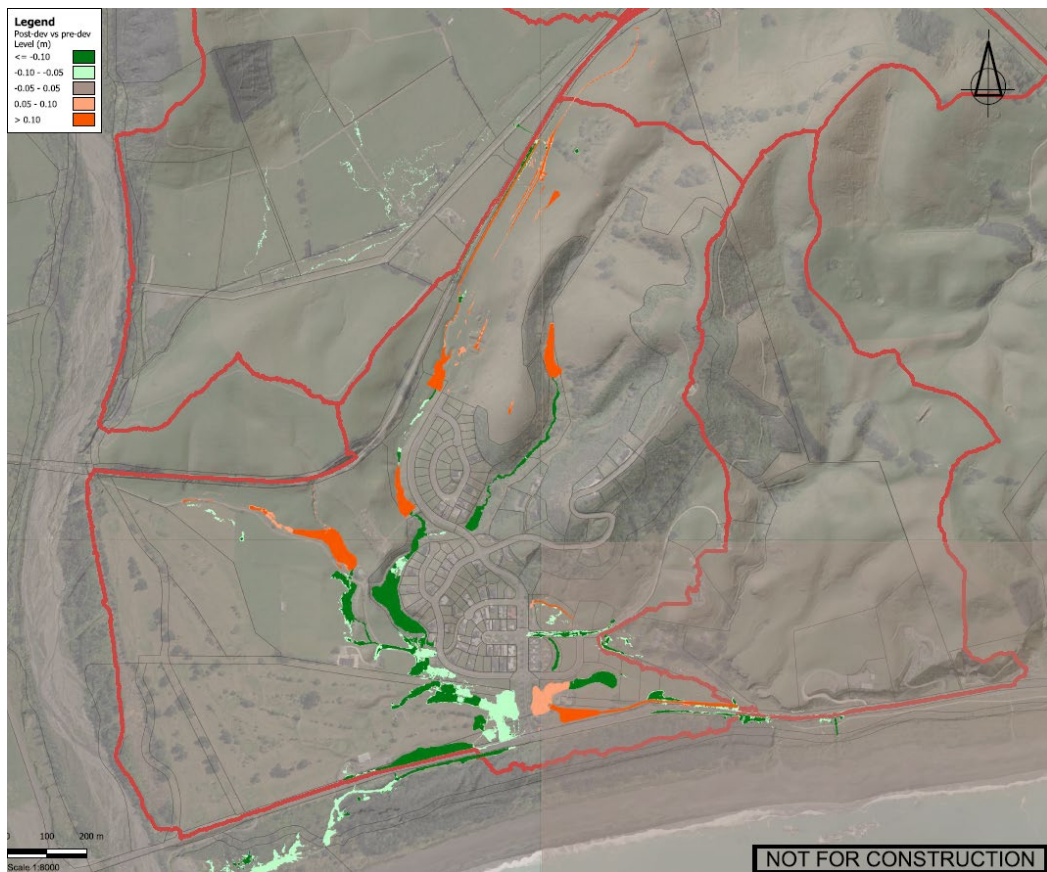
**Figure 9: 10-year Flood Level Difference**

The depth of floodwater increases significantly in existing gullies where new embankments and detention basins are present, as illustrated in Figures 9 and 10. However, it does not have any adverse effects on the development.

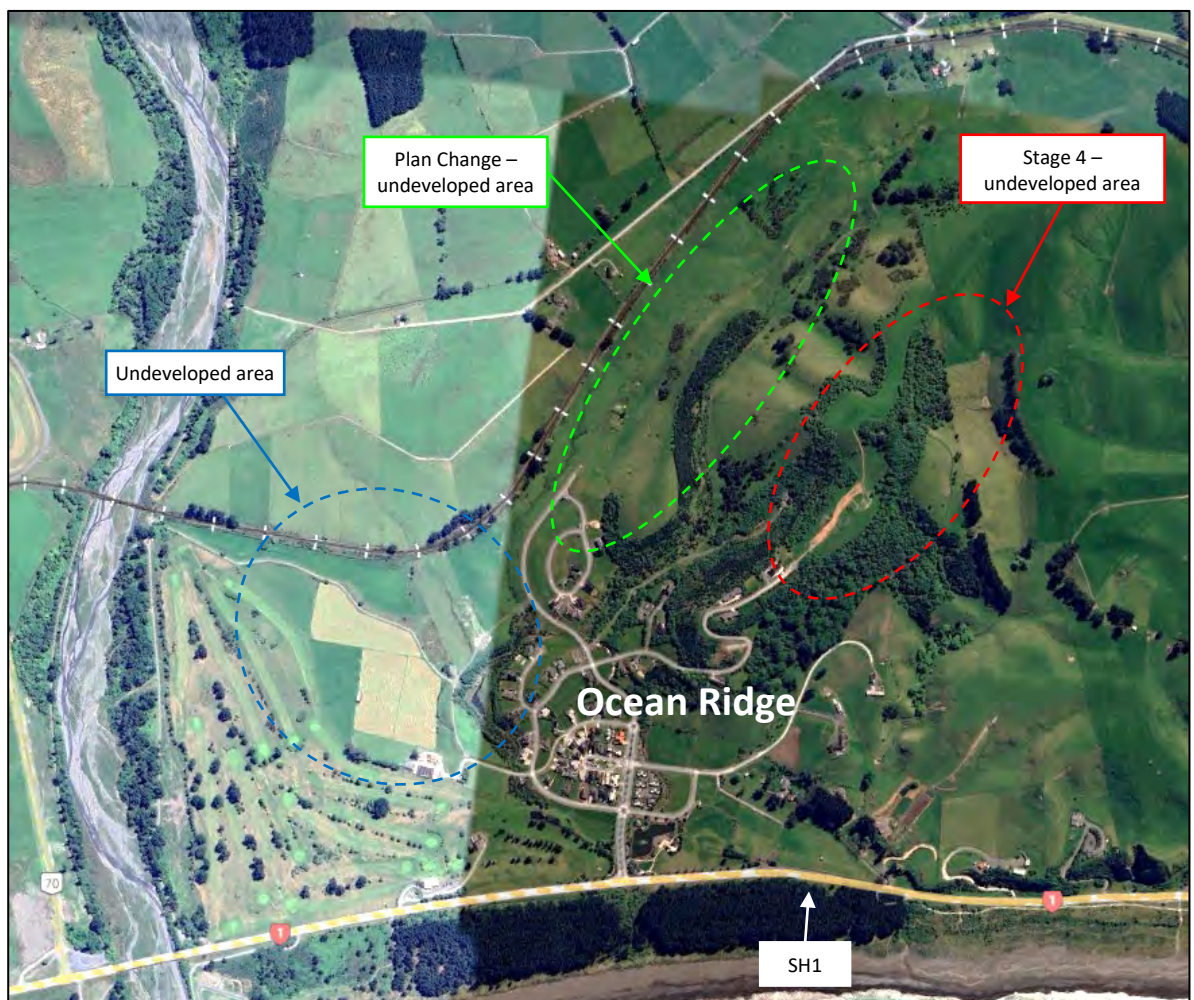
**Figure 1: Ocean Ridge Subdivision – Site Location**

Stormwater runoff is collected through a network of pipe reticulated drains and gutters, which discharge into a series of channels and in-line stormwater basins/ponds, followed by discharge off-site, south, below SH1.

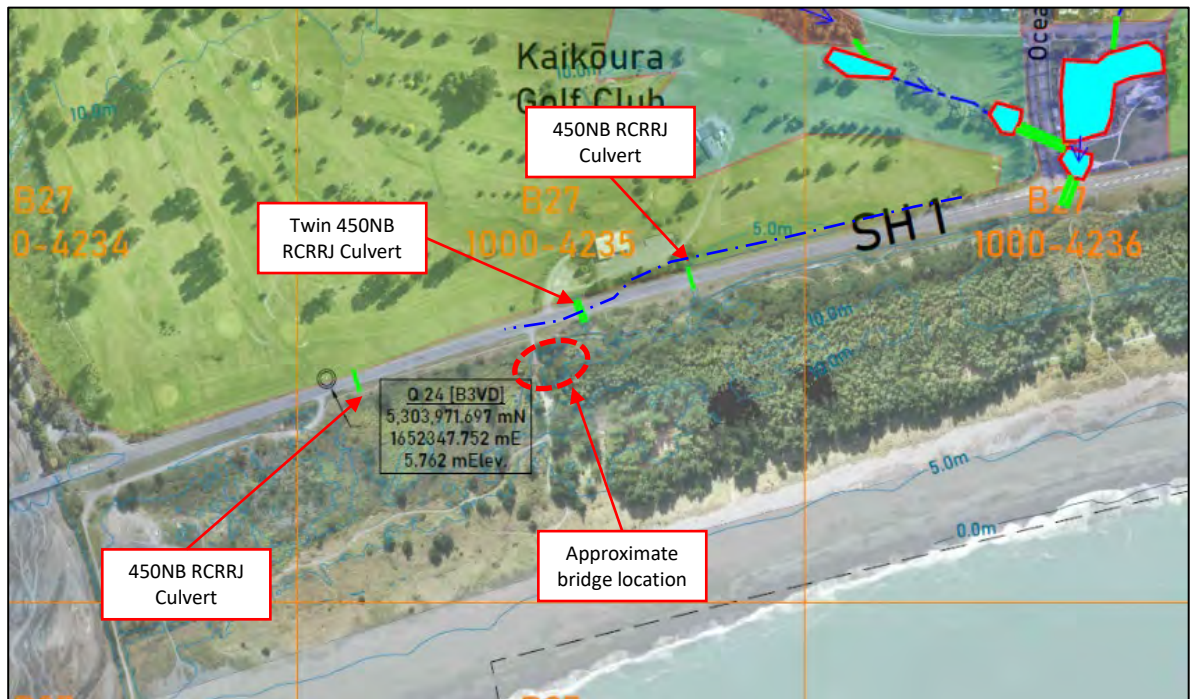
Stormwater runoff from the adjacent Kaikoura Golf Club greens discharges off-site, below SH1, through 450NB RCRRJ culvert pipes at the three locations shown in Figure 3. These culverts were not actively flowing.

**Figure 3: 450NB RCRRJ Culvert Pipes Discharging from the Golf Course and Crossing SH1**

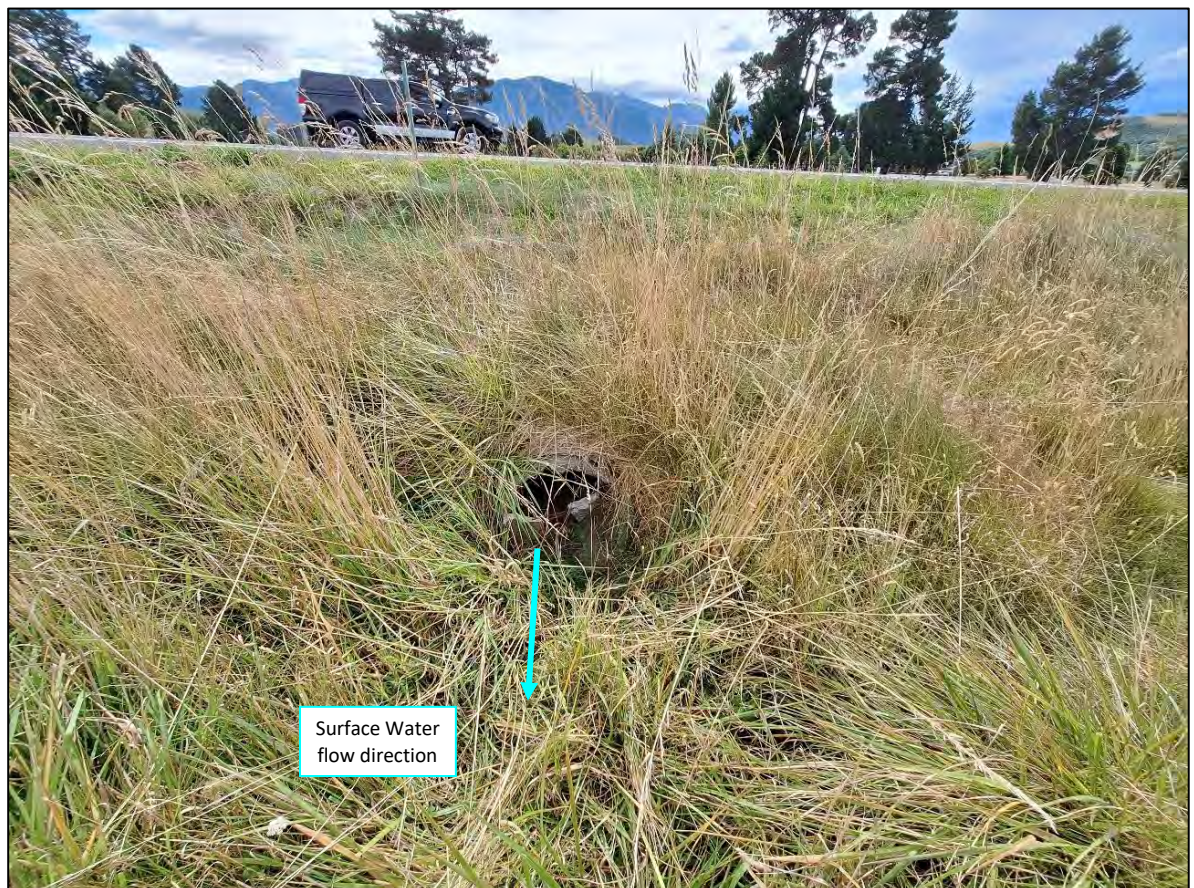
The 450NB SH1 culvert outlets (at the south side of SH1) were found to be either partially broken or obstructed by vegetation. All culverts were angled eastwards, which follows the expected drainage path trend.

**Figure 4: 450NB RCRRJ Culvert Outlet Discharging from the Golf Course (Crossing SH1)**

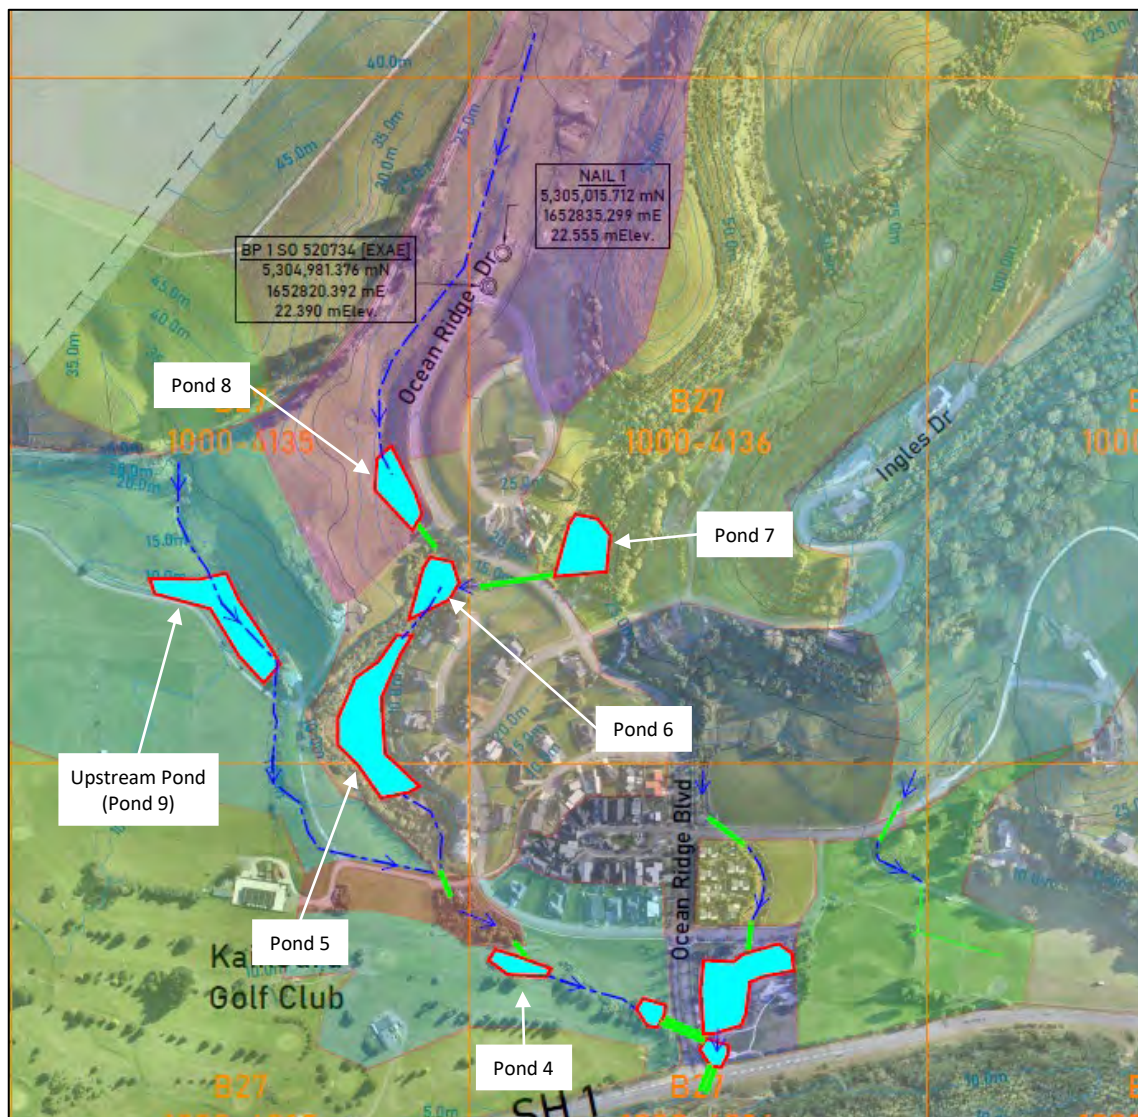
Runoff from the northern part of Ocean Ridge flows southwards through Ponds 8, 7, 6, 5 and then onto Pond 4.

Pond 9 flows south east to Pond 4, and was found to be heavily vegetated at the time of the site investigation.

Figure 7: Stormwater Drainage Network Showing Ponds 9 to 4

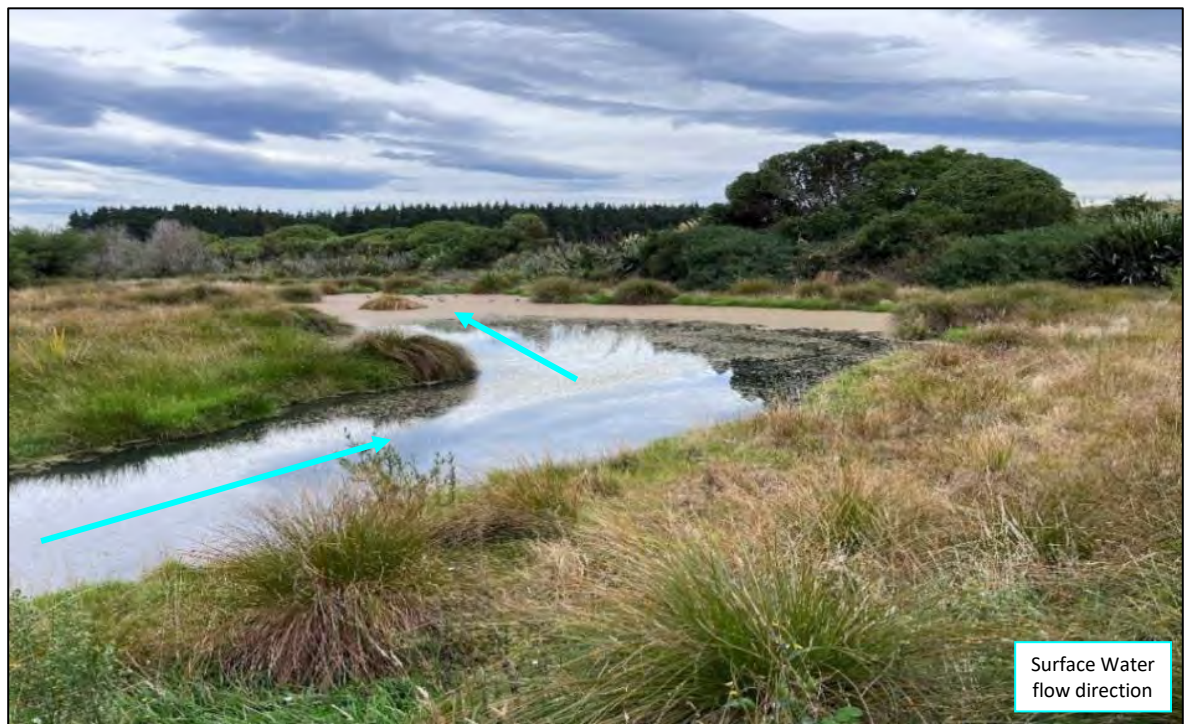
**Figure 13: Pond 5**

Pond 5 had a slow moving flow through to Pond 4 at the time of the site investigation.

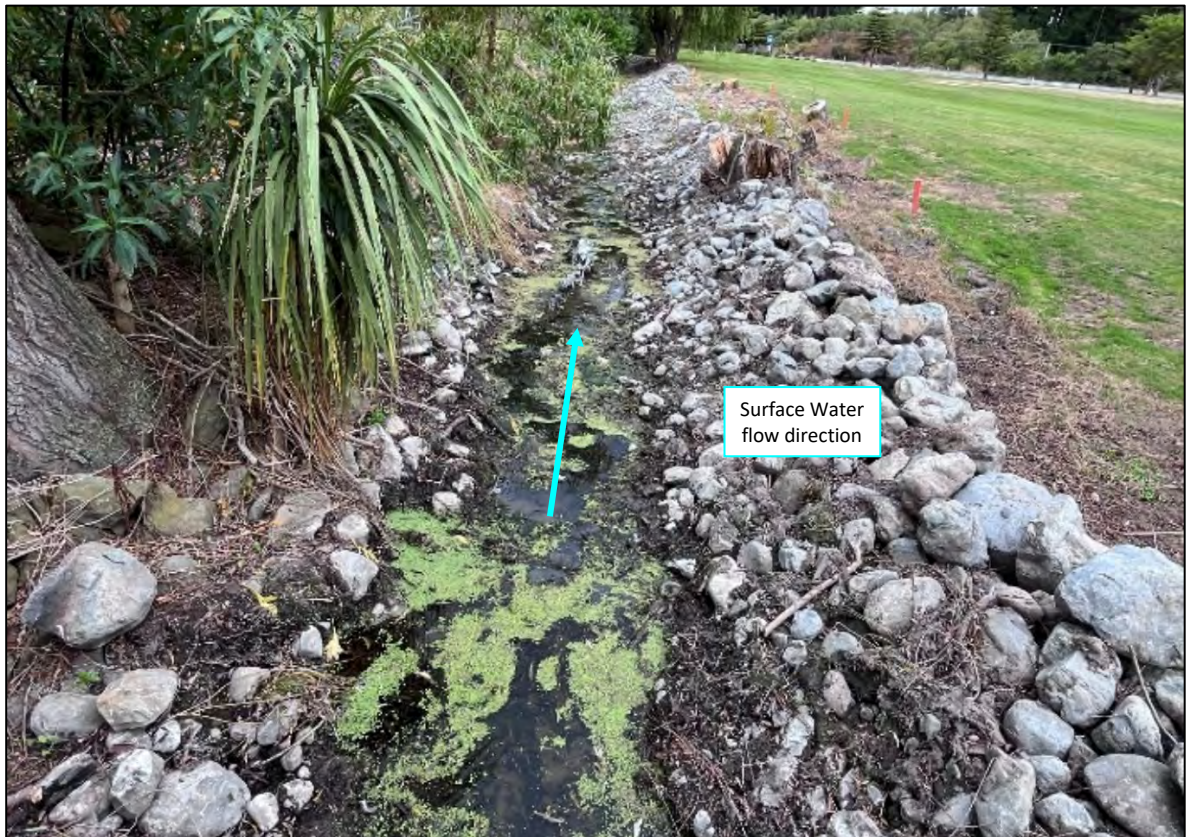
Water from Pond 5 to Pond 4 via an open channel as shown in Figure 14.

Figure 14: Open Channel from Pond 4 to Pond 3

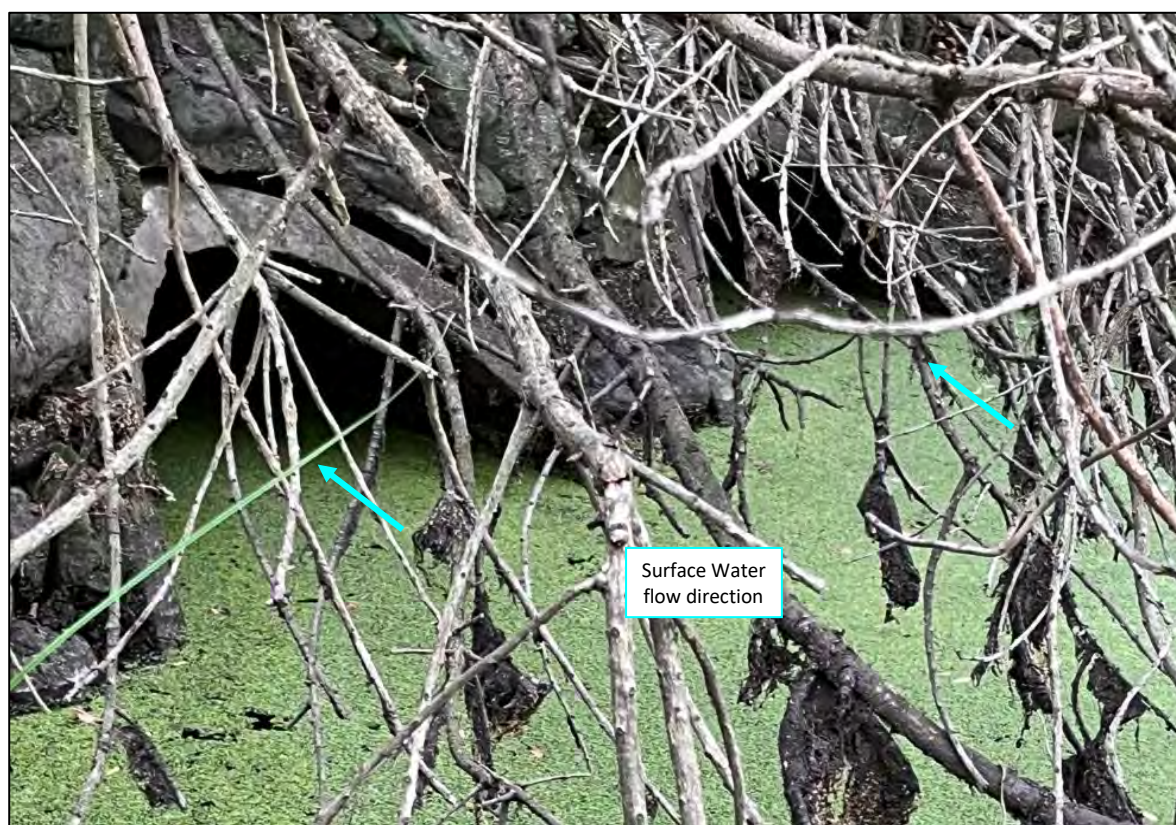
**Figure 16: Pond 3 Twin 900NB RCRRJ Culvert Pipe Outlets (to Pond 1)**

Twin 900NB RCRRJ culvert pipes situated underneath Ocean Ridge Boulevard carry stormwater runoff from Pond 3 to Pond 1. Both pipes were be partially submerged at the time of the investigation. Pond 1 inlets were also submerged at the time of the investigation. The partially submerged pipelines were observed on multiple visits. Historic design drawings denote these ponds as wet ponds.

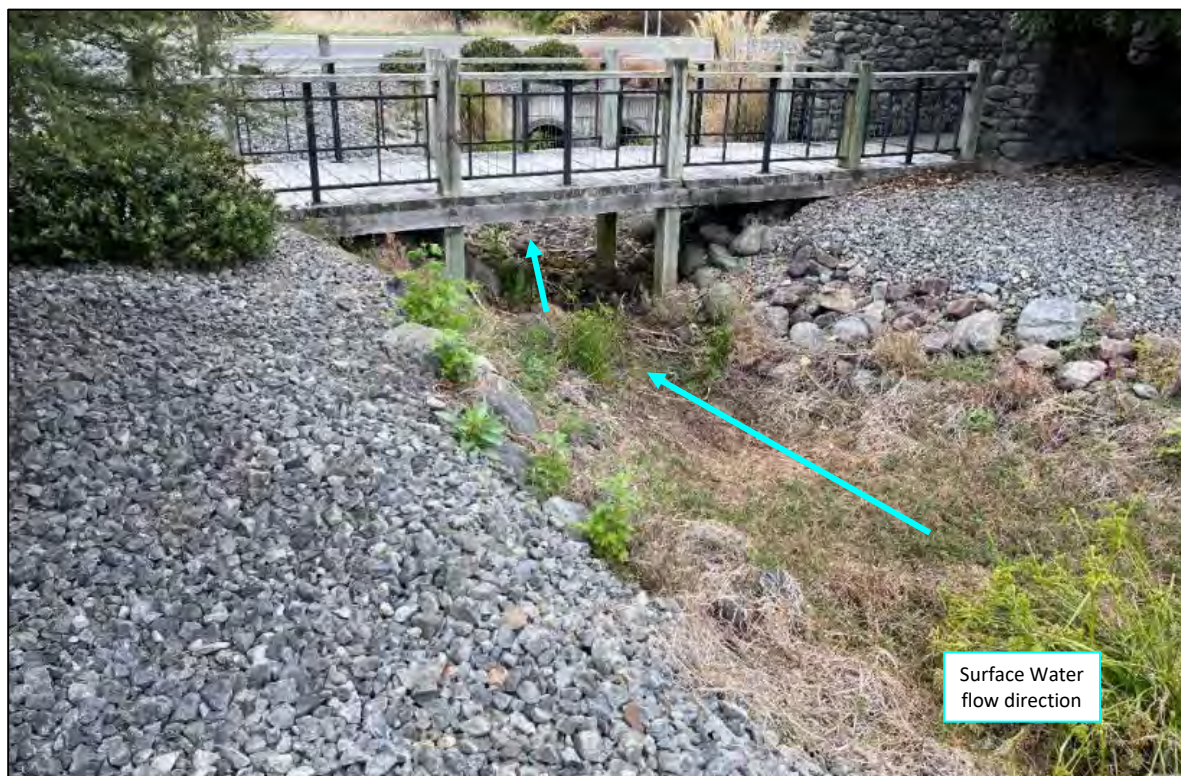
**Figure 18: Pond 1 Outlet to Twin 900NB RCRRJ Culvert Pipelines Crossing SH1**

Pond 1 was partially dry at the time of the site investigation. Upstream Pond 3 900NB RCRRJ outlet pipes were partially submerged, however the inlet to Pond 1 had no surface water present.

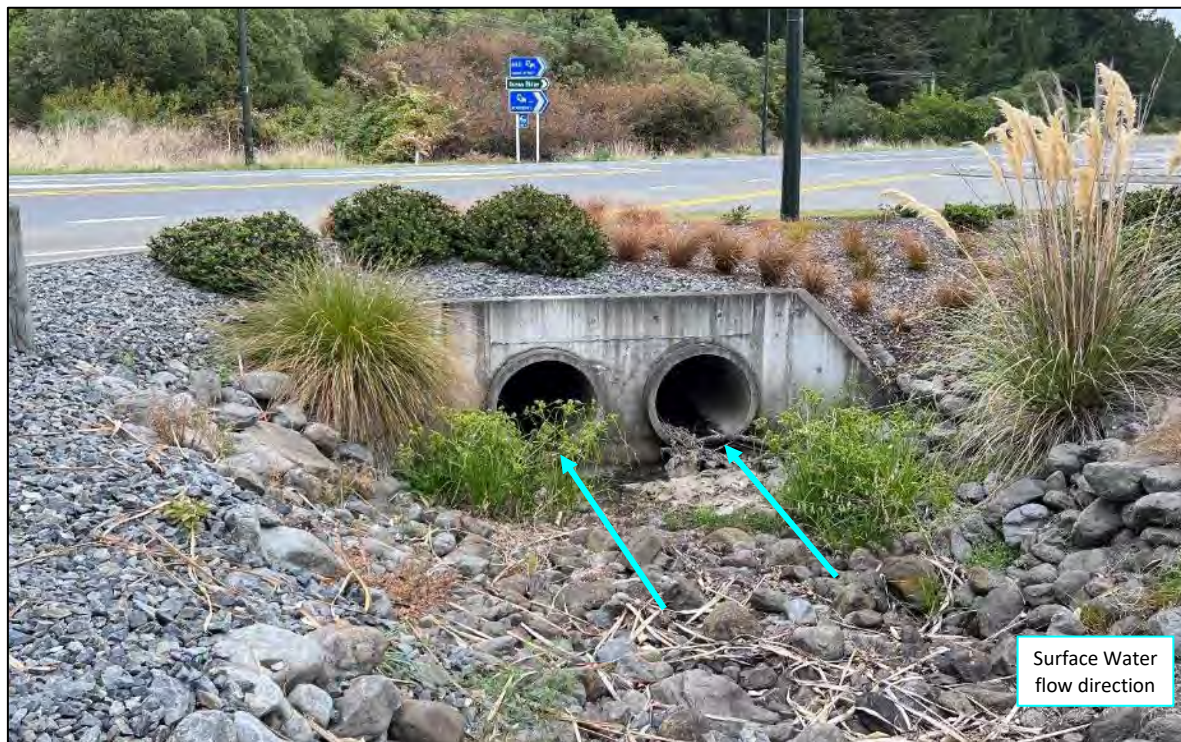
**Figure 19: Pond 1 Outlet - Twin 900NB RCRRJ Culvert Pipes Crossing SH1**

The invert level of the twin 900NB RCRRJ culvert pipes crossing Ocean Ridge Boulevard is 220mm lower than the invert of the twin-pipe crossing SH1. The invert level for the twin 900NB RCRRJ culvert pipes crossing SH1 is 0.4m higher than that shown on the as-built drawings.

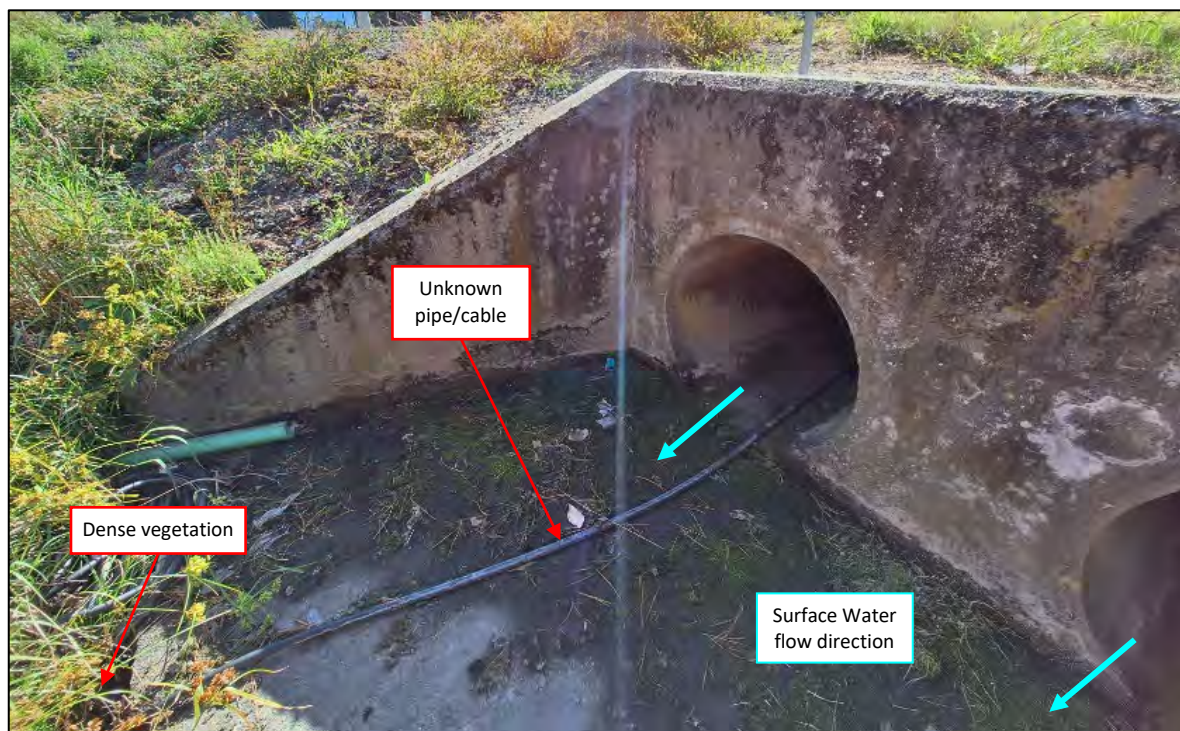
**Figure 21: Twin 900NB RCRRJ culvert pipe south of SH1**

Stormwater flows discharging from the site to the south side of SH1 are directed by an (expected) overgrown channel, east alongside the highway, and under a timber footbridge, prior to flowing to the sea.

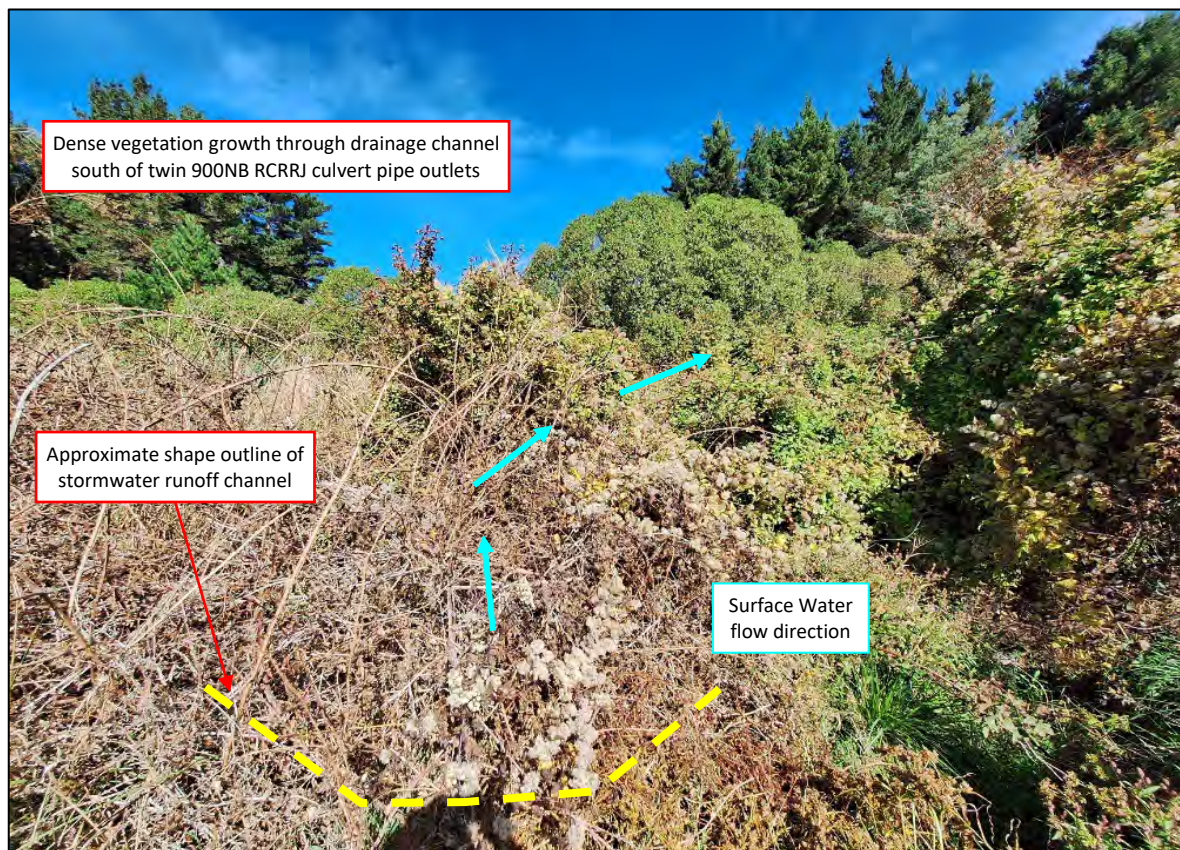
The exact extent and geometry of the expected channel was unable to be confirmed due to dense vegetation growth obscuring access to, and views of, the channel.

**Figure 22: Drainage Channel South of Twin 900NB RCRRJ Culvert Pipes Heading Eastwards**

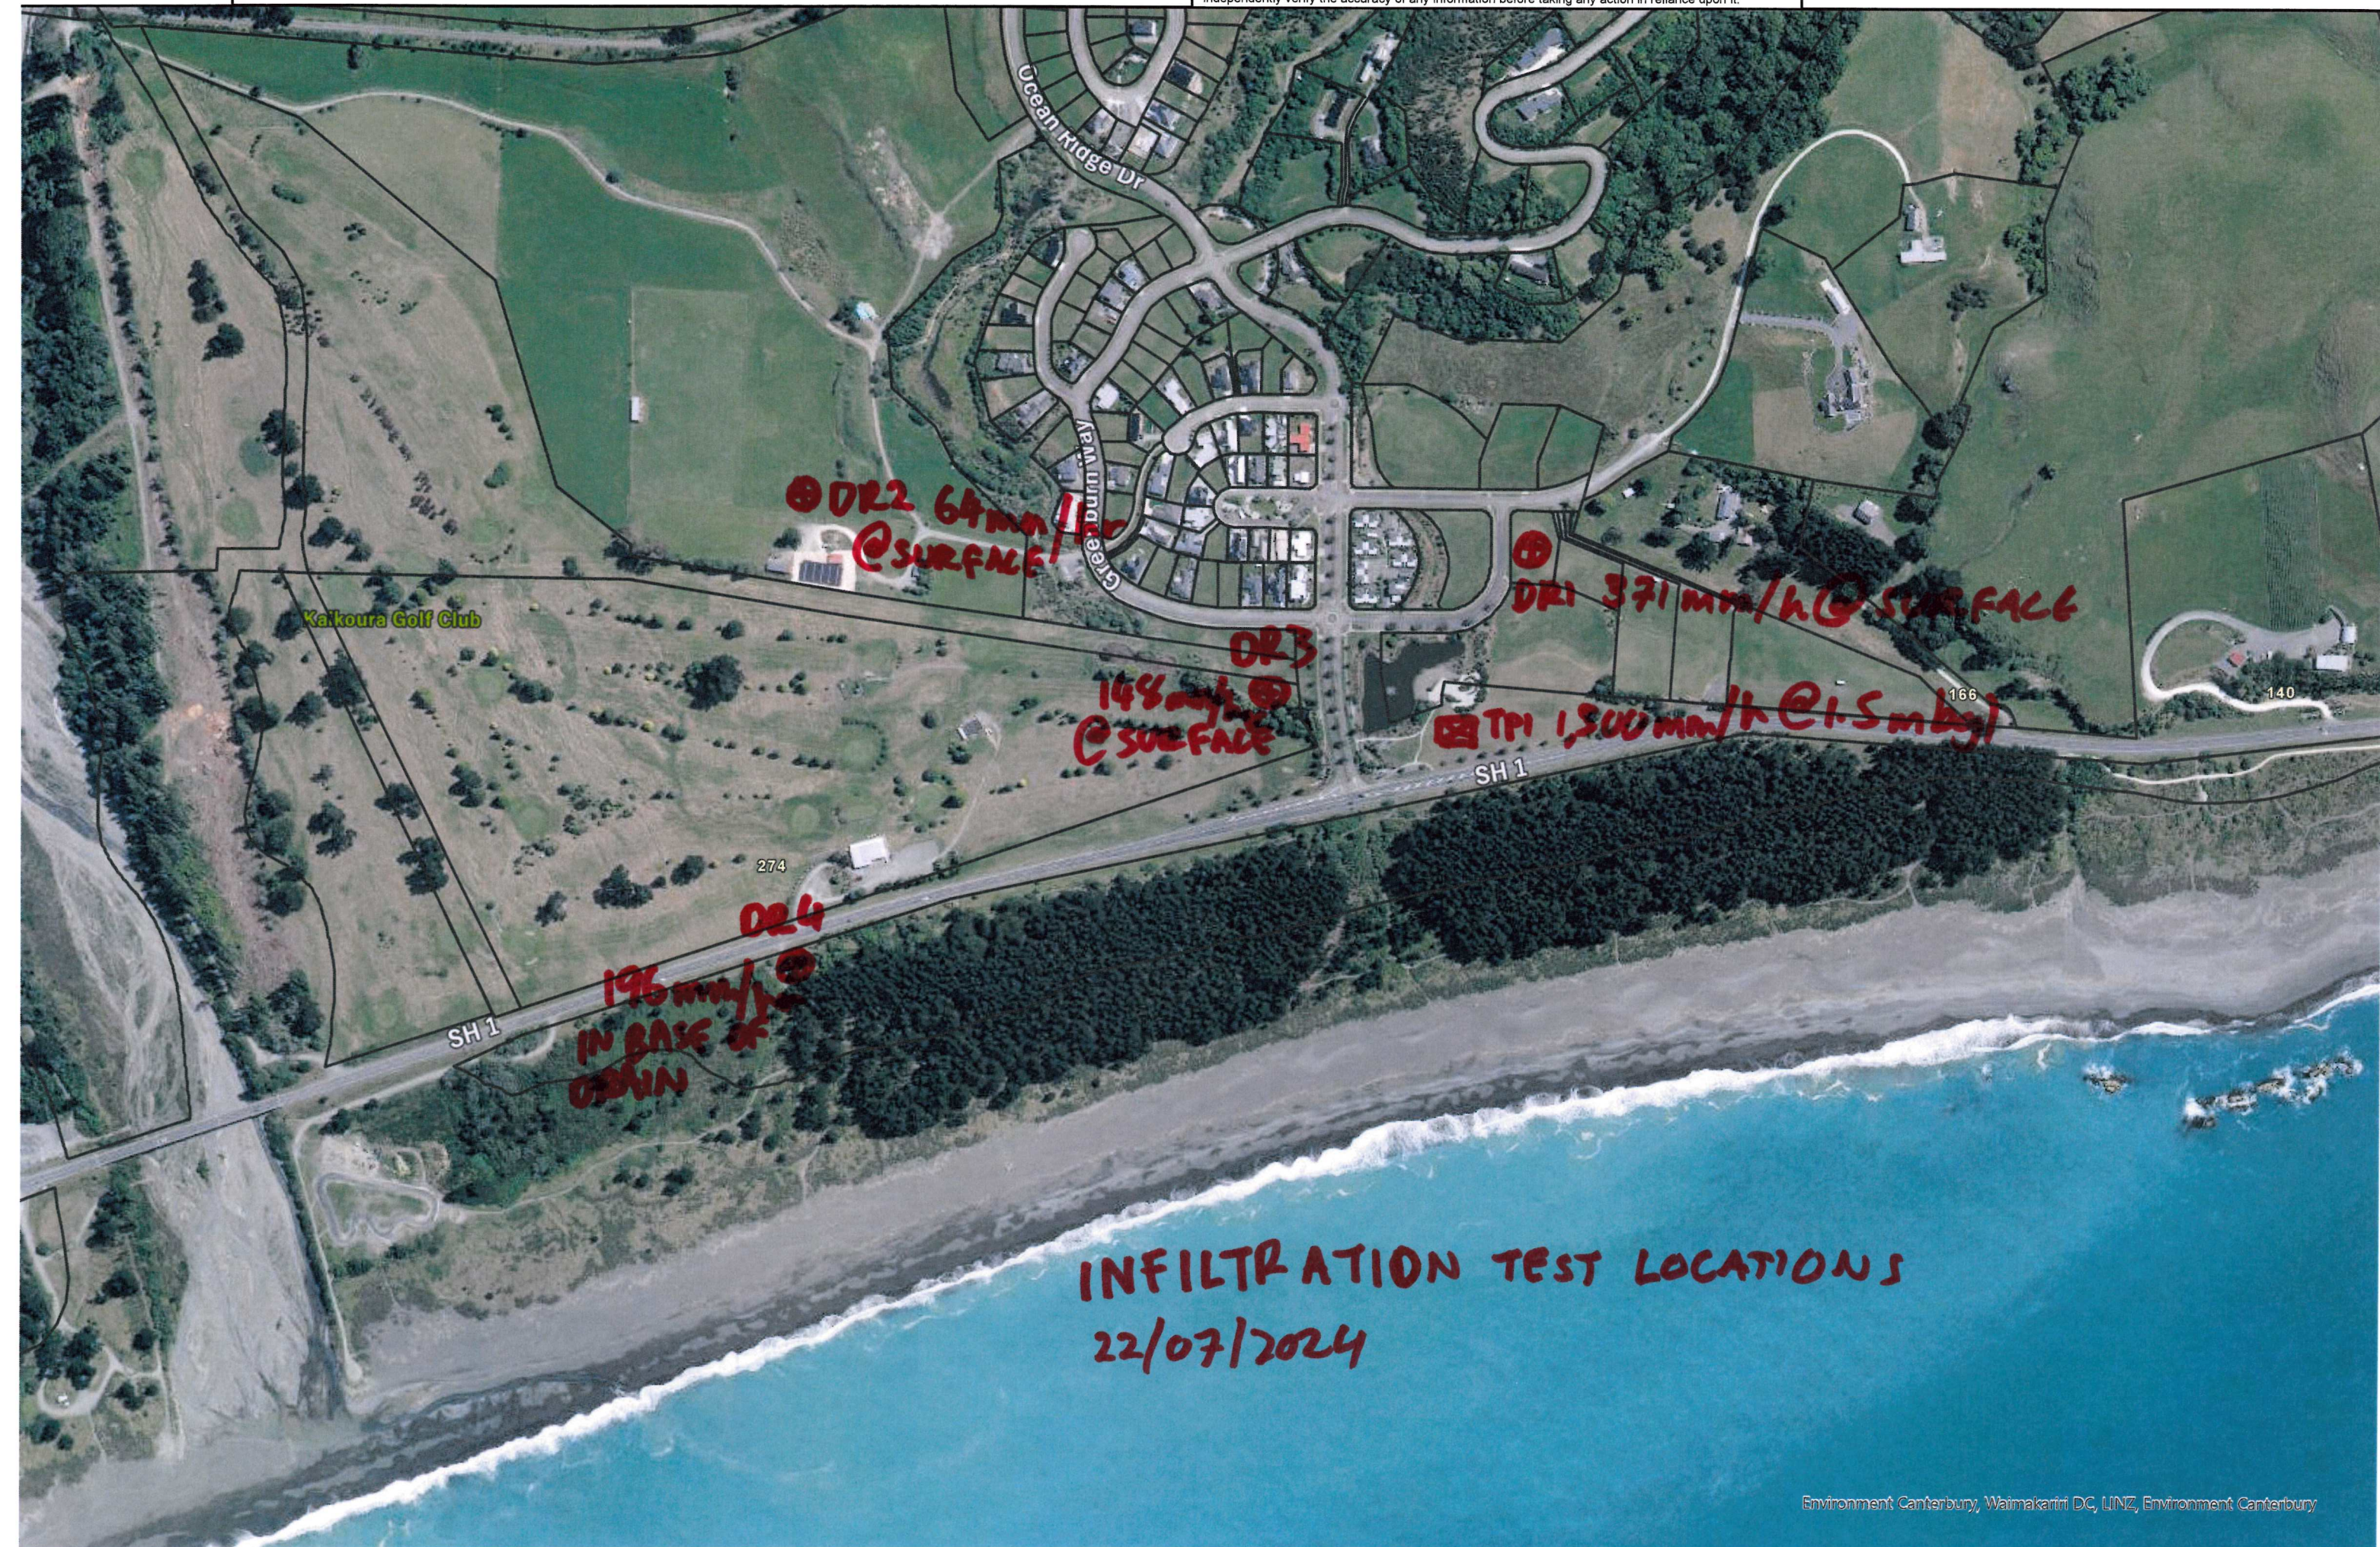
## ***Site Plan Mark-Up***

A single machine excavated test pit, numbered TP1, measuring approximately 0.9 m long by 0.7 m wide, was excavated to a depth of approximately 1.5 m below the existing ground surface, generally at the location of a potential infiltration basin. The test pit location is shown on the appended marked-up plan.

Four double-ring infiltration tests were undertaken at the ground surface, at the locations of DR1, DR2, DR3 and DR4, shown on the appended marked-up plan, in order to test the infiltration characteristics of the surficial soils for flood modelling purposes.

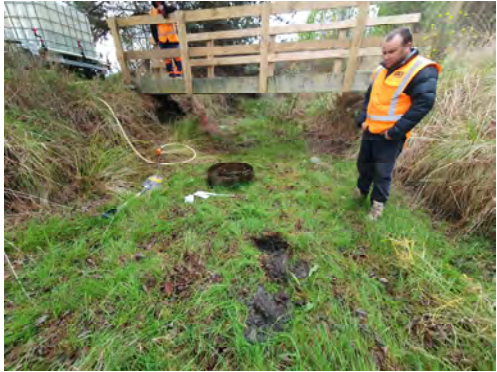
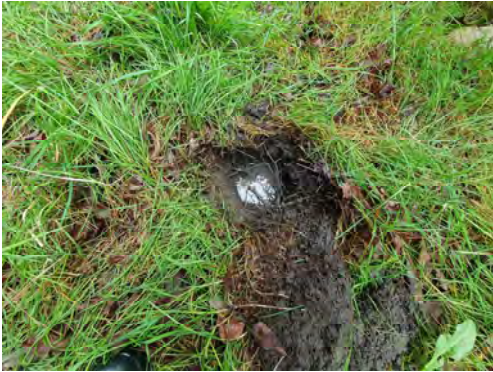
Remarks:  
1. Hand dug test pit put down next to location of double ring infiltration test in base of drain running parallel to and south of SH1.  
2. Base of drain is approximately 1.3m below surrounding ground surface.  
3. Standing groundwater was encountered at a depth of approximately 0.15m below the base of drain on 22/07/2024.

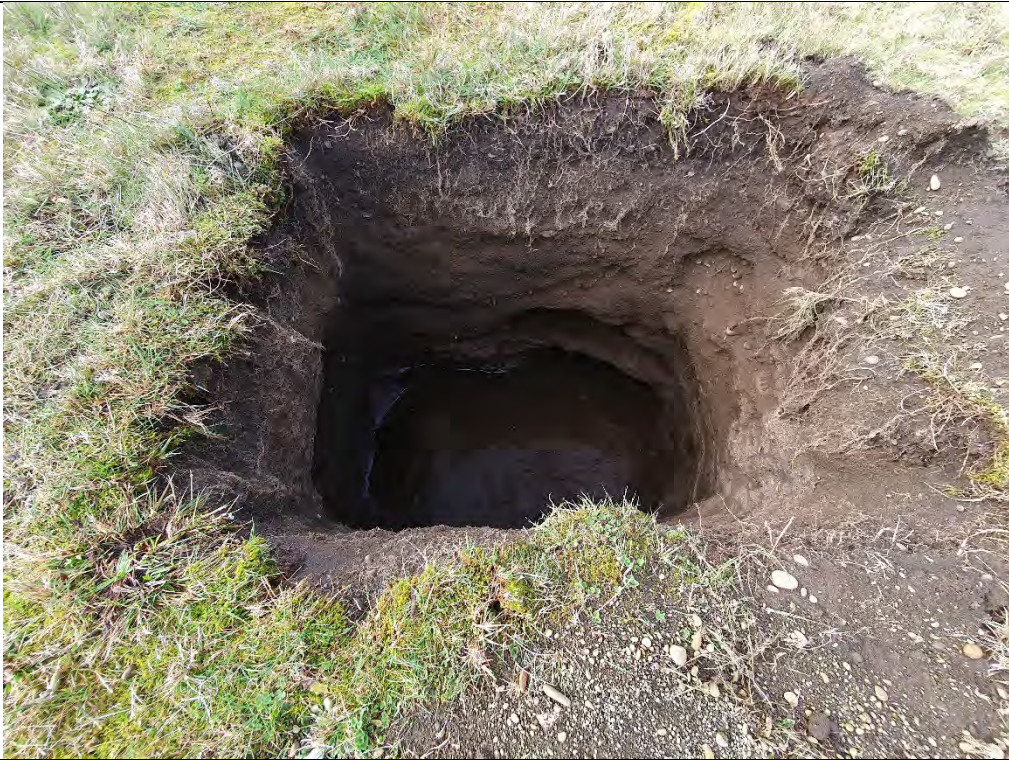
**P1:** TP1 after completion of infiltration test.
