OCEAN RIDGE, KAIKOURA  
PROPOSED PLAN CHANGE

STORMWATER MODELLING

**CARGILL STATION LTD**  
**OCEAN RIDGE, KAIKOURA - PROPOSED PLAN CHANGE**

**STORMWATER MODELLING STUDY**

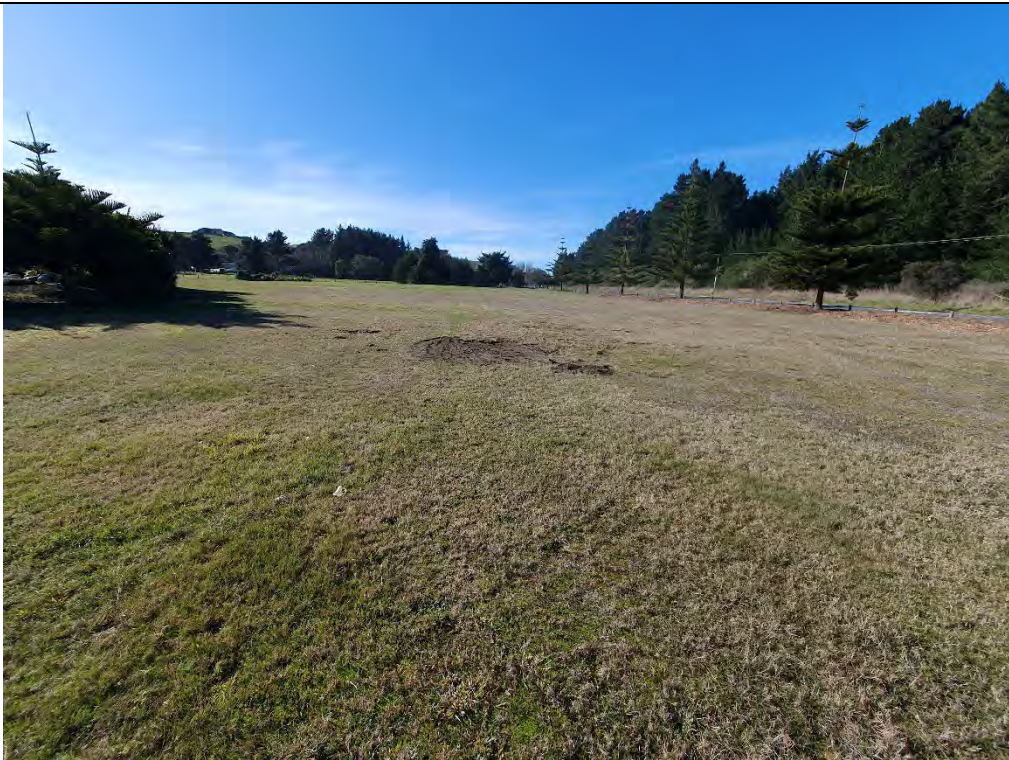
**P2:** View looking east across potential infiltration basin. TP1 in middle ground.

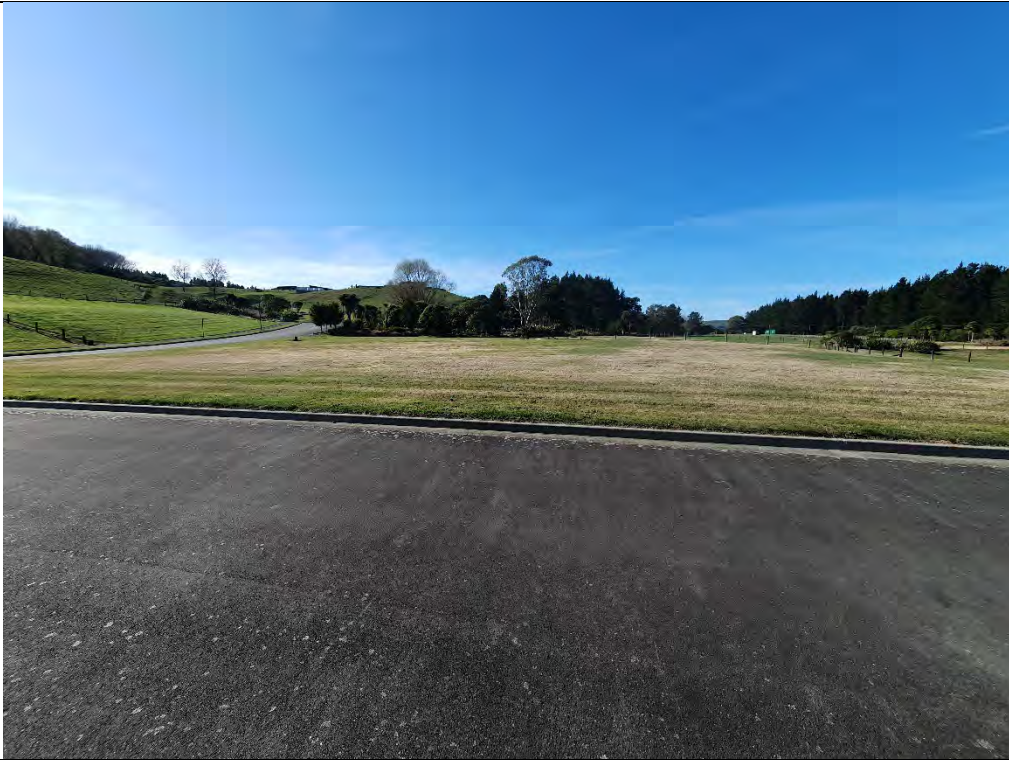
**P3:** Double-ring test DR1 located approximately in centre of this lot.

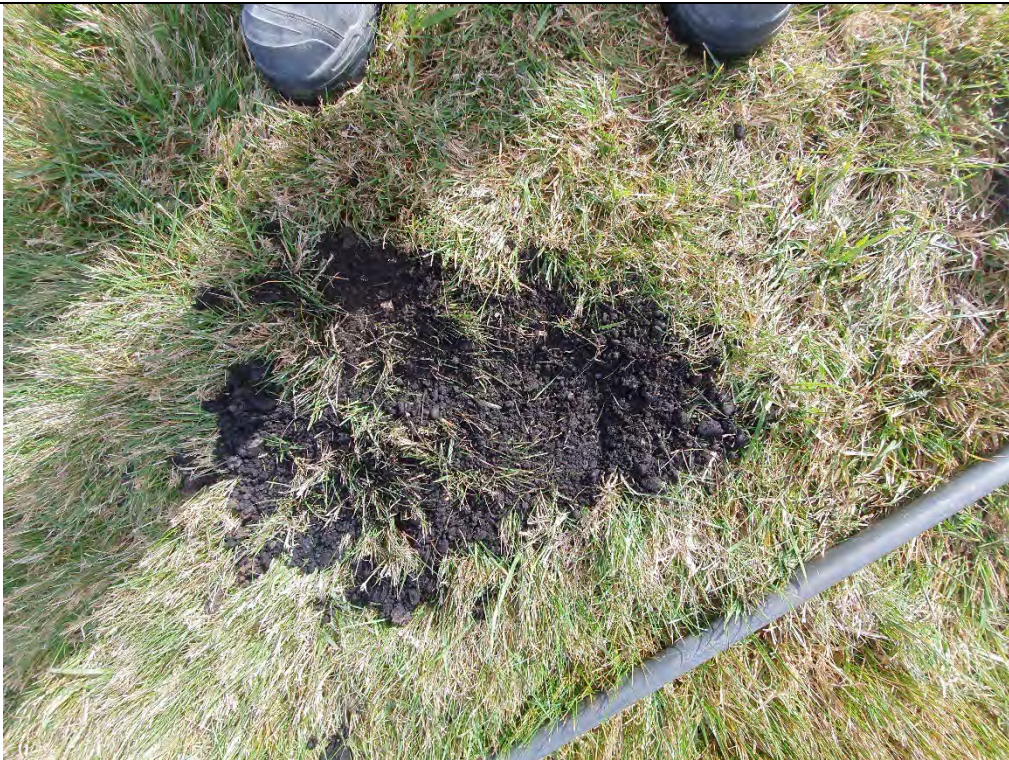
**P4:** DR1 topsoil/fill.

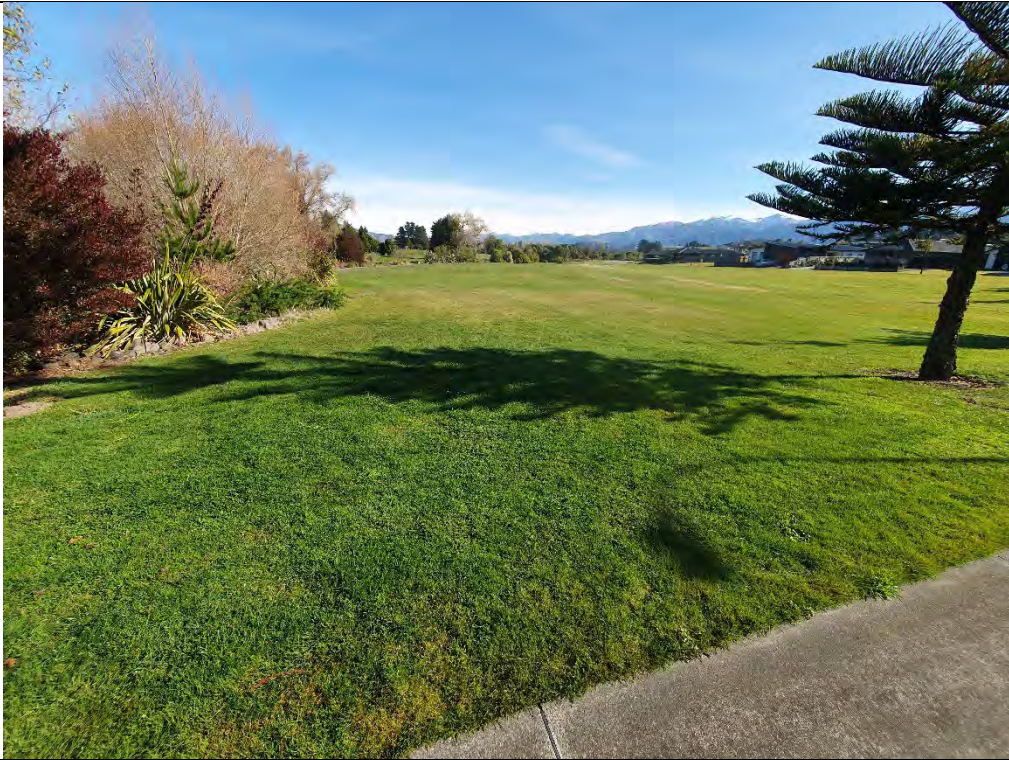
**P5:** Double-ring test DR3 was located approximately in centre of this photo.

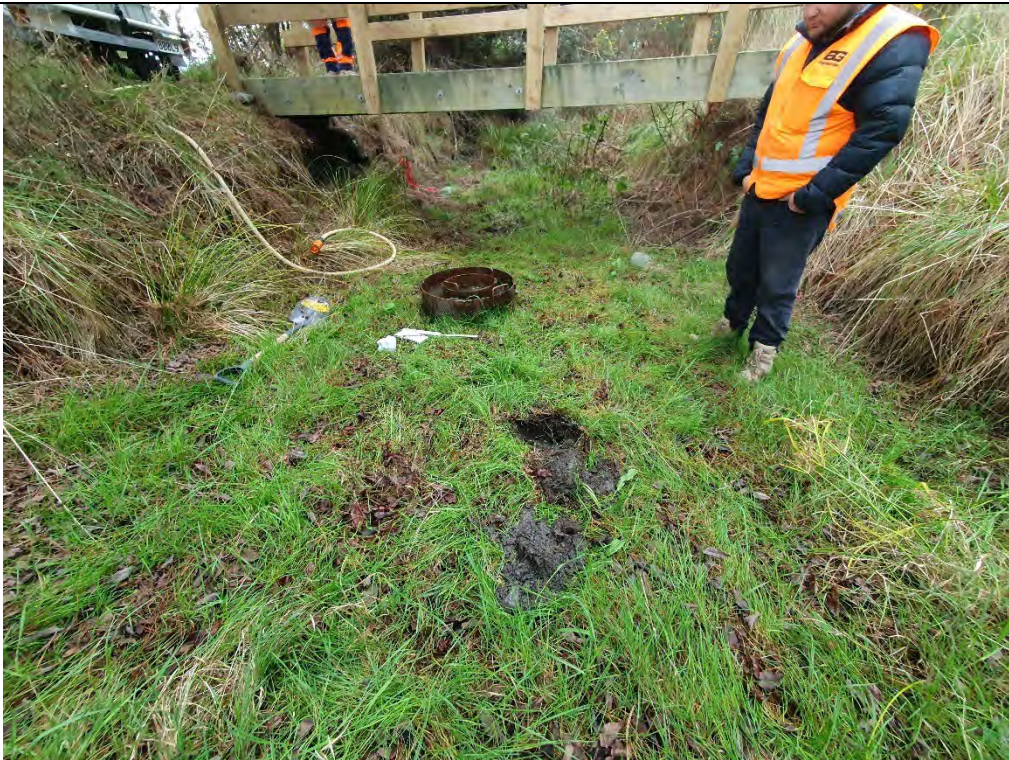
**P6:** Double-ring test DR4 and hand dug test pit located in base of open drain.

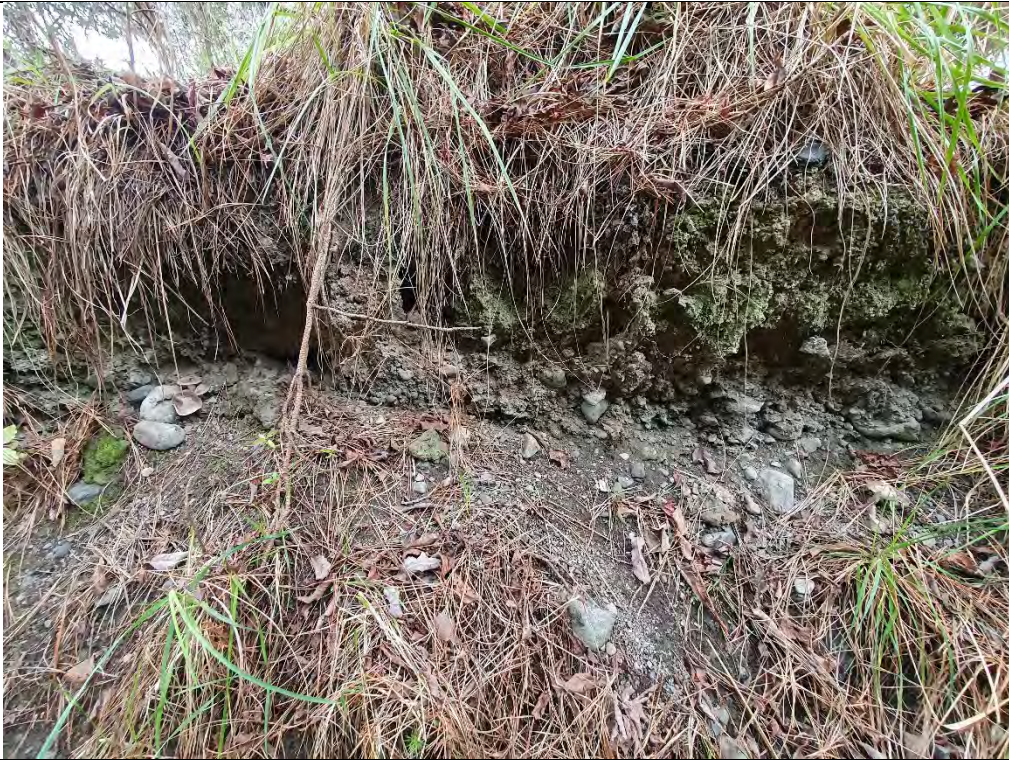
**P7:** View of side wall of open drain showing sandy silty gravels.

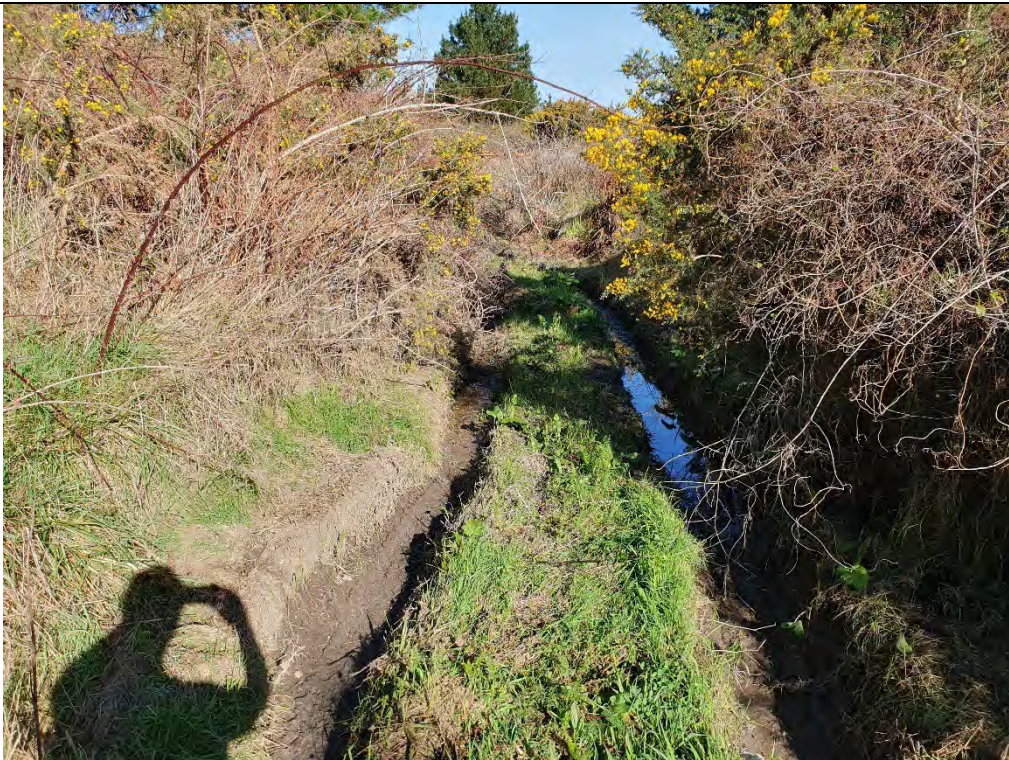
**P8:** View of open drain south-west of DR3. This section of open drain is not as well formed and has been used as a four wheel drive track, note the standing water in ruts. This section terminates at walking track that runs along the tops of the sand dunes to the south, and does not appear to outlet to the ocean.

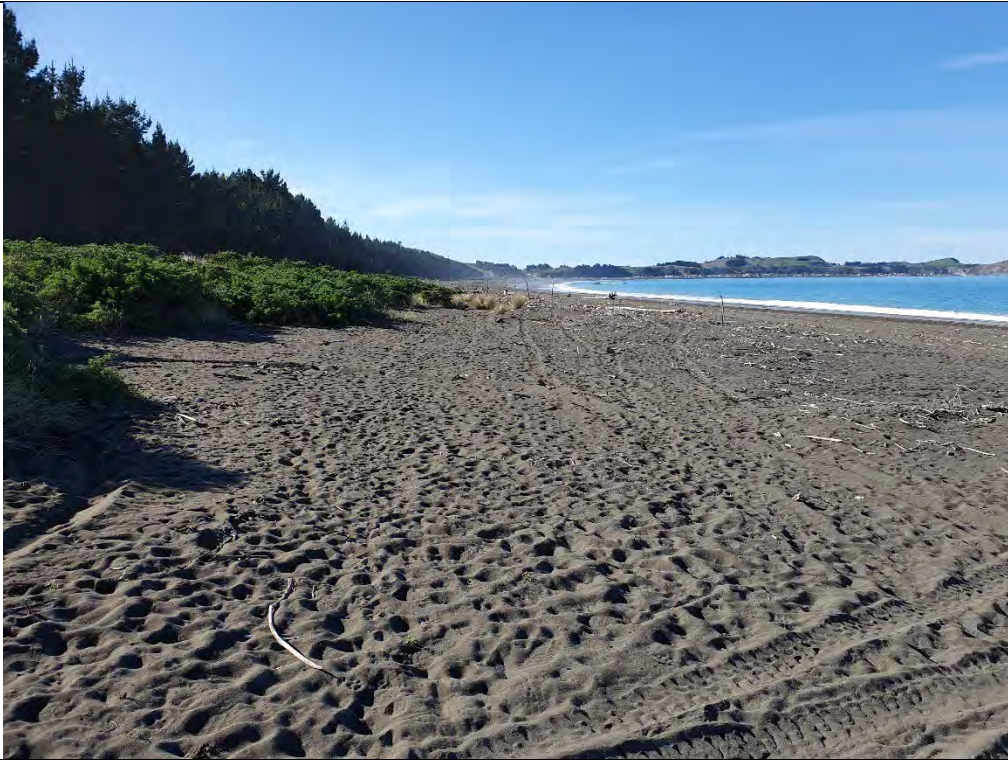
**P9:** View of beach showing clean sand beach deposits, which were also encountered in the dunes along with some gravelly sands similar in nature to those encountered in TP1

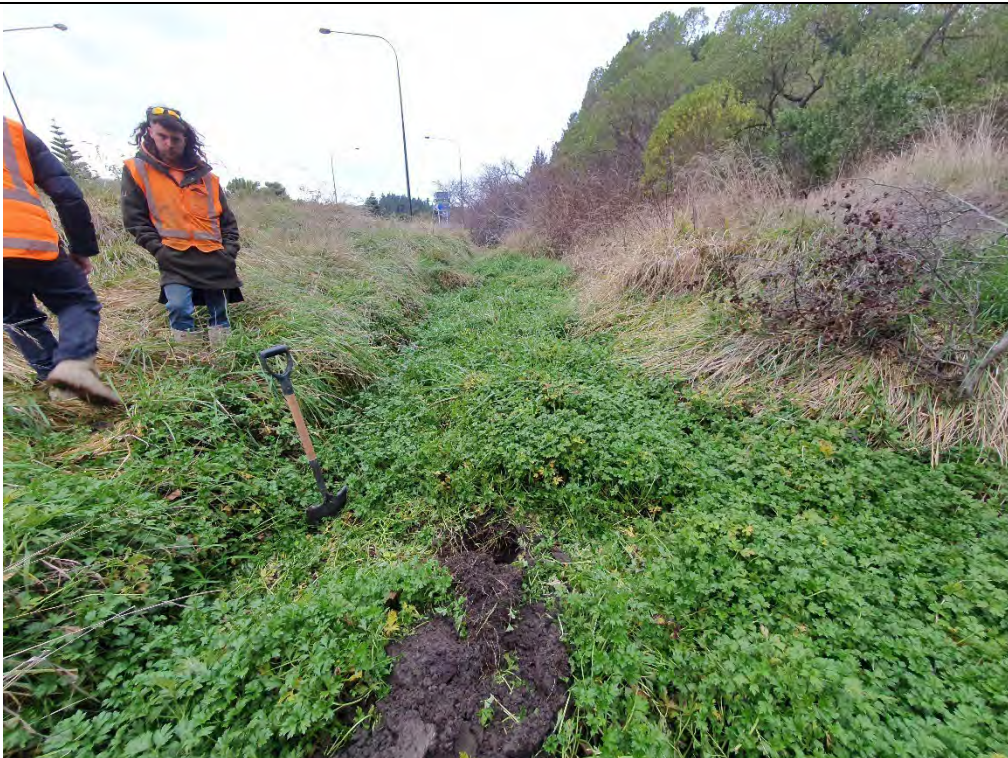
**P10:** View of open drain south-west of twin 900 outlet. A hand dug test pit was also excavated here, which found topsoil.

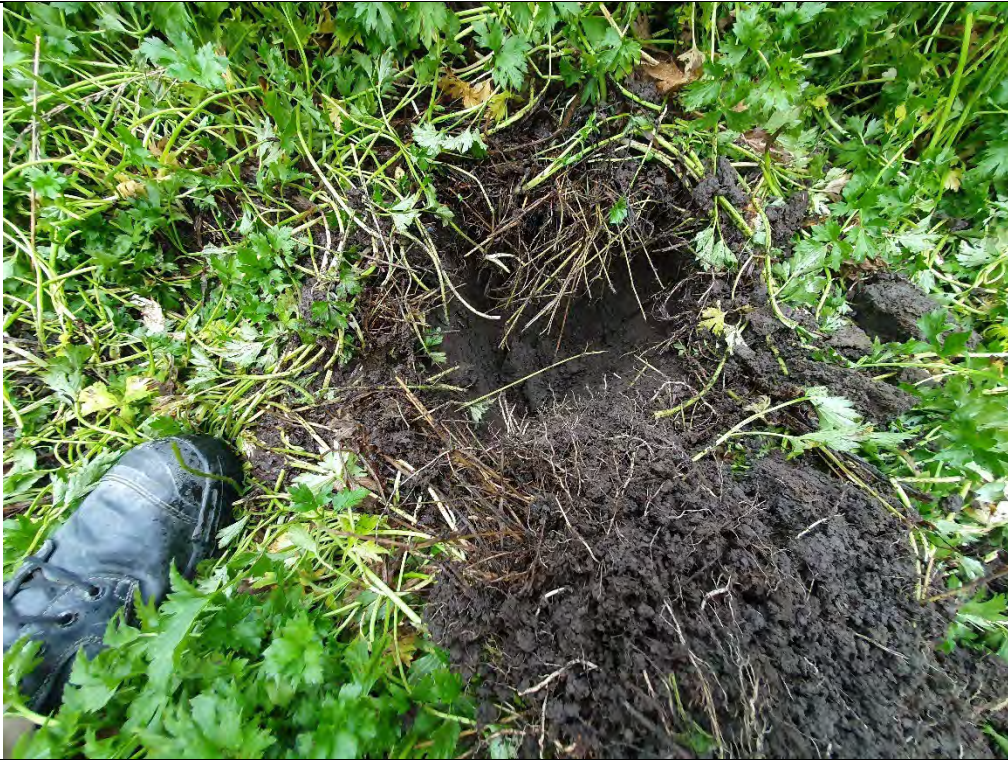
**P11** View of topsoil in hand dug test pit from P9.

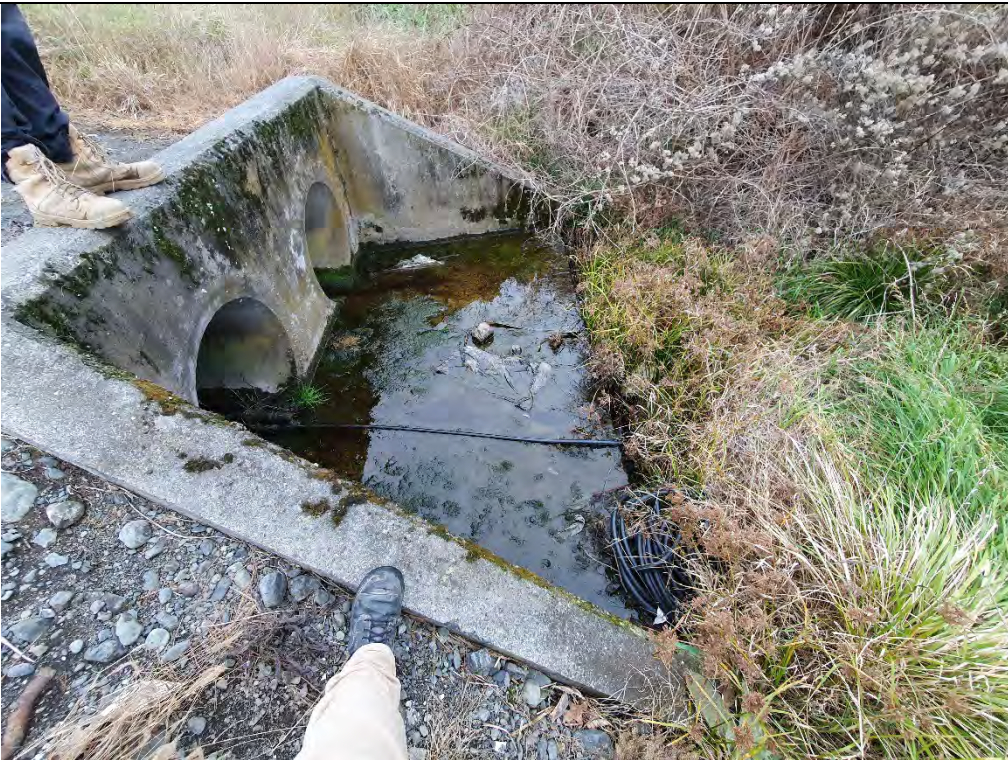
**P12:** View of twin 900 outlets at eastern end of open drain.

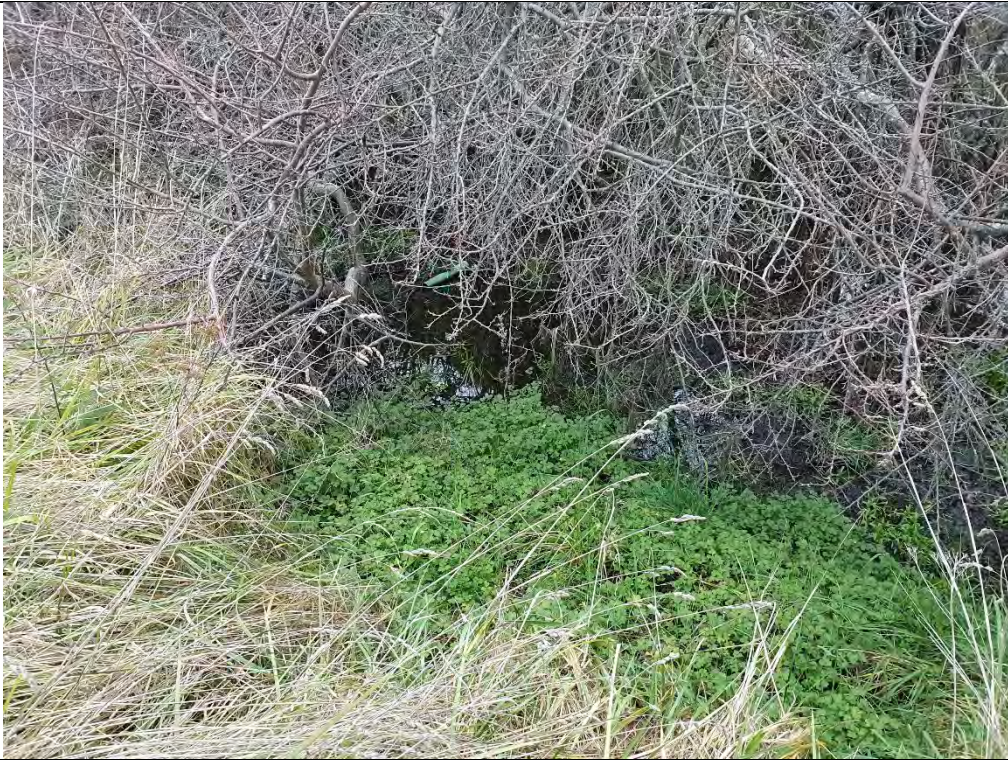
**P13:** View of open drain just down stream of outlets showing standing surface water.

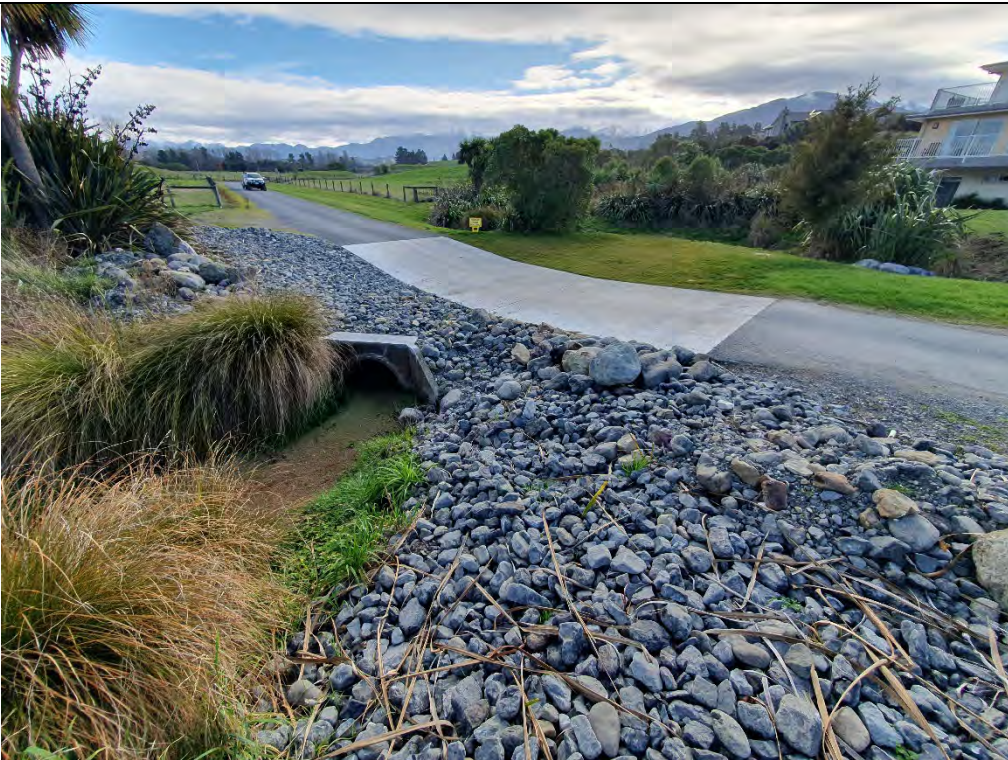
**P14:** View of weir located south of 21 Greenburn Way.

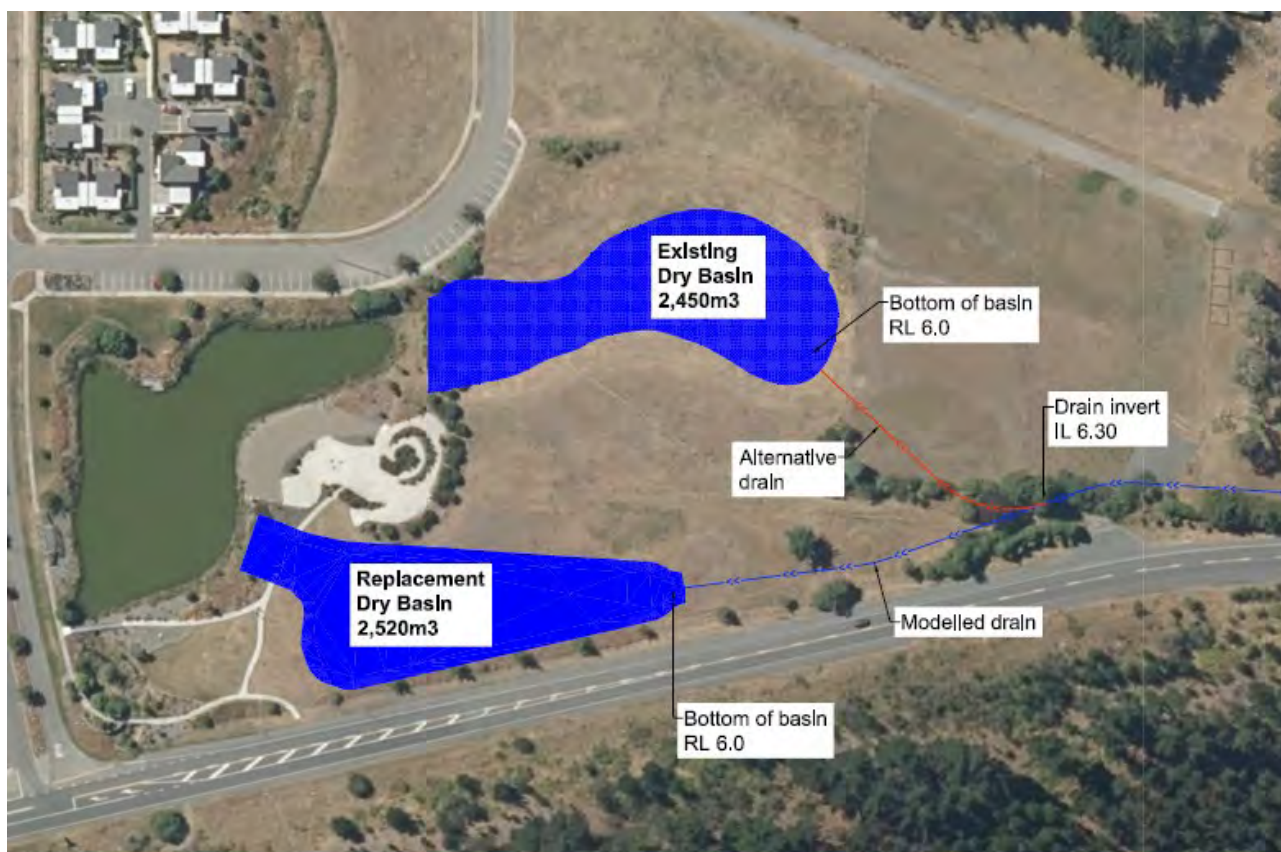
The existing and replacement dry basins have the same invert and top water levels, with total storage volumes differing by less than 3%, as shown in the table and figure below. Accordingly, they can be interchanged without materially affecting the model results.

The original model includes an open drain, directing runoff from the Hub into the replacement basin. An alternative drain connection to the existing basin is also feasible, as illustrated in the figure below.

**Figure 1: Existing and Replacement Dry Basin Volumes and Drainage Path**

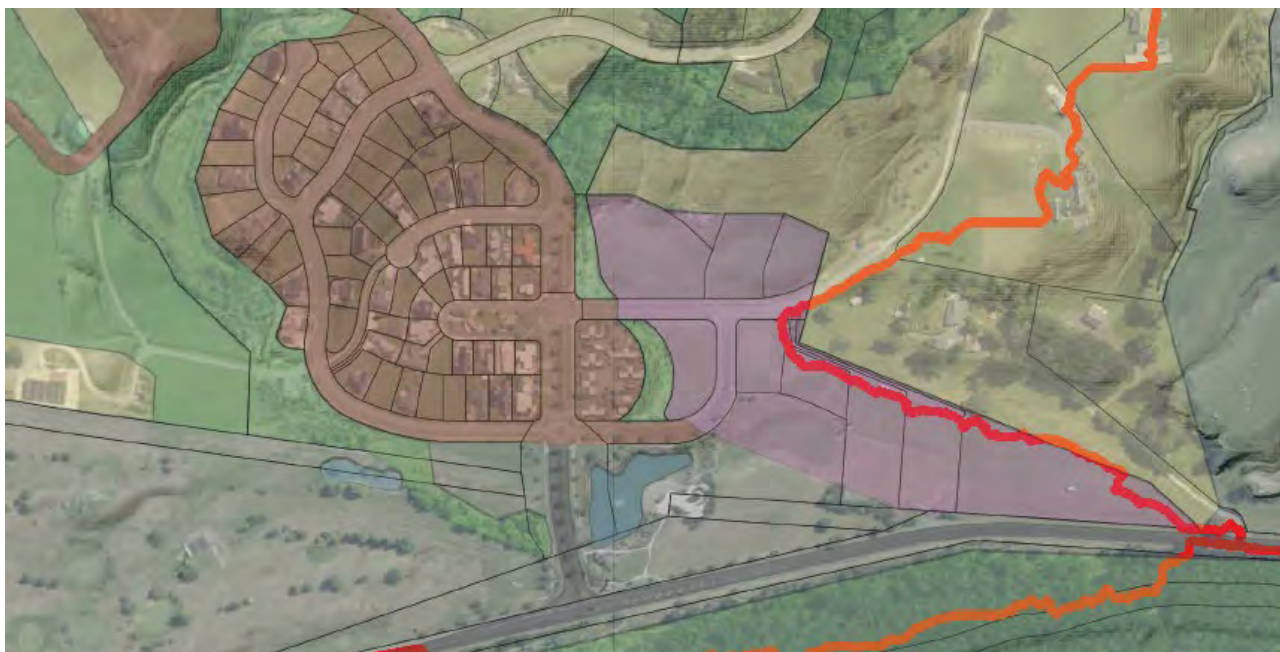
The July 2025 flood model assumes that a portion of the existing dry basin will be filled and redeveloped as a mixed-use area, as shown in the figure below. This area is approximately 5,800 m<sup>2</sup>, and is assumed to have an impervious coverage of 70%, compared with the existing dry basin's 0% imperviousness. The model, therefore, represents the worst-case scenario between the two development options in terms of the site coverage.

**Figure 2: Assumed Land-use in Stormwater Model**
