CARGILL  
STATION LTD

PRIVATE PLAN CHANGE, OCEAN  
RIDGE DEVELOPMENT AREA –  
KAIKŌURA

GEOTECHNICAL  
INVESTIGATION  
REPORT

| Project No. | CH01912 | Approved for Issue | |

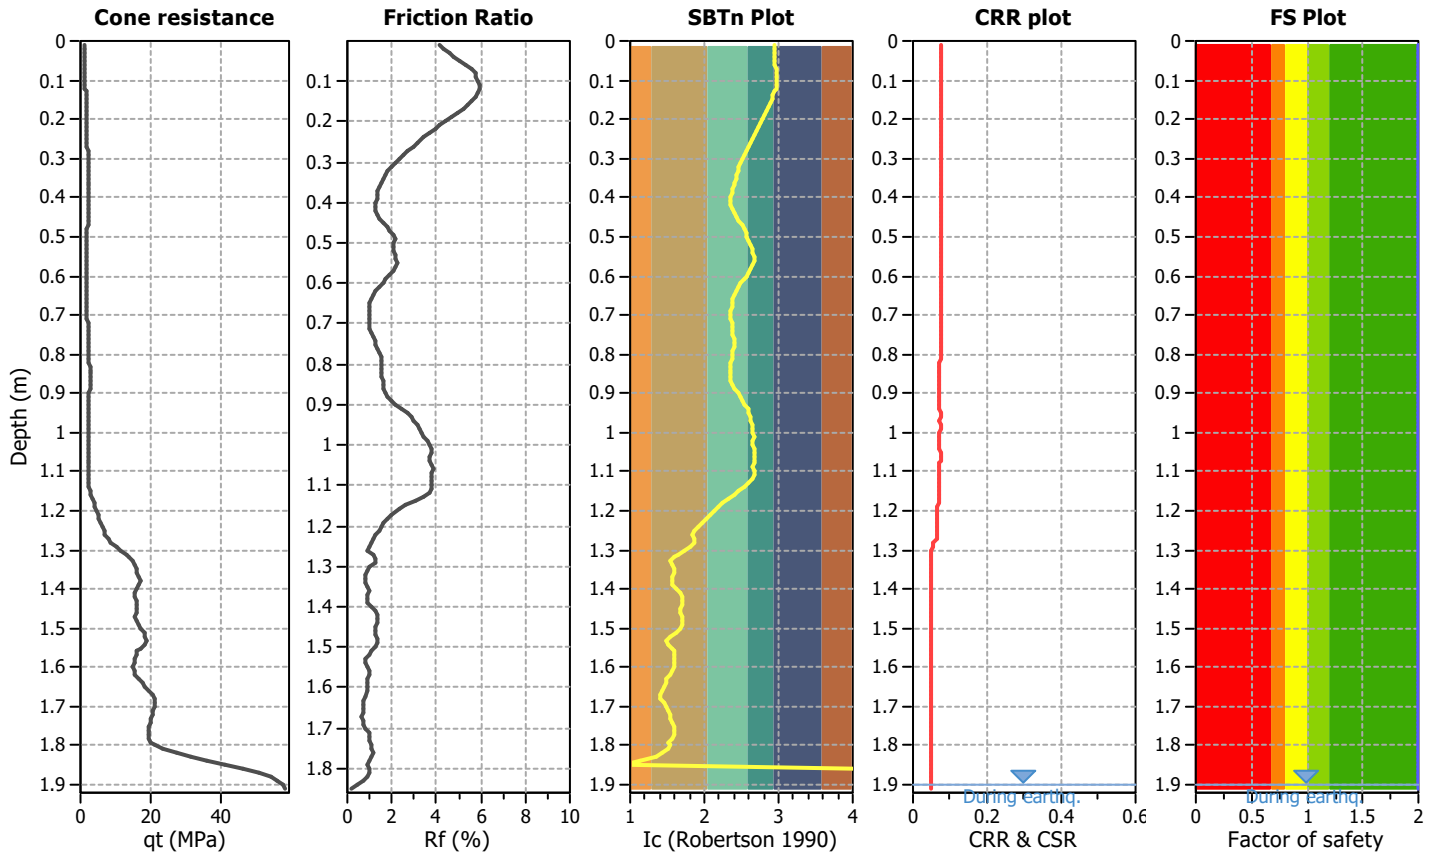
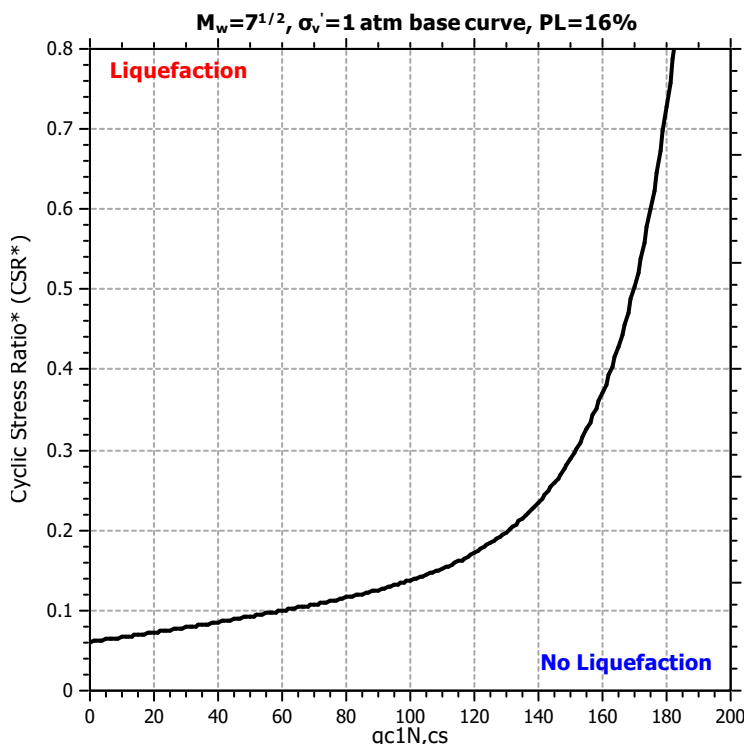
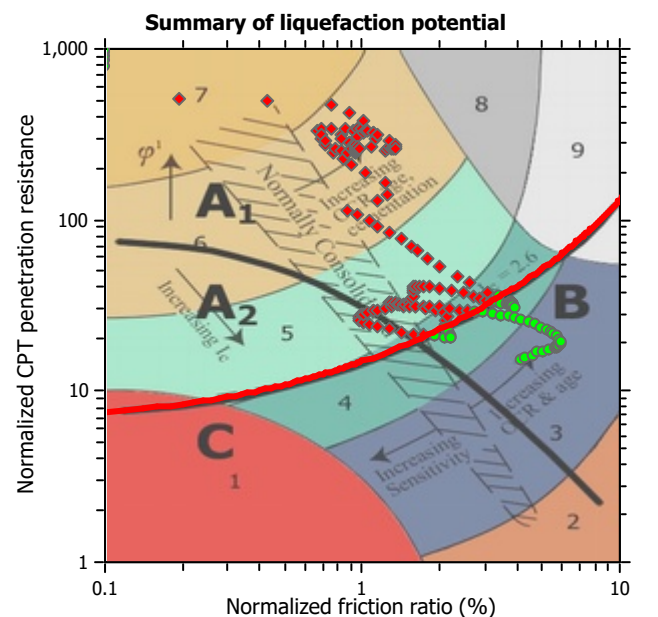
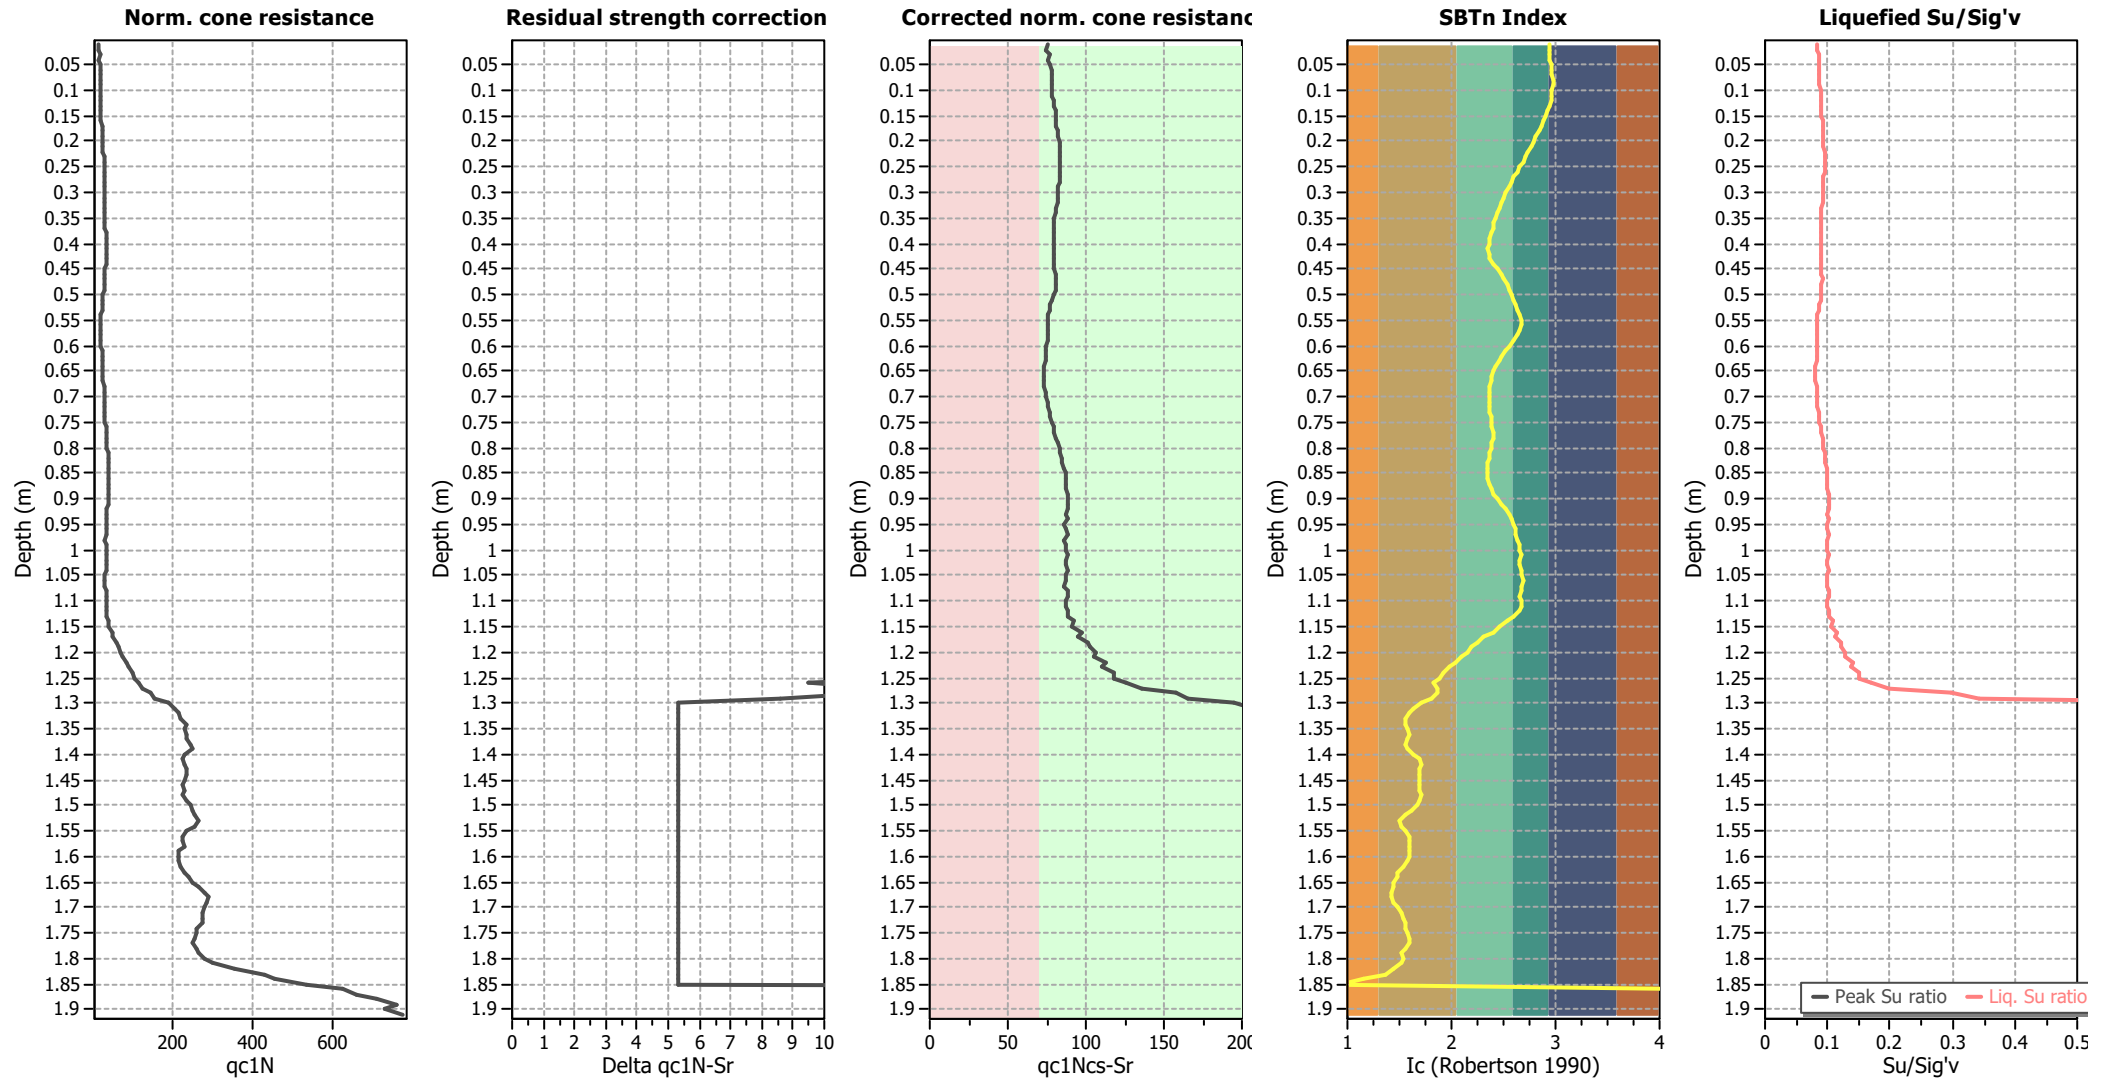
| Peak ground acceleration: | 0.14 | Unit weight calculation: | Based on SBT | $K_\sigma$ applied: | Yes | MSF method: | Method based |

Zone A<sub>1</sub>: Cyclic liquefaction likely depending on size and duration of cyclic loading  
 Zone A<sub>2</sub>: Cyclic liquefaction and strength loss likely depending on loading and ground geometry  
 Zone B: Liquefaction and post-earthquake strength loss unlikely, check cyclic softening  
 Zone C: Cyclic liquefaction and strength loss possible depending on soil plasticity, brittleness/sensitivity, strain to peak undrained strength and ground geometry

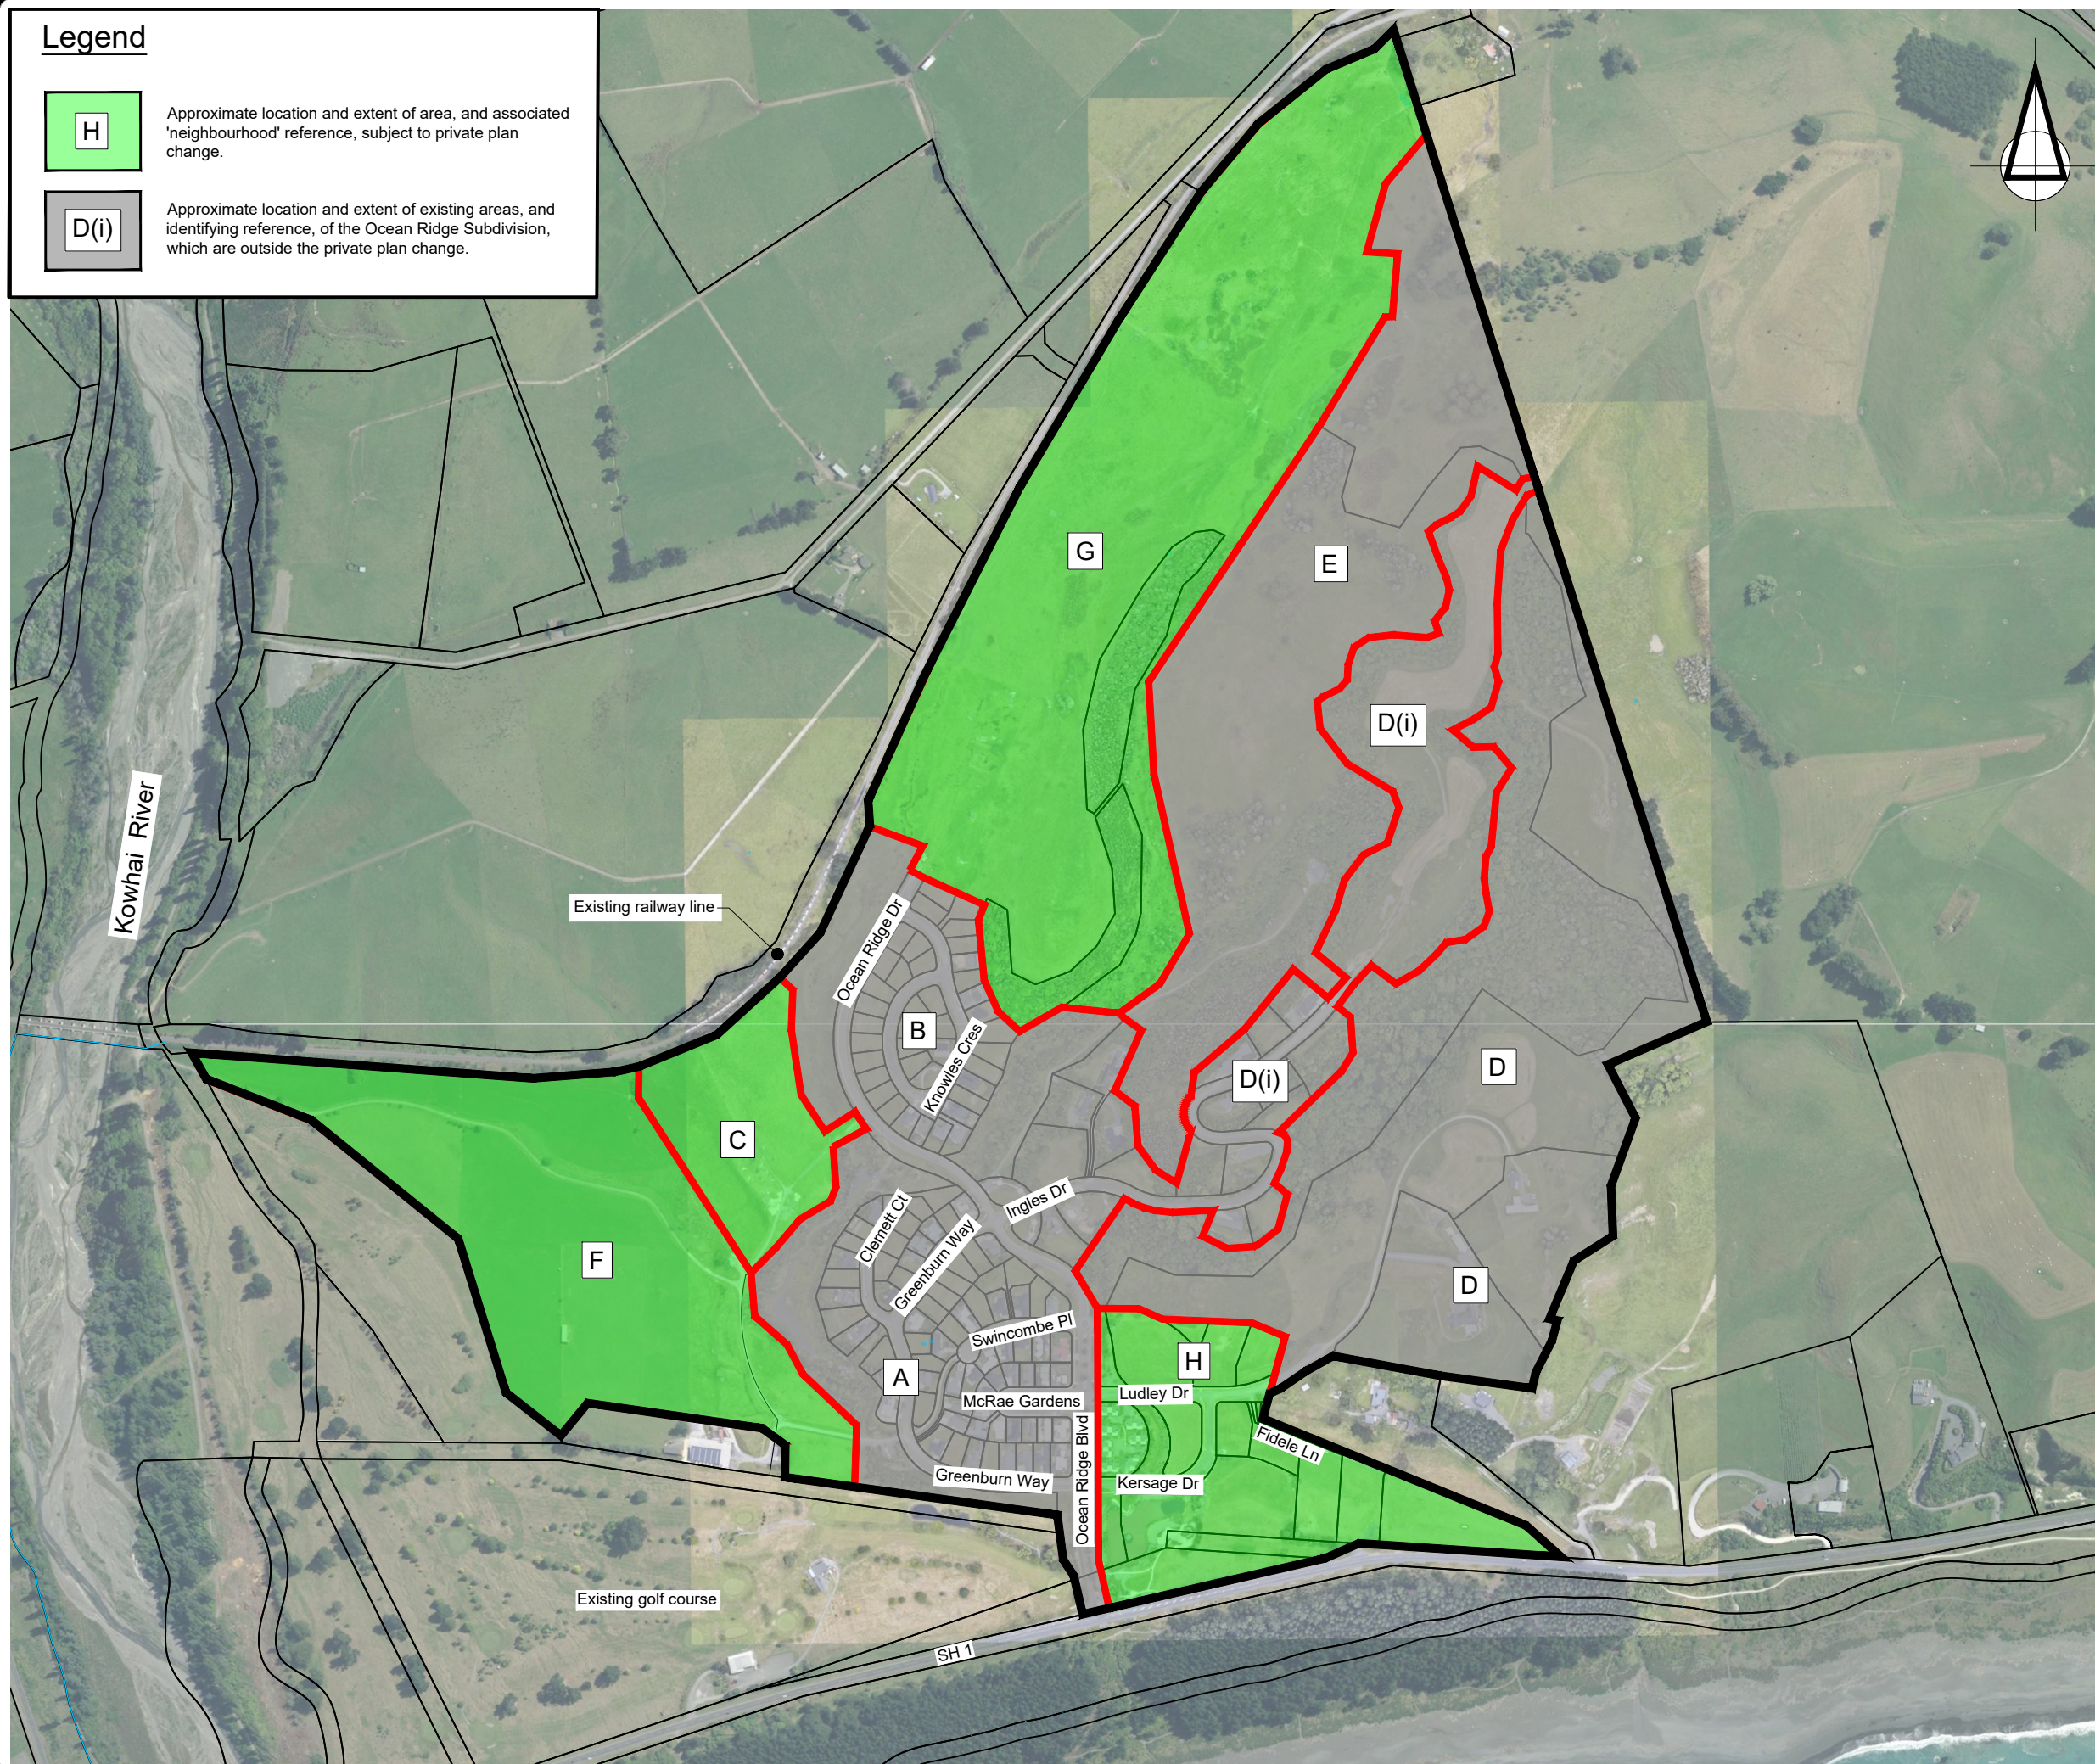
P:\\_CH Series\CH01912 - Ocean Ridge\Cad\03 Drawings\CH01912-G-01.dwg, gnaulls, 13/03/2025 2:19:10 pm

The approximate location and extent of the subject site, and the various development ‘neighbourhood’ area designations, are shown on the appended Fraser Thomas Ltd drawing CH01912-G-01. The overall masterplan for the proposed development is shown on drawing CH01912-G-02.

Approximate location and extent of existing areas, and identifying reference, of the Ocean Ridge Subdivision, which are outside the private plan change.
