PRIVATE PLAN CHANGE, OCEAN  
RIDGE DEVELOPMENT AREA –  
KAIKŌURA

CARGILL  
STATION  
LTD

# PRELIMINARY SITE INVESTIGATION - CONTAMINATION

| Authors | S Gladwin | Date | 17 March 2025 |

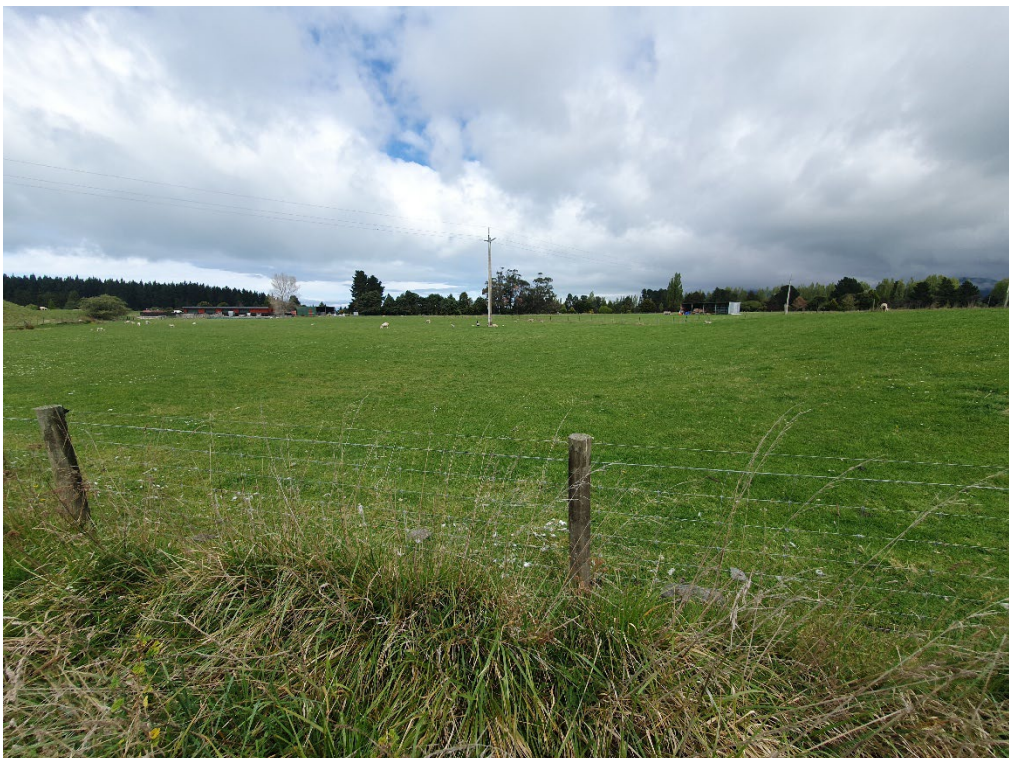
**P4:** Looking south across Area F from the existing river access track. The circa 1980 implement shed can be seen in the right background.

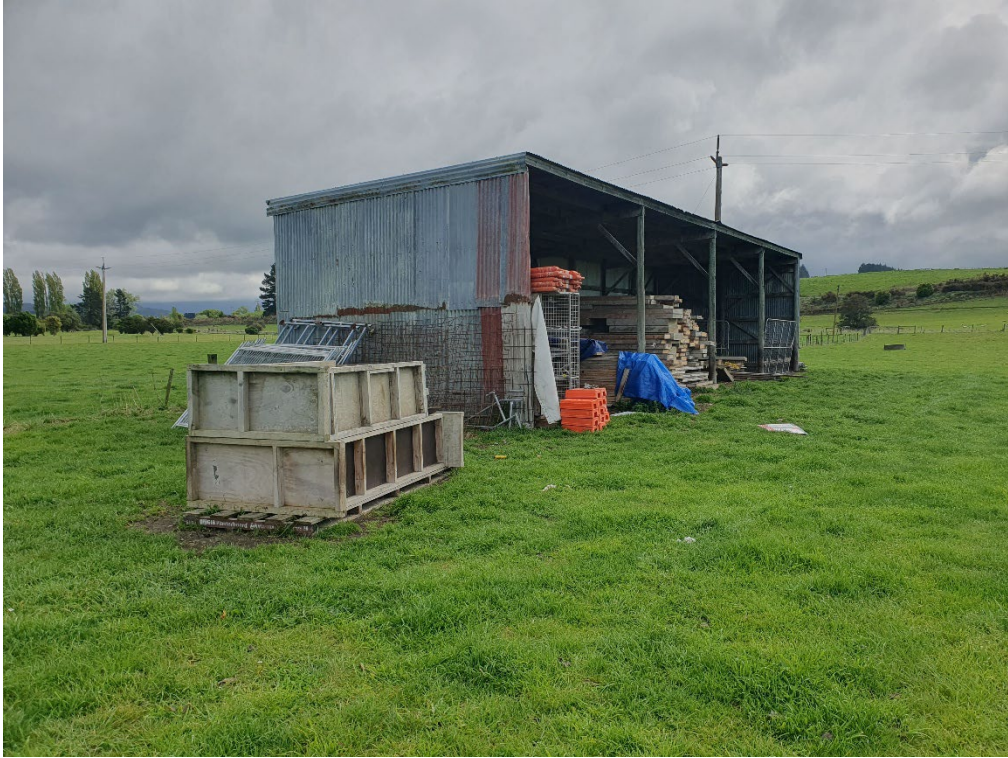
An existing (circa 1980) timber framed implement shed, with profiled metal cladding, is located in this part of Area F. The implement shed is currently being used to store building materials, mostly comprising bulk storage of timber formwork, timber offcuts and profiled metal cladding. Both H1.2 and H3.2 treated timber was observed in timber offcut stockpiles.

**P5:** Circa 1980 implement shed in Area F.

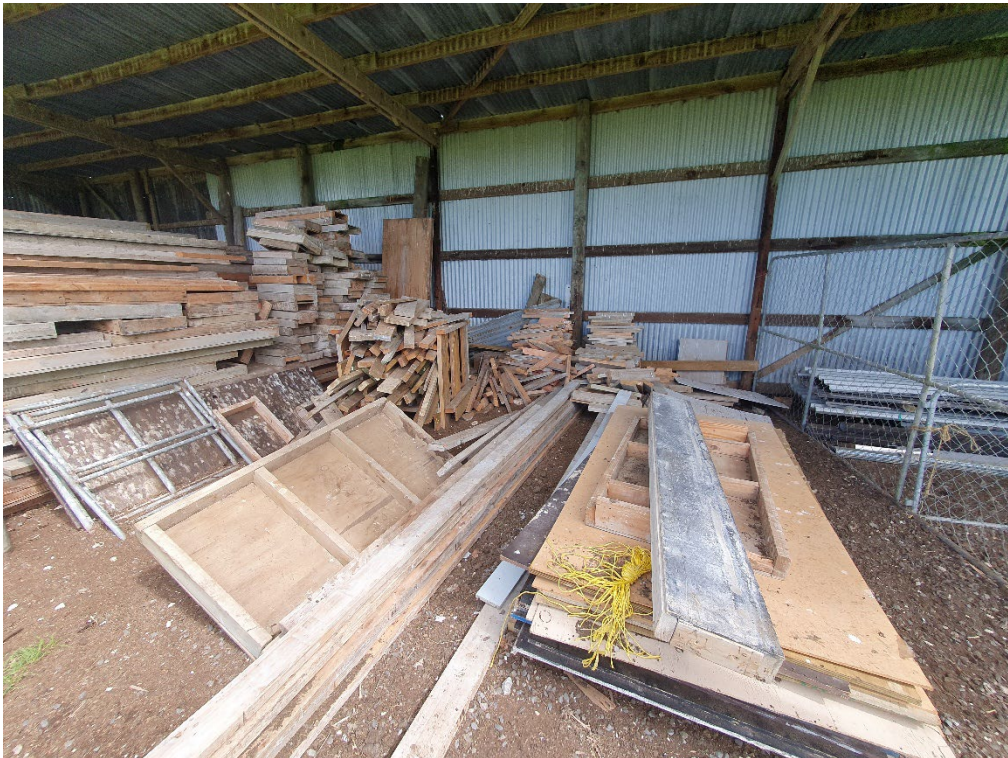
The leaching of Chromated Copper Arsenate (CCA) is a known potential source of soil contamination from the storage of treated timber on bare ground, and could potentially fall within HAIL I *“Any other land that has been subject to the intentional or accidental release of a hazardous substance in sufficient quantity that it could be a risk to human health or the environment”*.

However, it should be noted that in this case, the potential for soil contamination is considered low for the following reasons:

- The majority of the stored timber comprises what appears to be non-treated form work,
- The treated timber offcuts do not appear to be in a deteriorated condition, and
- The implement shed generally provides good protection from rain.

**P6:** Storage of timber framing and off-cuts within implement shed. Some of which were labelled with H1.2 and H3.2 treatment identification.

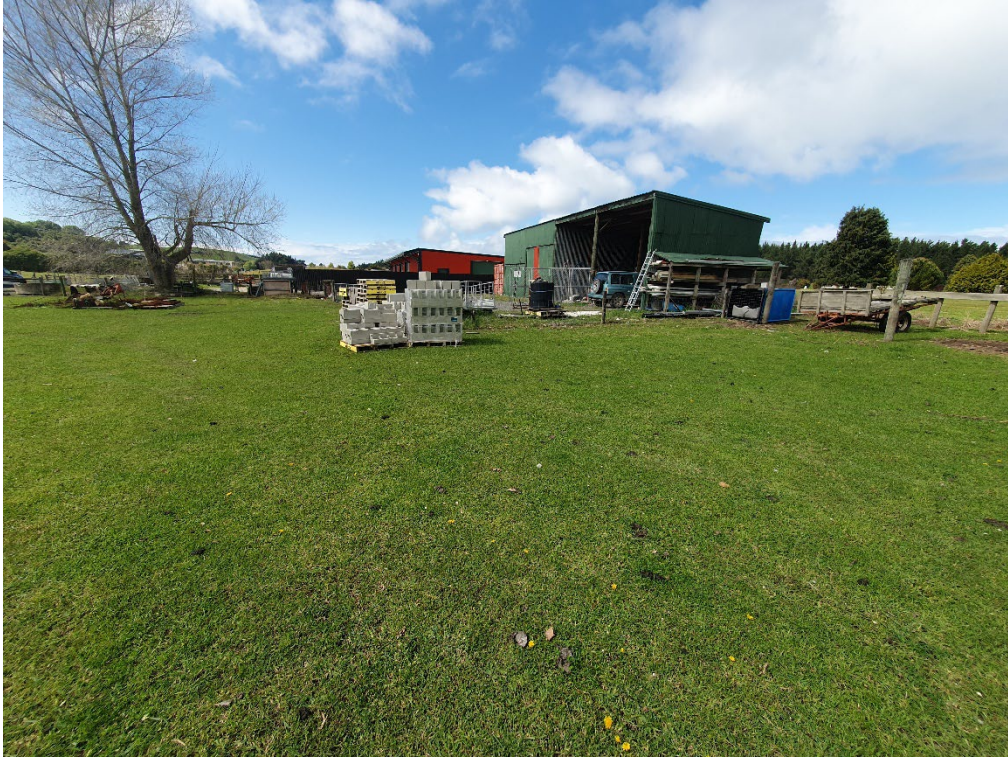
An existing farm yard area (circa 2012) comprising an implement shed and stockyard are located along the southern boundary of Area F. The following features of note were observed in this area:

**P7:** Implement shed, circa 2012, located along the southern boundary of Area F. Various building materials, generally comprising concrete blocks, reinforcing steel and timber are being stored either on pallets or raised above ground.

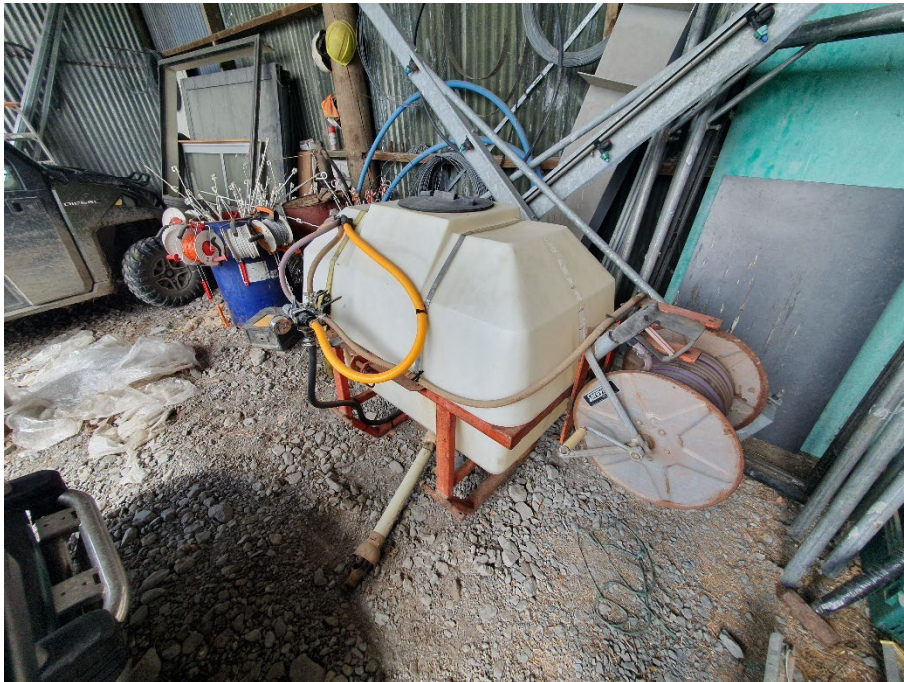
- HAIL A10 *"Persistent pesticide bulk storage or use, including sport turfs, market gardens, orchards, glass houses or spray sheds"*(600L Spray Tank, chemical storage associated with workshop),
- HAIL A17 *"Storage tanks or drums for fuel, chemicals or liquid waste"*( 208L drum of diesel engine oil),
- HAIL I *"Any other land..."* (makeshift oil drum burn pits and burn pile).

**P8:** 600L spray tank located in the implement shed. No markings indicating what the spray comprised were observed.

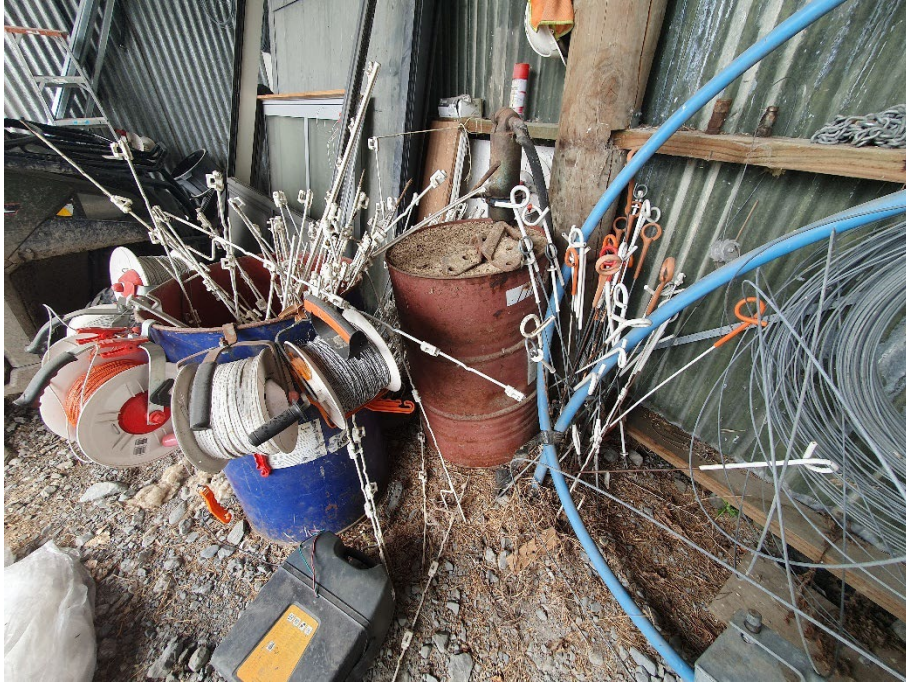
**P9:** Old 208L drum of diesel engine oil, with an attached pumping apparatus is located in the implement shed. The drum and pump are degraded and do not appear to have been used for a significant amount of time.

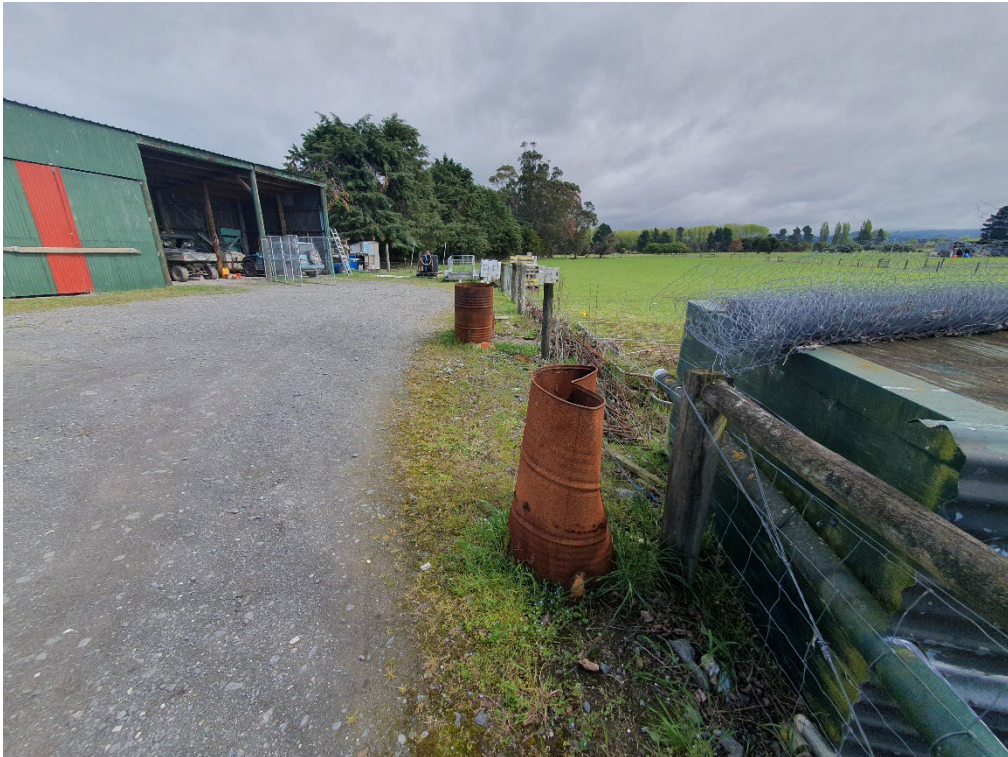
- At least three old 208L drums, which appear to have been used as makeshift burn pits.
- A trailer holding two empty 1,000L IBC’s. labelled as originally containing MasterRoc SA 160 are located next to the stockyards. MasterRoc SA 160 is a liquid hardening additive for concrete (it should be noted that this is most likely used on building sites, and not within Area F).

**P10:** Old 208L drums inferred to be used as make shift burn pits.

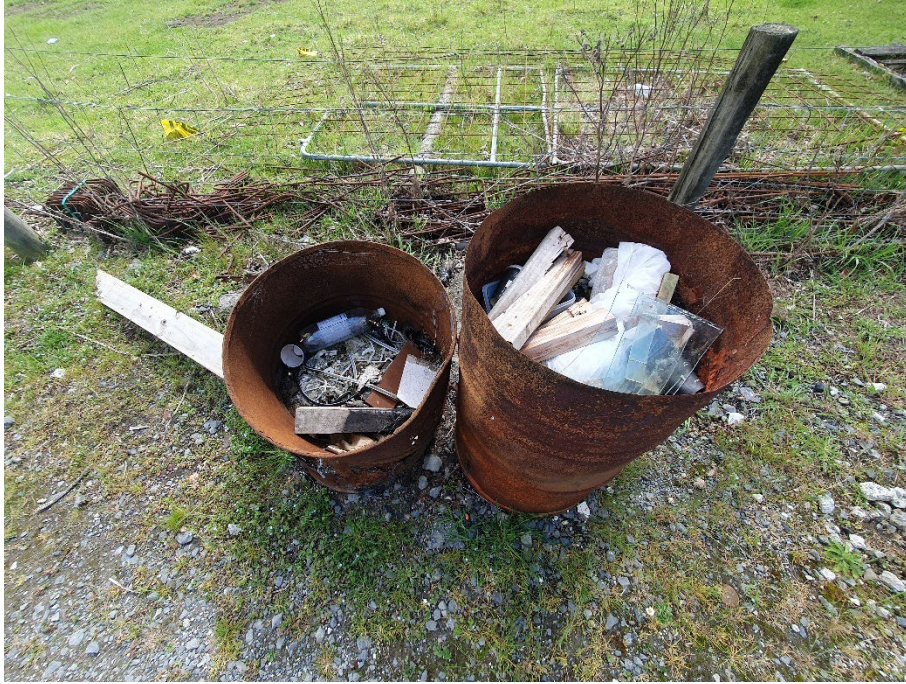
**P11:** Close up of drums, currently being used to store rubbish. The charred timber in the left drum supports inferred use as makeshift burn pits.

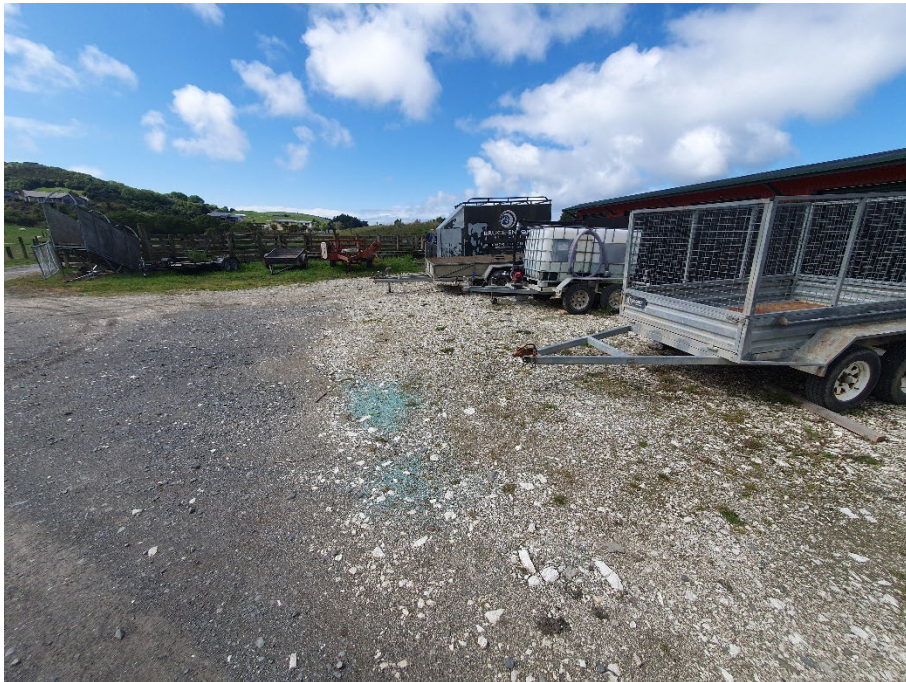
**P12:** Photo showing stockyard located along southern boundary of Area F. Several trailers, including one with two IBCs labelled as originally containing MasterRoc SA 160.

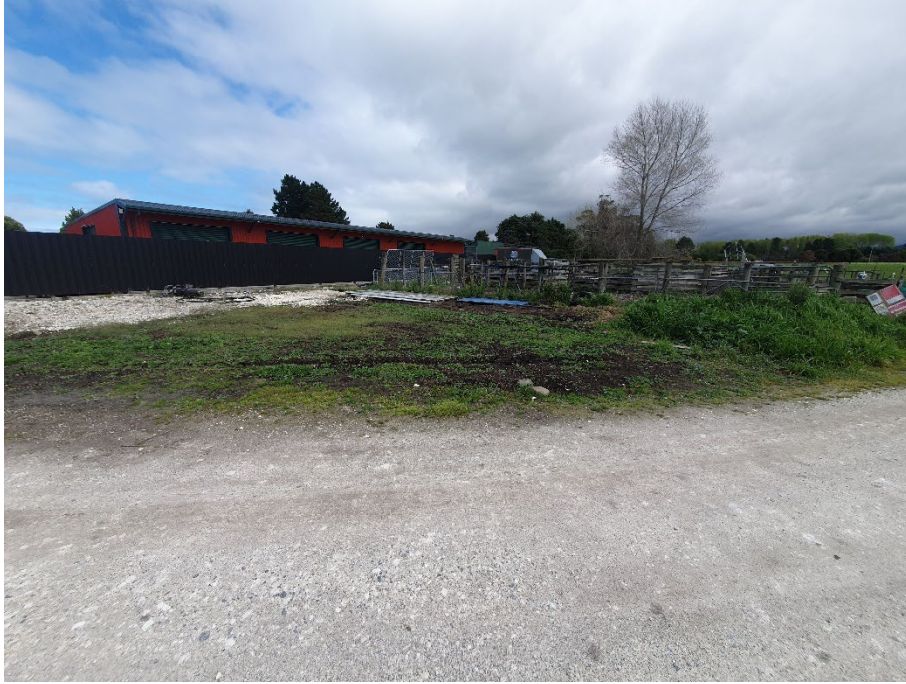
As seen in the latest aerial, one of the sheds and part of the farm yard area have been removed and replaced with a larger building. The building is understood to be a workshop, and is surrounded by concrete pavement. At the time of the site walkover, the gate was locked and this part of the site could not be accessed. A container with hazchem signage, a small backpack sprayer and two small (approx. 20L) chemical containers were observed, all being stored on the concrete pavement, which is in new condition.

**P13:** View of recently constructed workshop building to the south of the stockyards.

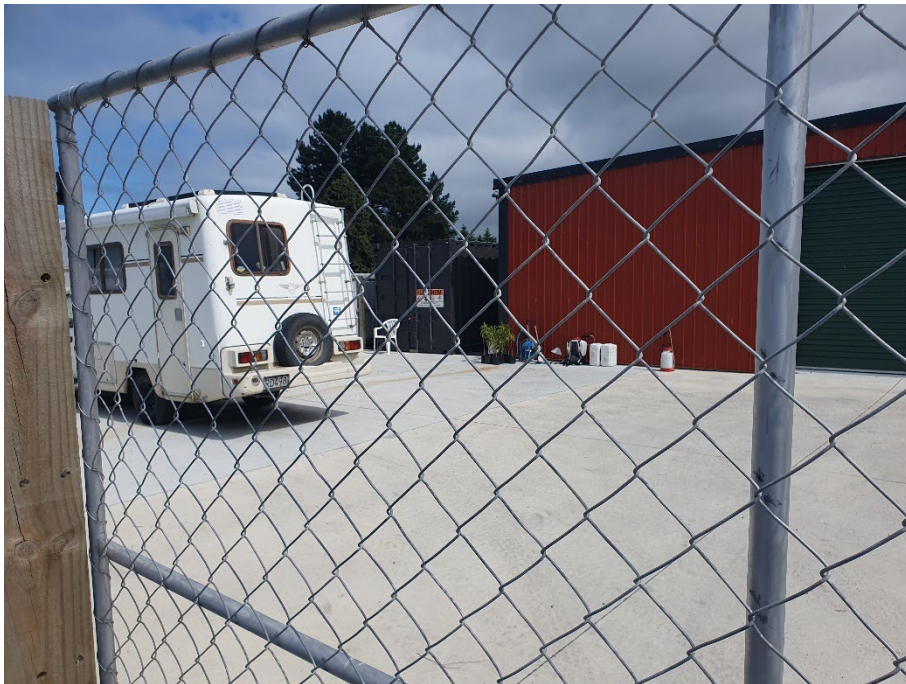
**P14:** View of workshop building showing good condition concrete pavement area, chemical storage in shipping container and minor chemical storage associated with back pack sprayer.

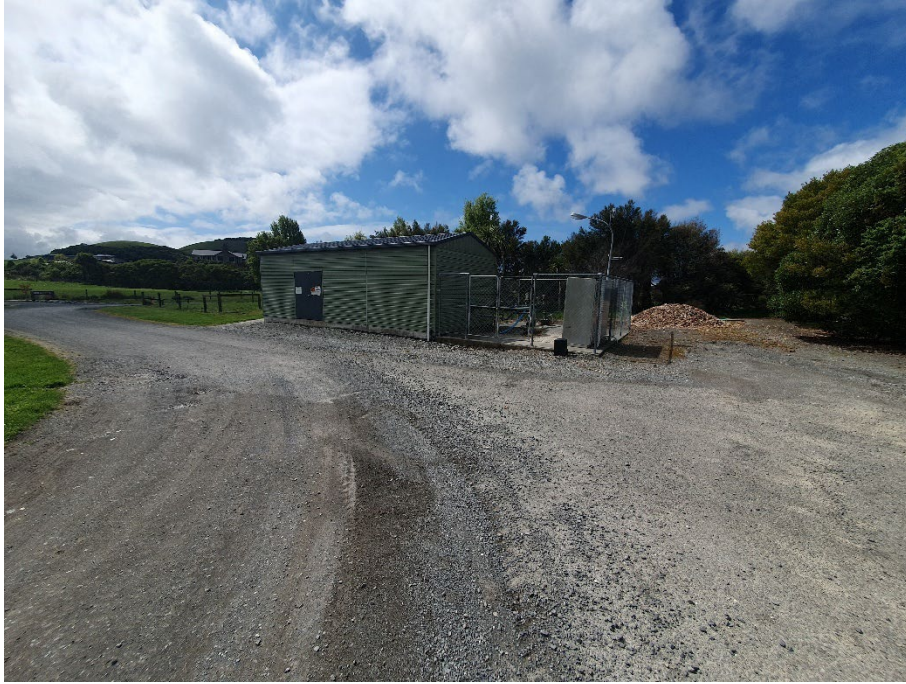
**P15:** Municipal water treatment facility, located to the east of the farm yard area. Signage indicates that Sodium Hypochlorite is used in the facility.

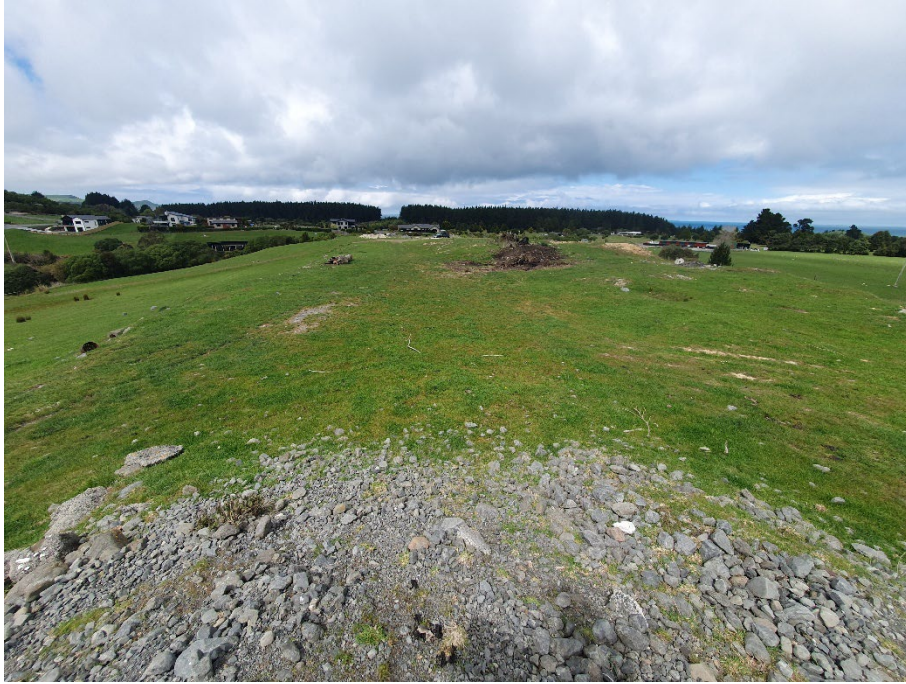
Several large stockpiles, were observed on the plateau area, generally in the same location as those identified in the historical aerial photographs.

**P16:** Looking south across stockpiles located in Area C. Note that the majority of stockpiles are vegetated with grass and are inferred have been placed in circa 2012.

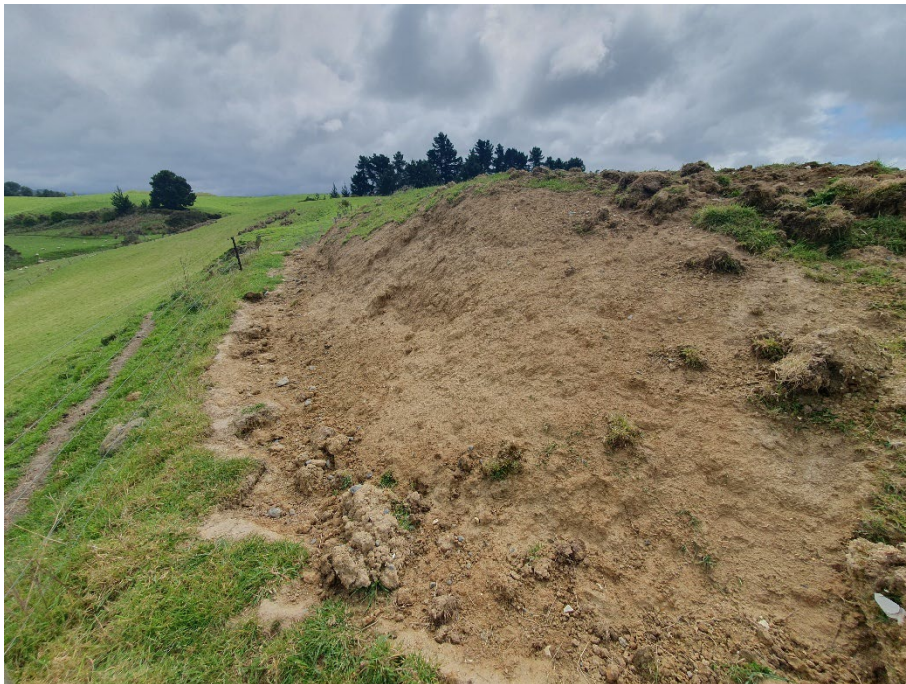
**P17:** Expsoed stockpiled sandy clayey silts (circa 2012).

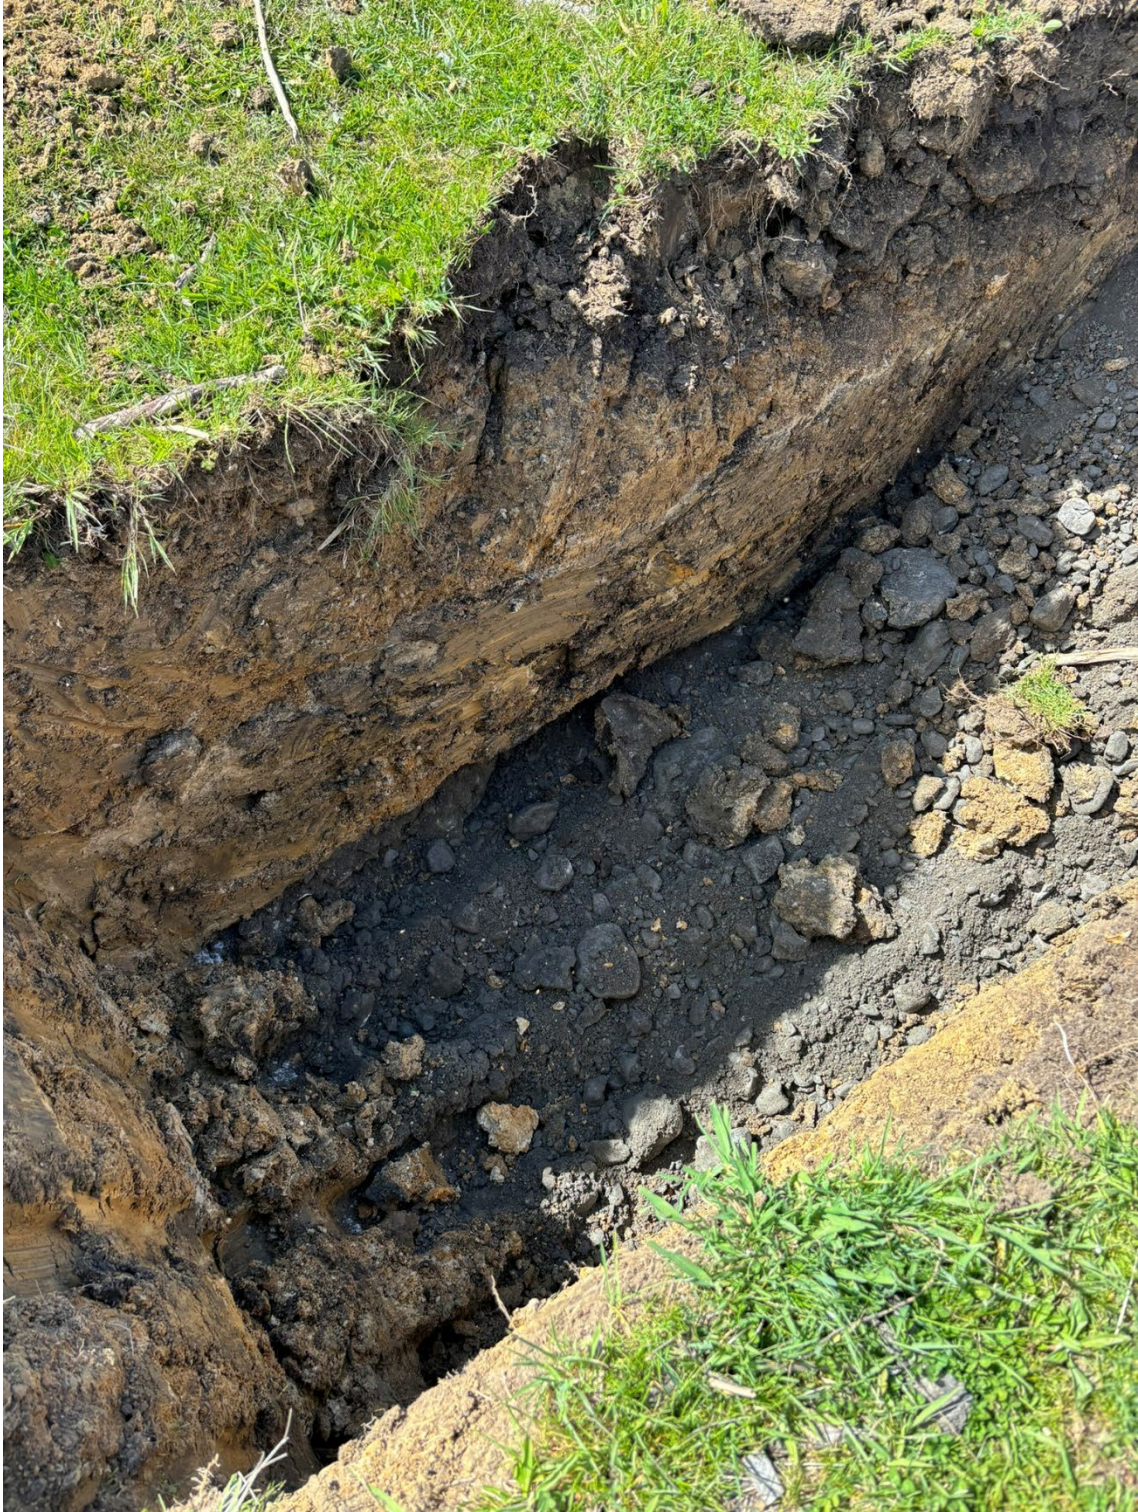
**P18:** View of test pit put down through clayey silt stockpile (circa 2012). The test pit appears to confirm that the majority of soils in the vegetated stockpiles, are likely to comprise sandy clayey silts, which are in turn underlain by sandy gravels. The sandy gravels in the base of the test pit were not encountered in geotechnical test pits and hand augers put down outside the extent, but in the vicinity of the stockpiles. Thus, these sandy gravels are inferred to be excess imported fill.

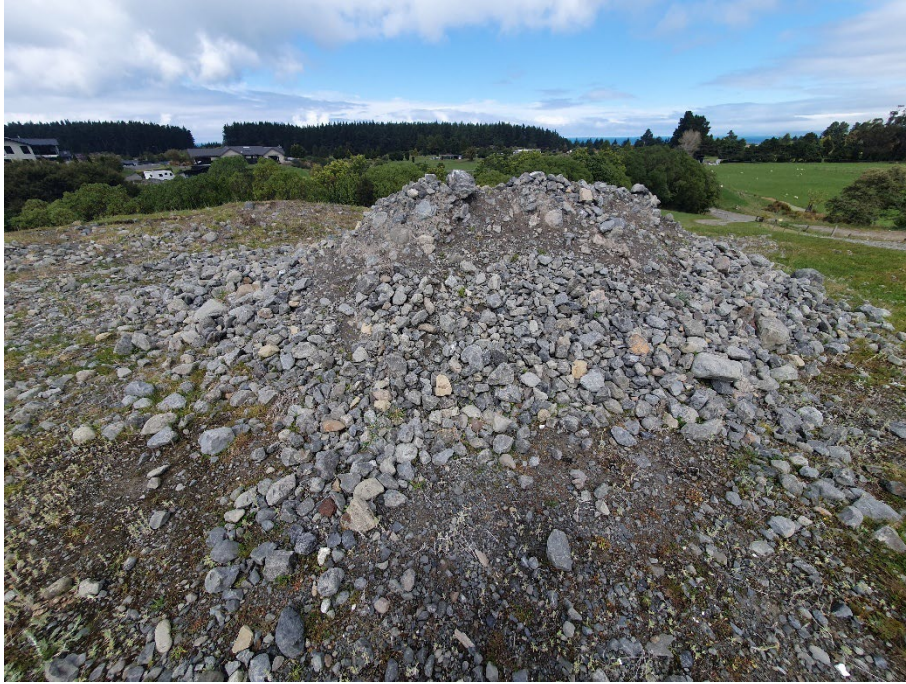
**P19:** Stockpiled fine to coarse greywacke gravels with some cobbles (circa 2016).

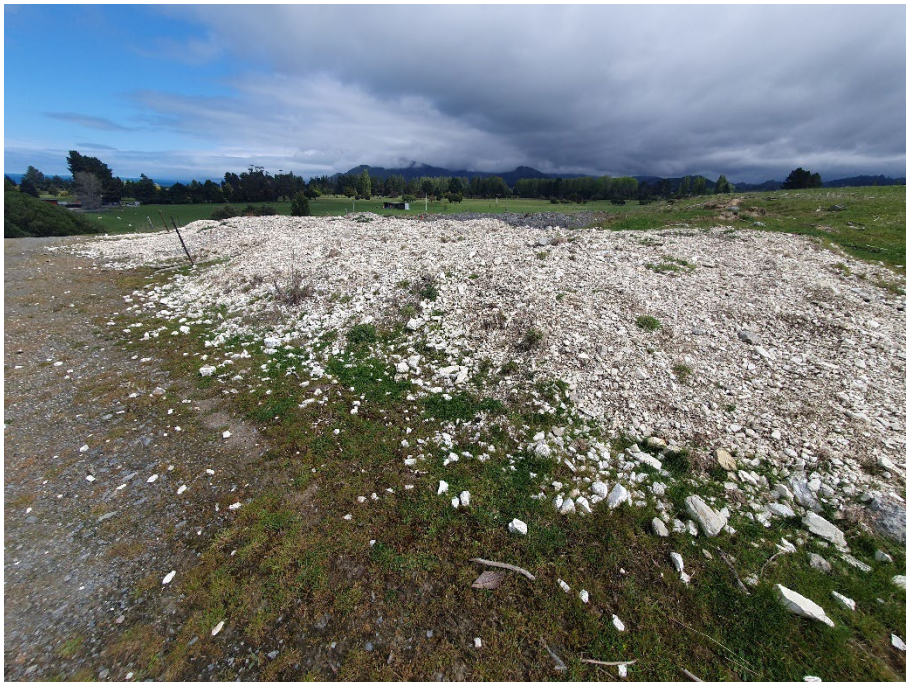
**P20:** Stockpiled natural crushed limestone (latest materials to be stockpiled)

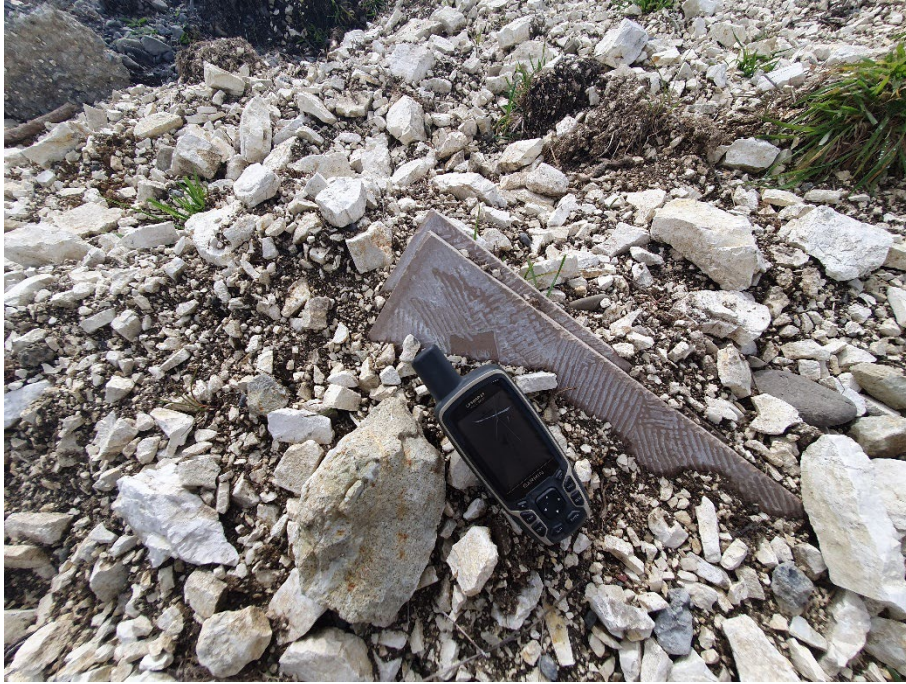
The materials generally appear to be 'clean'; however, isolated instances of concrete fragments and tiles were observed within the crushed limestone.

**P21:** Example of tiles intemixed within stockpiled natural crushed limestone (latest materials to be stockpiled).

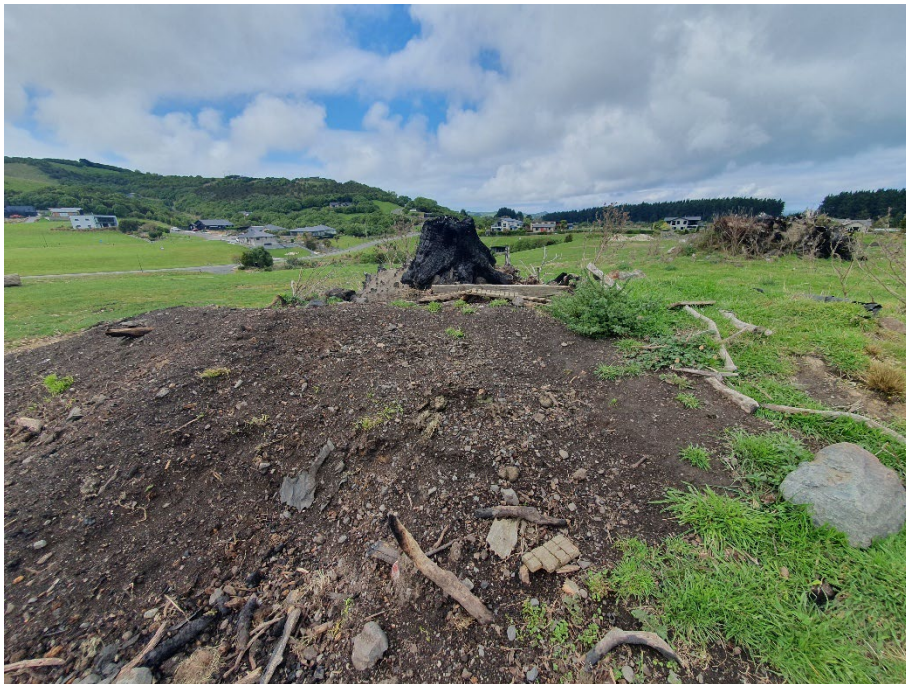
- Three burn piles, in which tree stumps and process timber appear to have been burnt,
- Several smaller stockpiles of concrete, asphalt and various other man-made materials including ceramic pipes, timber and PE hose,
- A shallow offal pit with evidence of several sheep carcasses.

The stockpiled soils, offal pit and burn piles should be considered potential HAIL I.

**P22:** One of the burn pile areas, located in northern part of the stockpile.

It is recommended that these potential/actual HAIL areas be further investigated and remediated, as necessary, as part of enabling (pre-construction) works prior to any bulk earthworks or other soil disturbance activities.

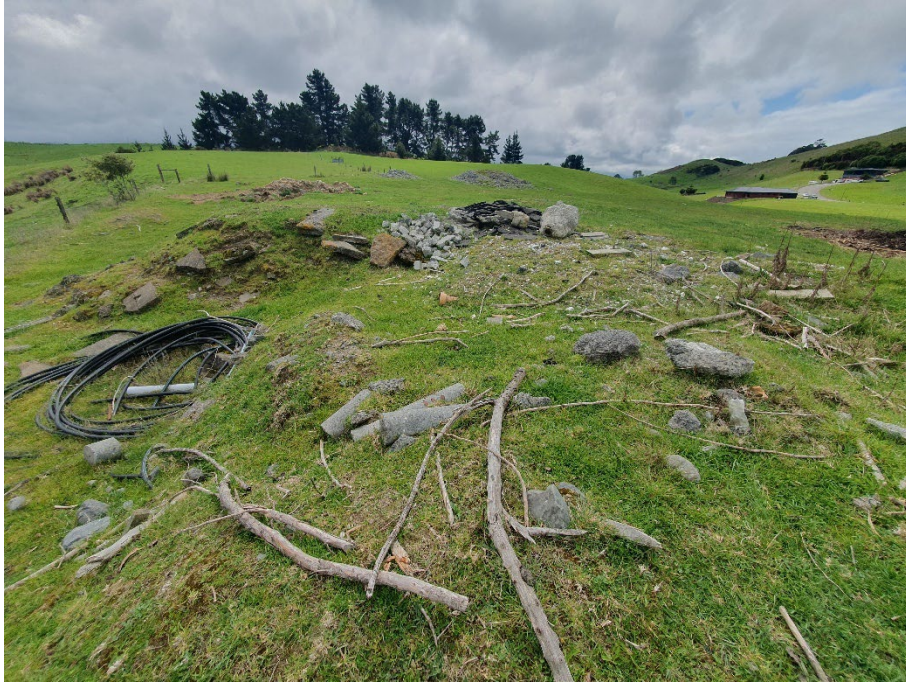
**P23:** Smaller stockpiles of concrete, asphalt and other man-made materials, located in northern part of the stockpile area.

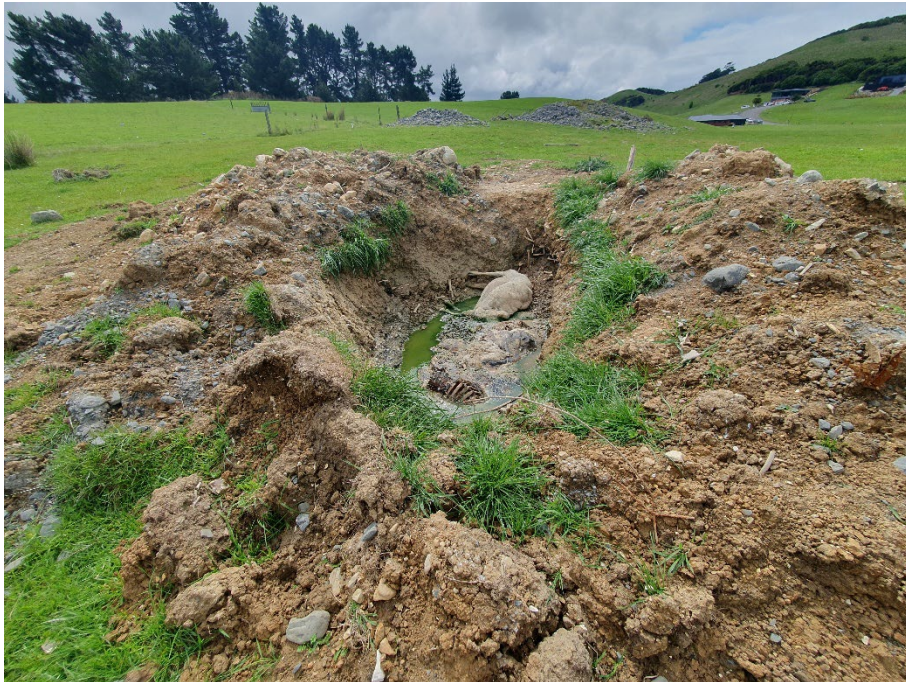
**P24:** Shallow offal pit located on top of a stockpile in Area C. There is potential for generation of leachate, particularly if other rubbish has been disposed to pit.

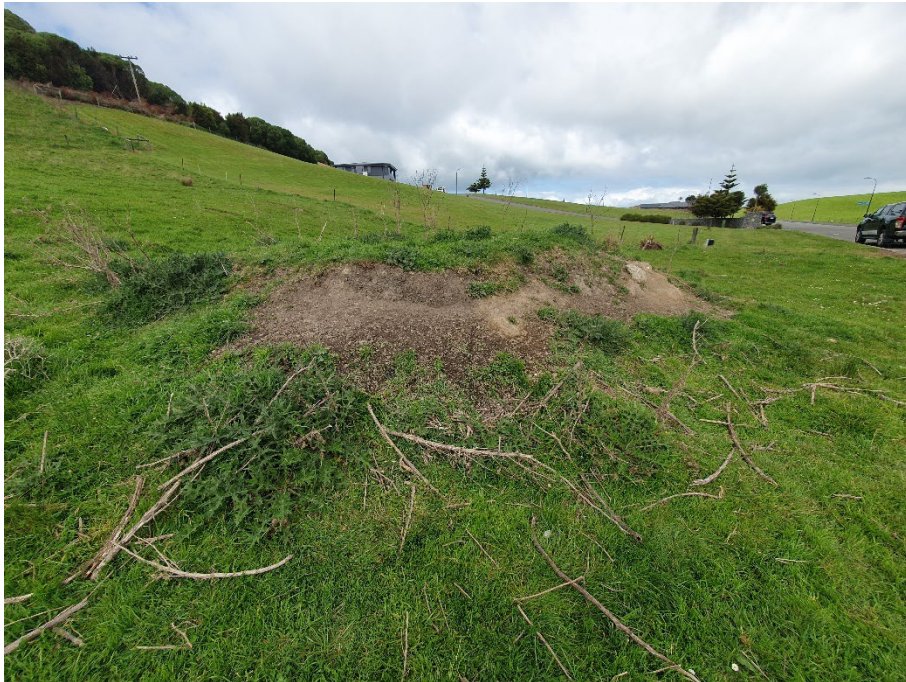
**P26:** Small sandy clayey silt stockpile located near south-western end of Area G. This stockpile is inferred to comprises excess soils from bulk earthworks or building construction in earlier stages of Ocean Ridge.

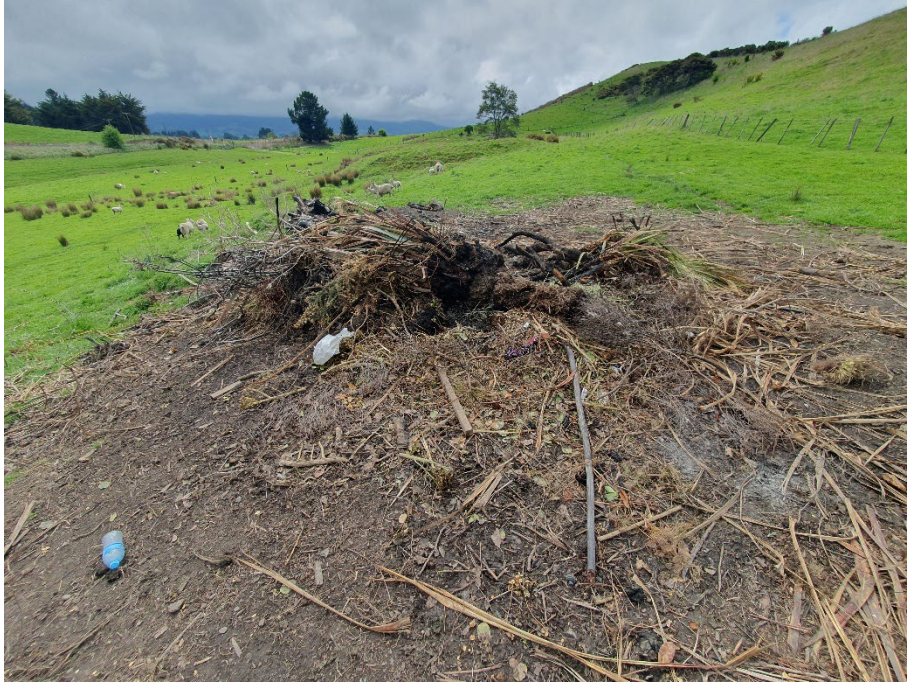
A small burn pile, approximately 5m to 6m in diameter, is located to in the south-western part of Area G. Based on site observations, the burn pile appears to have been used to burn vegetation and some general rubbish.

The stockpiled soils, man-made materials and burn pile should be considered potential HAIL I.

**P27:** Burn pile located in south-western part of Area G. Both vegetation and potentially general rubbish appear to have been burnt here.

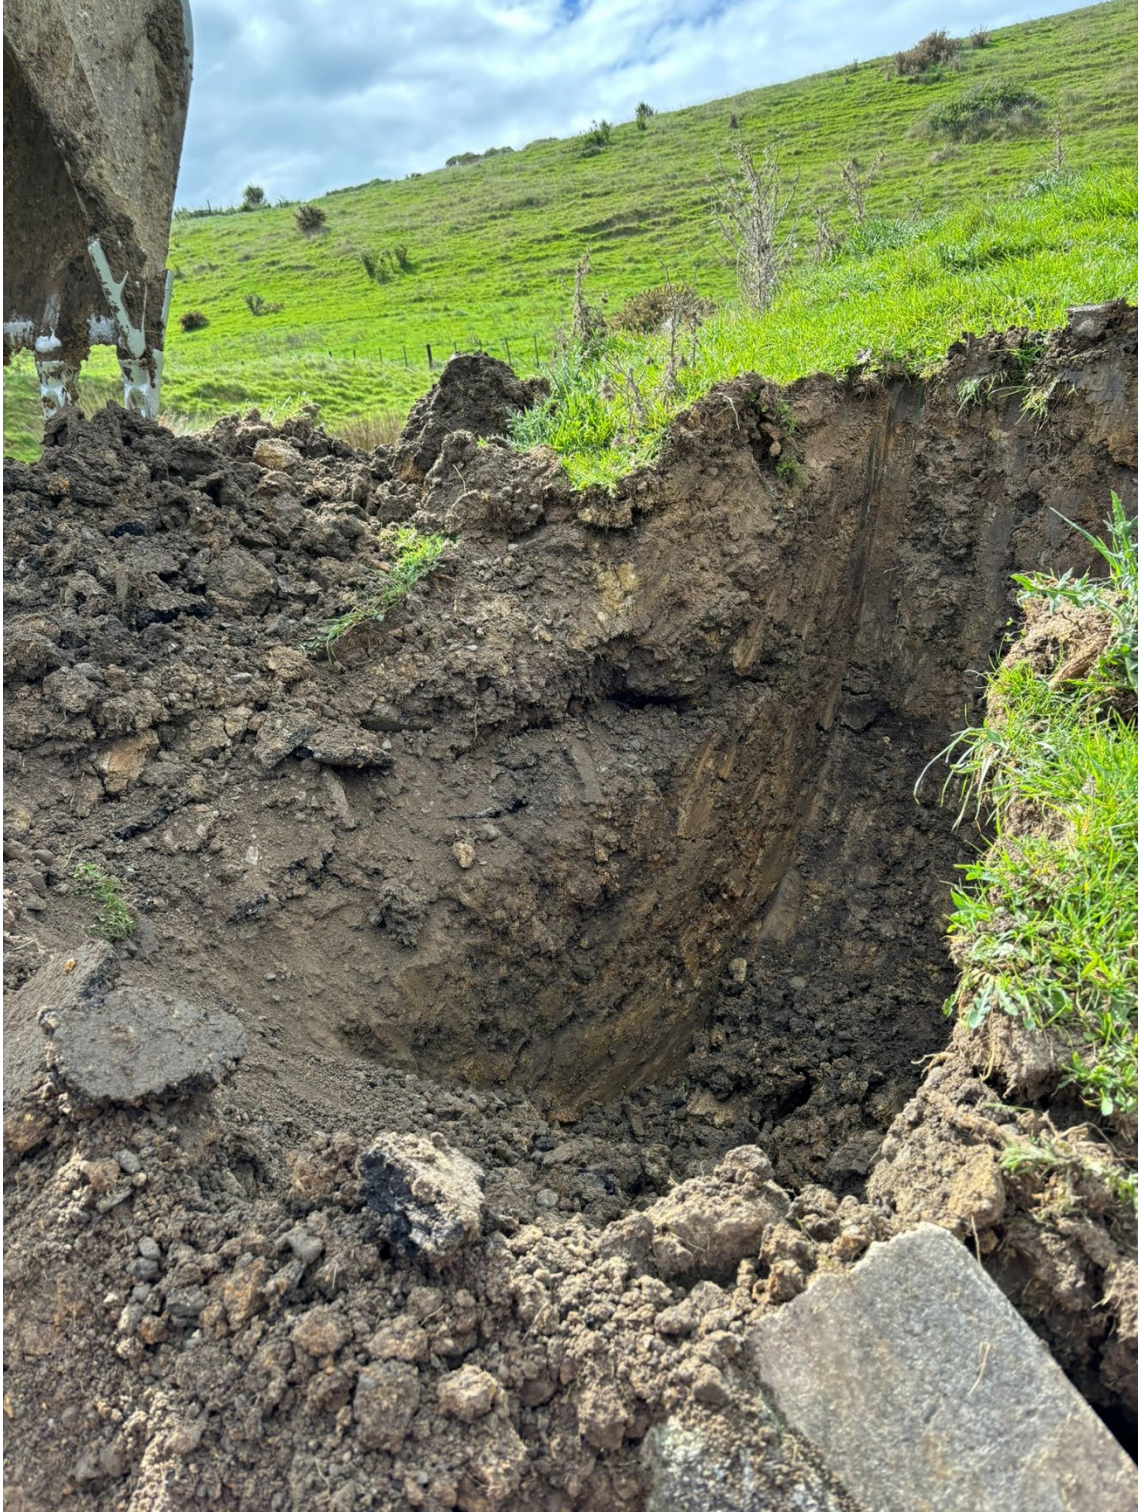
**P29:** View of test pit put down through one of the overgrown stockpiles (circa 2012). The stockpile generally comprises sandy clayey silts, intermixed with topsoil and trace amounts of concrete and asphalt.

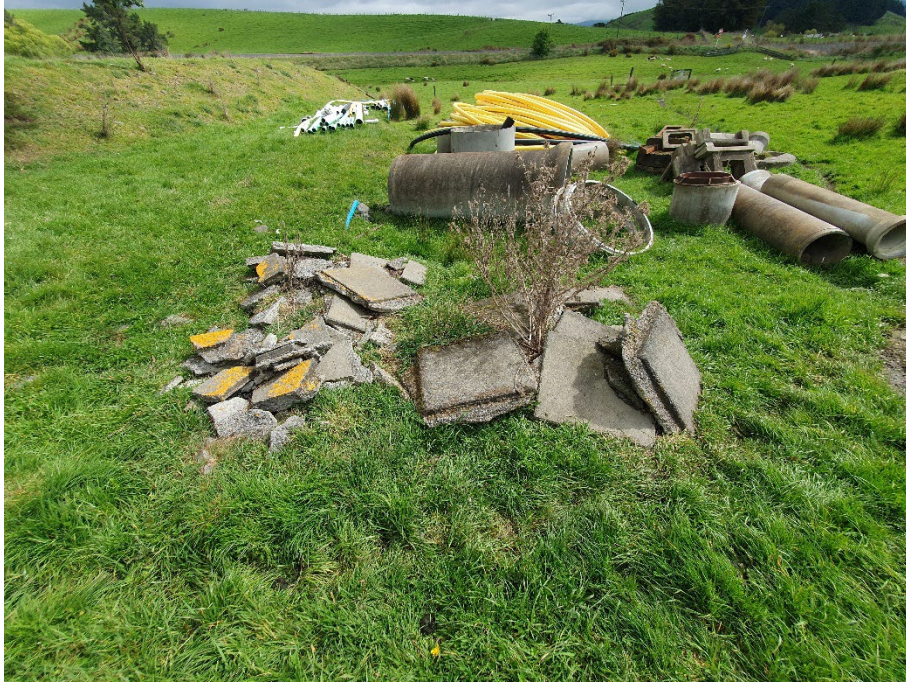
**P30:** Various construction materials lying on ground in vicinity of stockpiles.

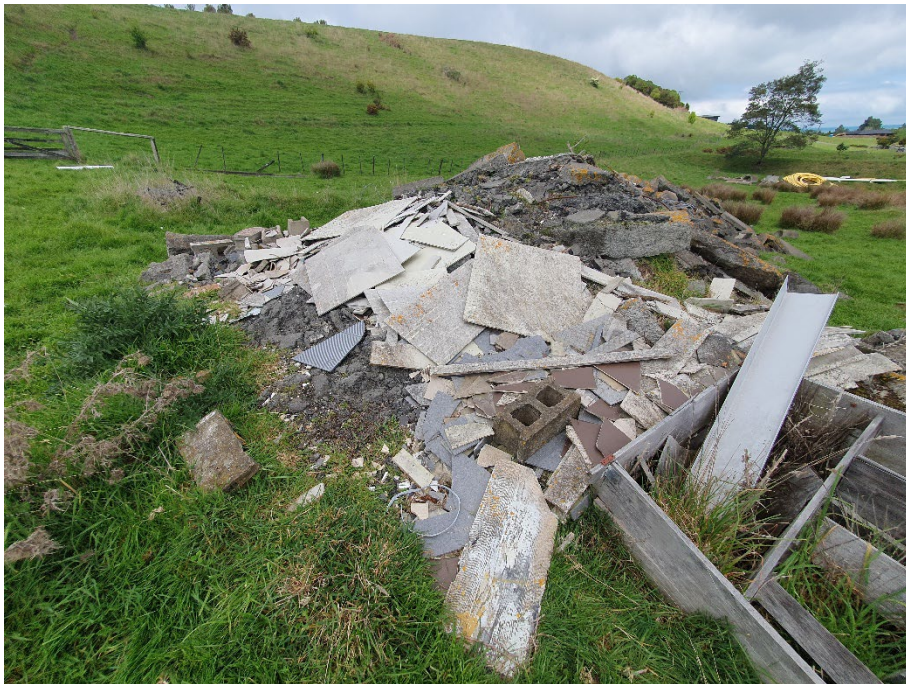
- Sandy clayey silts. These soils constitute the majority of the stockpiled volume, are vegetated with grass and are inferred to have been stockpiled sometime before July 2012 (first date observed in aerials),
- A large stockpile of man-made materials comprising concrete, asphalt, timber, and plasterboard

**P31:** Larger stockpile of various construction materials stockpiled in south-western part of Area G.
