TECHNICAL REPORT Science Group

Waiau Toa/Clarence River floodplain investigation

Report No. R19/34

Michelle Wild

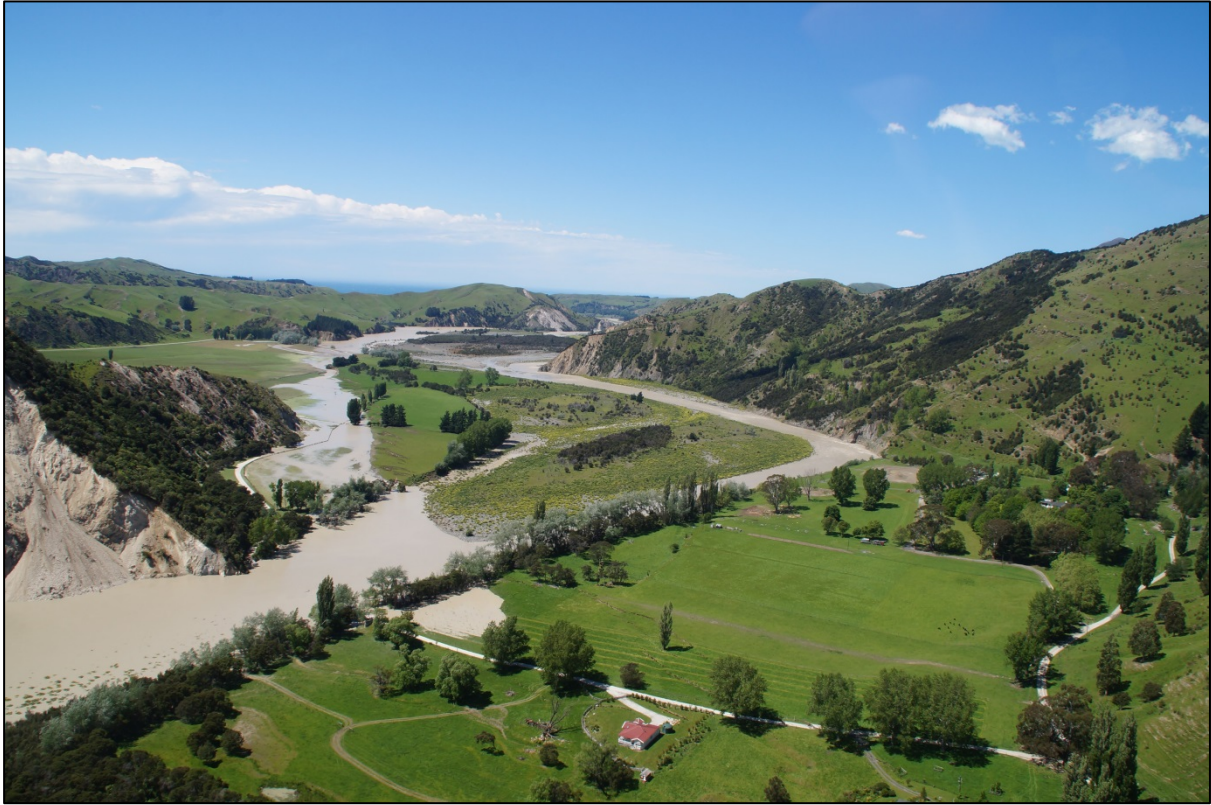
15 November 2016 - Looking downstream along the Papatea Fault towards the Clarence Valley Road bridge site and Woodbank Station overflow, showing the new river channel forming (left side of photo).

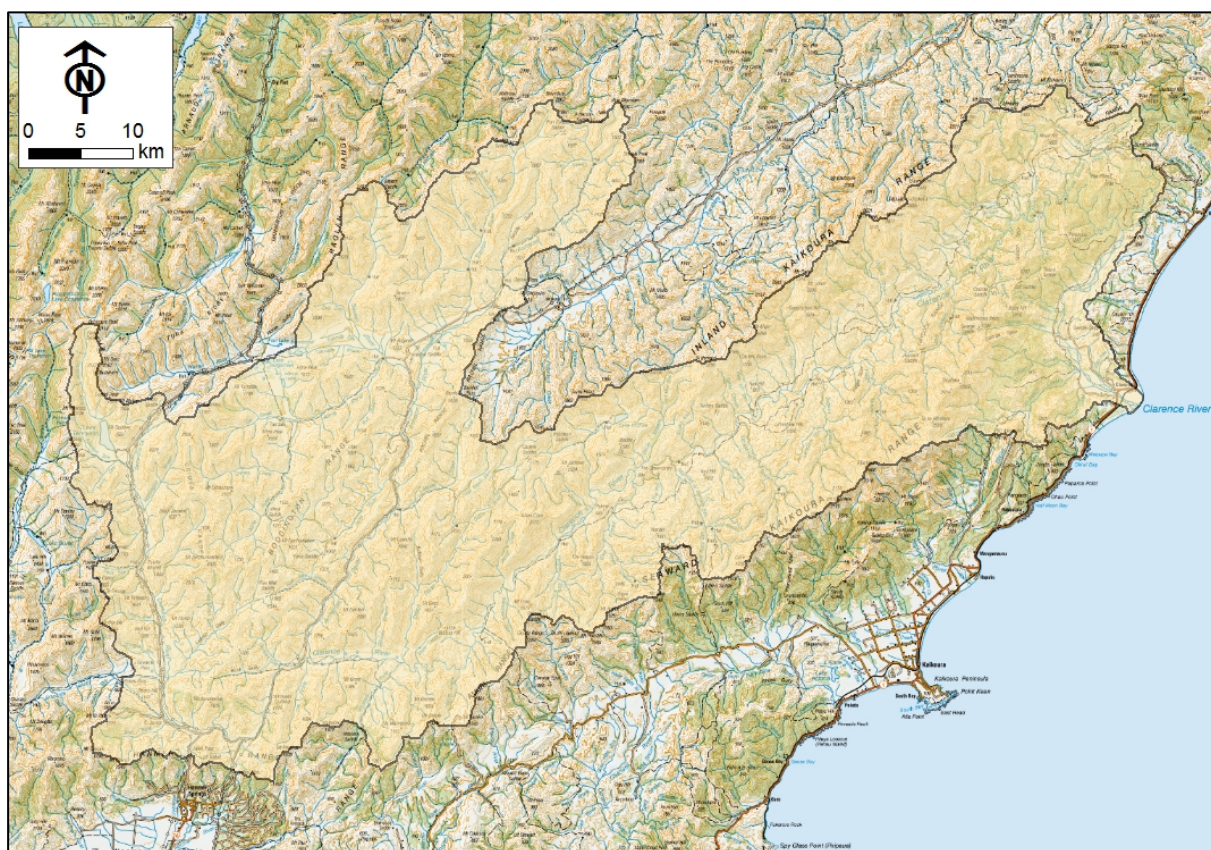
Figure 2-1: Waiau Toa/Clarence River catchment location map

The Waiau Toa/Clarence River has a catchment area of over 3300 km², with the upper catchment originating to the north of Hanmer Springs, upstream of Lake Tennyson (Figure 2-1). The river traverses over 200 km of remote landscape before reaching the coast, making the Waiau Toa/Clarence River one of the longer rivers in New Zealand.

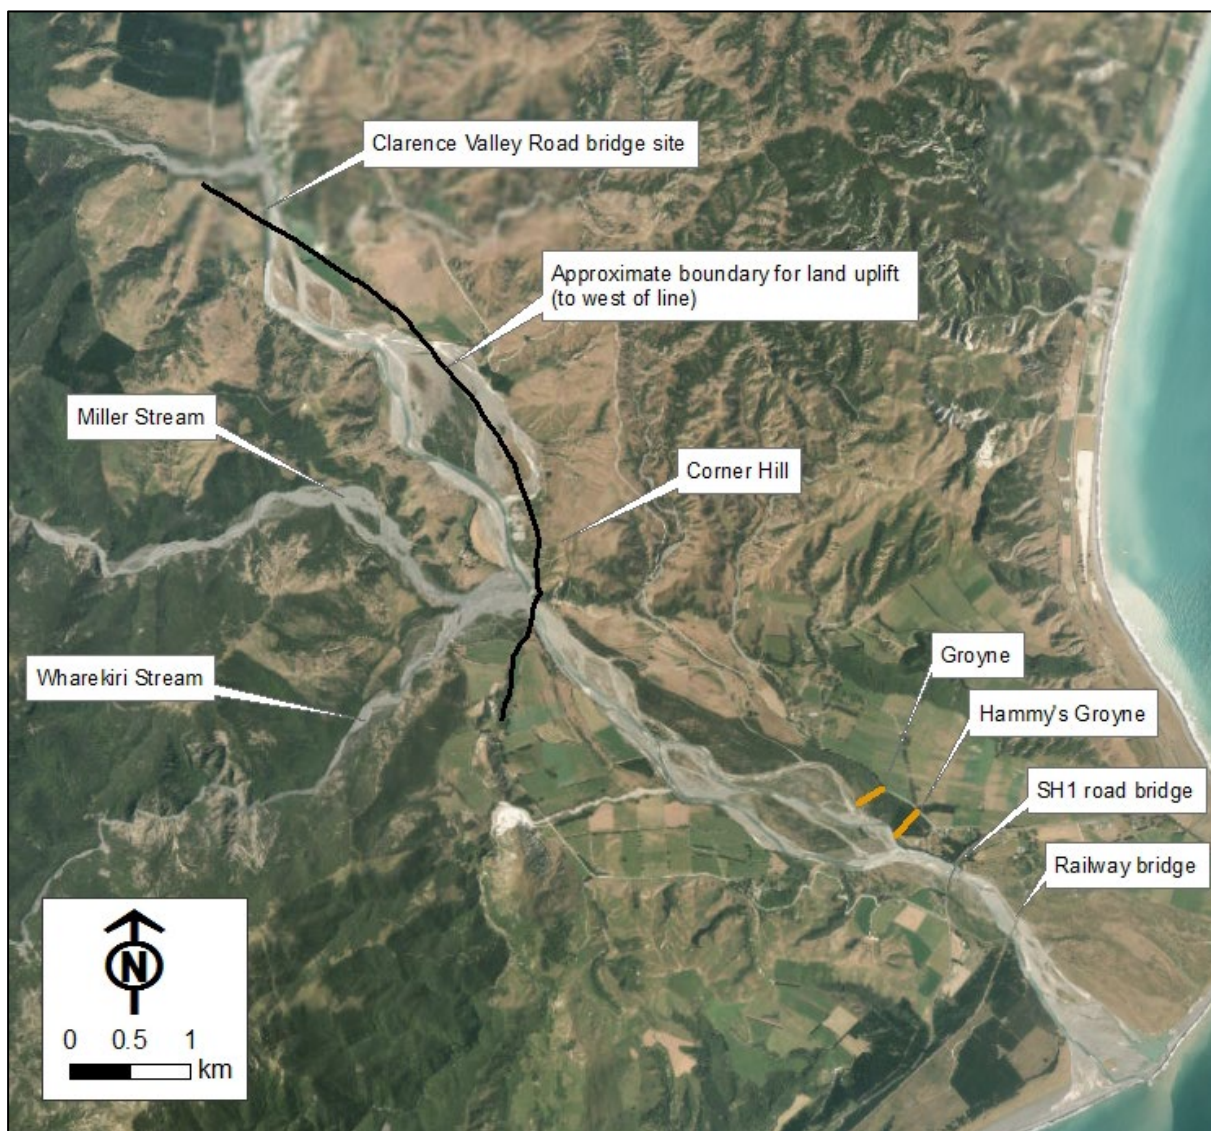
Figure 2-2: Lower Waiau Toa/Clarence River location map

Approximately 6.5 km upstream of the sea, the Miller and Wharekiri Streams flow into the Waiau Toa/Clarence River (Figure 2-2). The large sediment supply from these sub-catchments creates an alluvial fan that constricts Waiau Toa/Clarence River flows. Upstream of this constriction, the Waiau

Toa/Clarence River has a more gradual channel slope, and finer riverbed material (Thomson, 1966). Downstream of the constriction, the channel slope is greater, and the larger bed material is likely to be due to reworking of old terrace gravels (Thomson, 1966).

Land uplift, during the 14 November 2016 Kaikōura Earthquake Sequence (Figure 2-2), has made significant changes to the Waiau Toa/Clarence River floodplain. Large additional volumes of sediment have also entered the river system in the form of rock falls and landslides, with one landslide temporarily damming the river. Further information on the 2016 Kaikōura Earthquake Sequence is summarised below.

The 14 November 2016 Kaikōura Earthquake Sequence caused the Papatea Fault, between Corner Hill and the Clarence Valley Road Bridge site, to uplift the Waiau Toa/Clarence riverbed by over 5 m relative to the floodplain area on the north-eastern side (Figure 2-2, Figure 2-5 and Figure 2-6). This

After the 1923 flood, two stone and netting groynes were constructed to protect the old highway bridge approach (Figure 2-2). However, maintenance was minimal for many years and over 7 m of silt had reportedly built up behind the upstream (Hammy's) groyne by 2003 (CRC Flood Hazard Assessment, Ref: AD5C-0018), compromising the effectiveness of this structure. There are also concrete block and steel bank protection works (sputniks) between the downstream groyne and the SH1 road bridge, although some of the blocks have been undermined and dislodged.

Water depths increase by up to 1 m deep on the Clarence Valley Road for the southerly or easterly flood event with the Foster’s stopbank removed. Further downstream, on the berm/floodplain area upstream of Hammy’s Groyne (see Figure 2-2 for location), additional flood water is also directed towards Hammy’s Groyne when the Foster’s stopbank is not present. There are no significant changes to water depths adjacent to the Clarence settlement, or downstream of SH1 (i.e. flood water depths are not dependent on the integrity of the Foster’s stopbank in these areas). The Clarence Settlement does, however, rely on both Hammy’s Groyne, and a stopbank running along the riverbank from Hammy’s Groyne to the SH1 Bridge, for flood protection. These structures need to be monitored, and maintained, to minimise flood risk within the settlement.

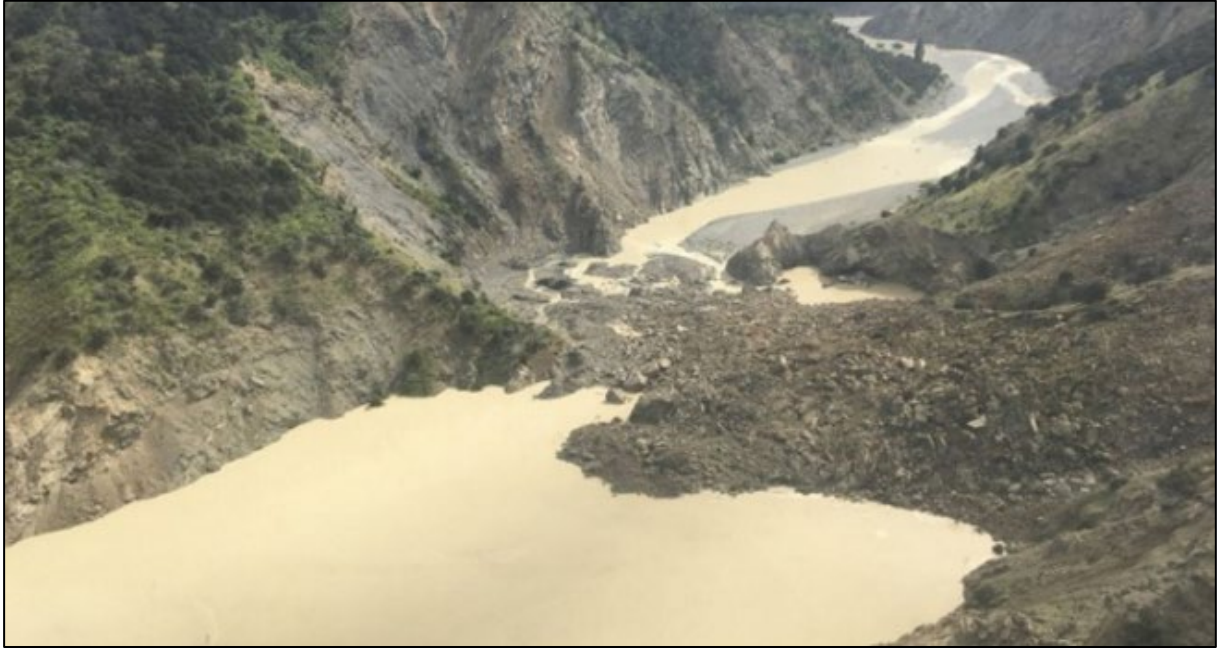
Figure 2-3: 14 November 2016 - Looking downstream towards the Waiau Toa/Clarence River landslide dam before it breached around 4:20pm

A large landslide, originating on Haycock Range, blocked the Waiau Toa/Clarence River upstream of the Dart Stream confluence. Due to the remote location, approximately 44 km upstream of the Waiau Toa/Clarence River mouth, it was not initially observed – although a passing helicopter did observe the breach around 4:20pm on 14 November 2016; (<http://www.stuff.co.nz/national/86436608/warning-as-large-clarence-river-dammed-by-landslide>, accessed 16 May 2017). Figure 2-3 and Figure 2-4 show the landslide dam.

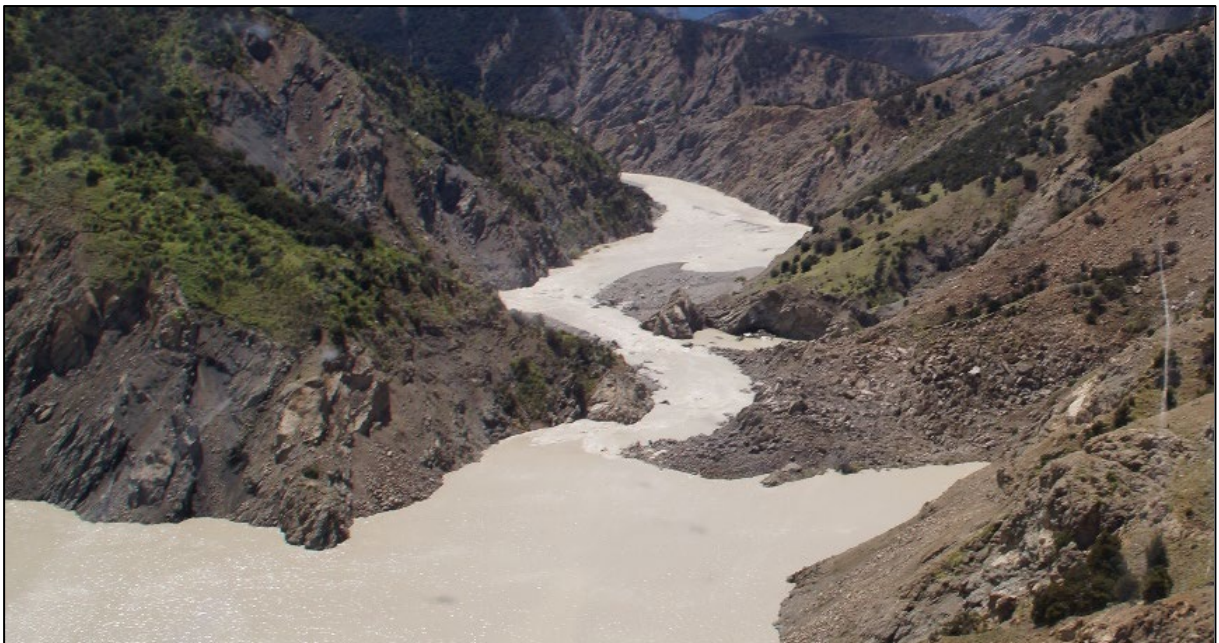
Figure 2-4: 15 November 2016 at 12:15pm - Looking downstream at the Waiau Toa/Clarence River landslide dam after it breached

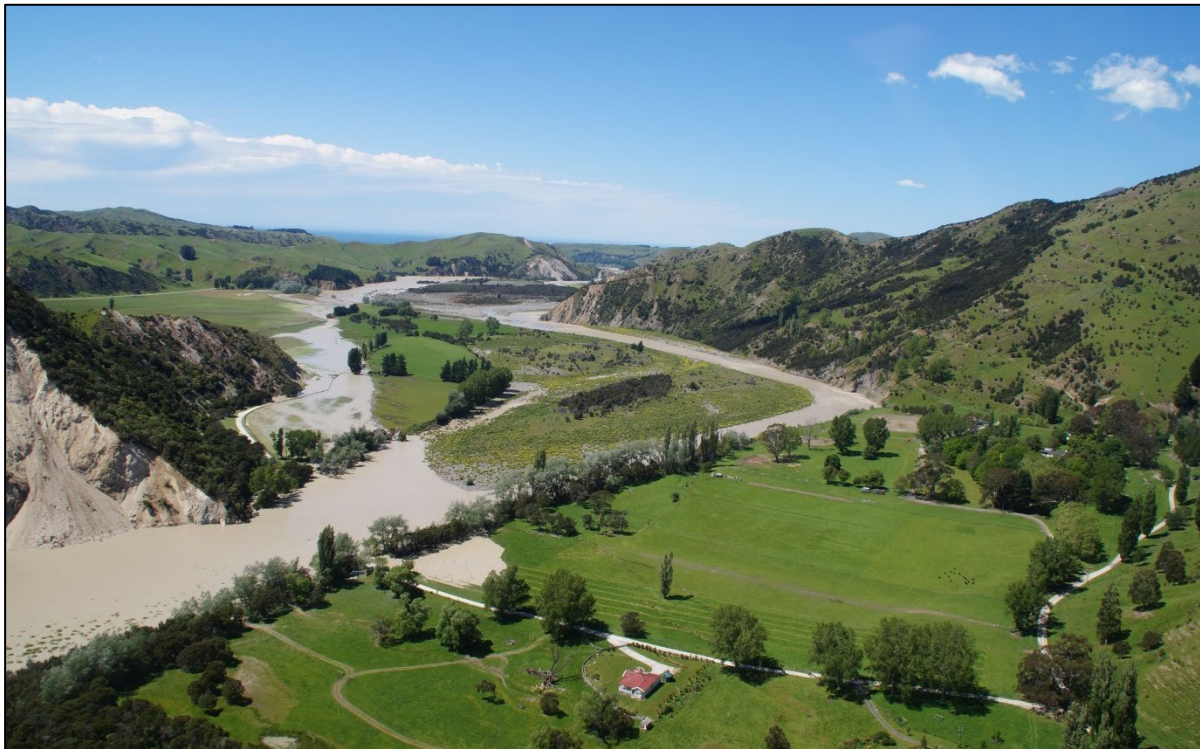
Figure 2-5: 15 November 2016 - Looking downstream along the Waiau Toa/Clarence River towards the Clarence Valley Road bridge site and Woodbank Station overflows

destroyed the Clarence Valley Road Bridge, and significantly increased the likelihood of flooding, with a river course change through the portion of Woodbank Station upstream of Corner Hill (Heslop, 2016).

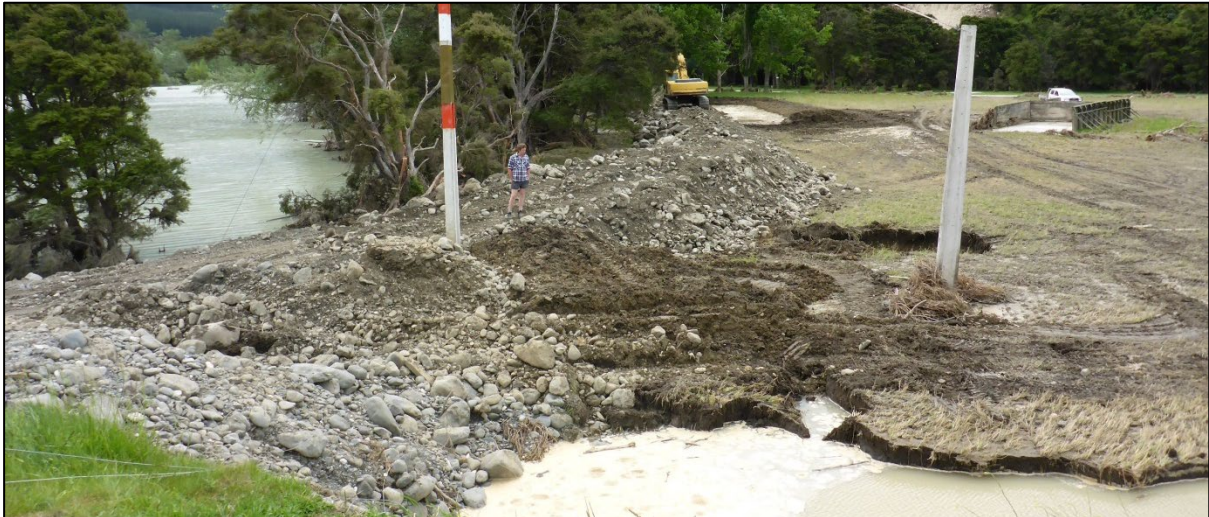
Figure 2-7: 25 November 2016 - Woodbank Station stopbank constructed in the area immediately downstream of the Clarence Valley Road bridge site

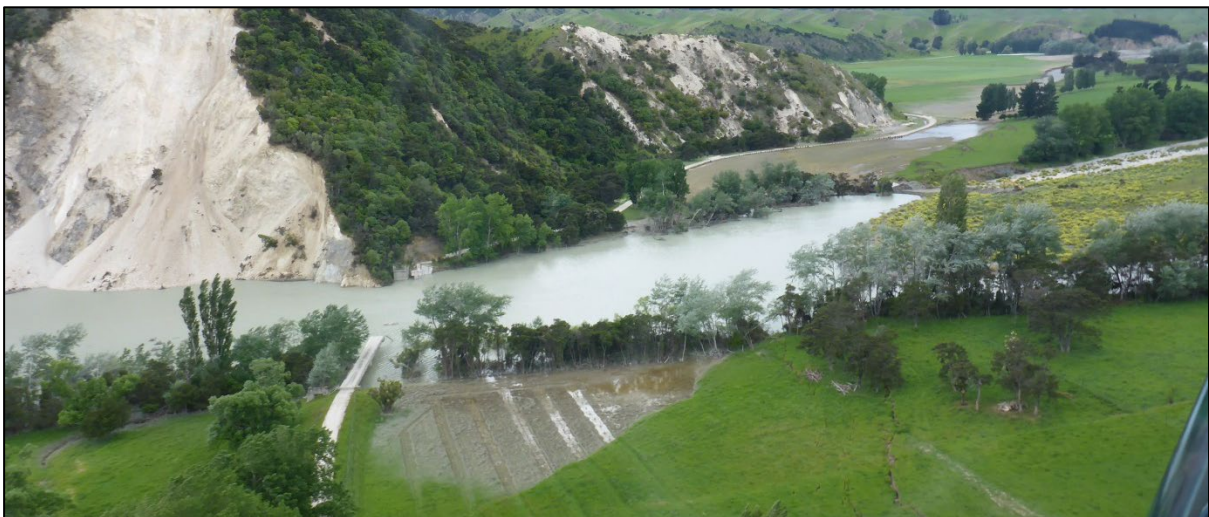
Figure 2-8: 25 November 2016 - Clarence Valley Road bridge site with Woodbank Station stopbank constructed post-2016 Kaikōura Earthquake Sequence

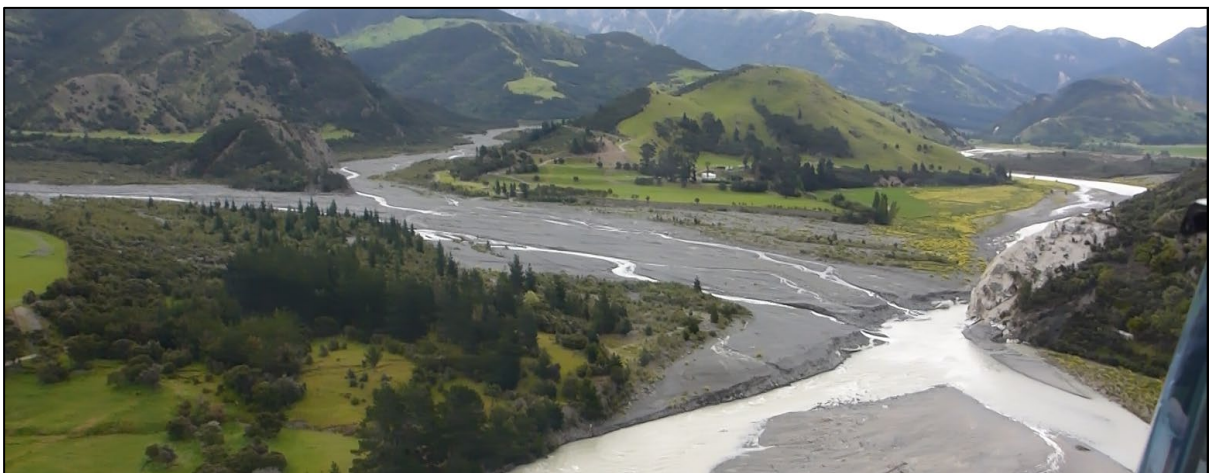
Figure 2-9: 25 November 2016 - Looking upstream at the elevated Wharekiri and Miller Stream confluence where it meets the Waiau Toa/Clarence River

At Corner Hill, the earthquakes also caused the Wharekiri and Millers stream confluence to be uplifted by over 4 m (Figure 2-9), producing a new waterfall/rapid in the Waiau Toa/Clarence River reach upstream of Corner Hill.

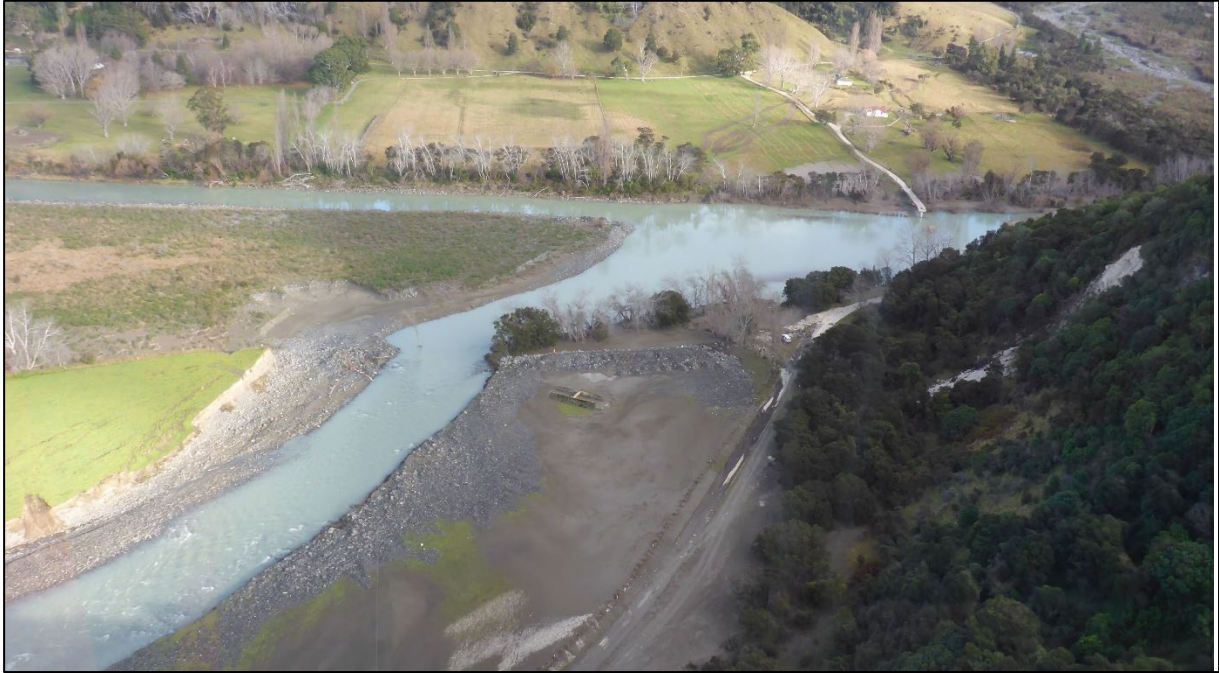
Figure 2-10: 18 July 2017 - Looking upstream along the new Waiau Toa/Clarence River channel to the destroyed section of Woodbank Station stopbank and Clarence Valley Road Bridge

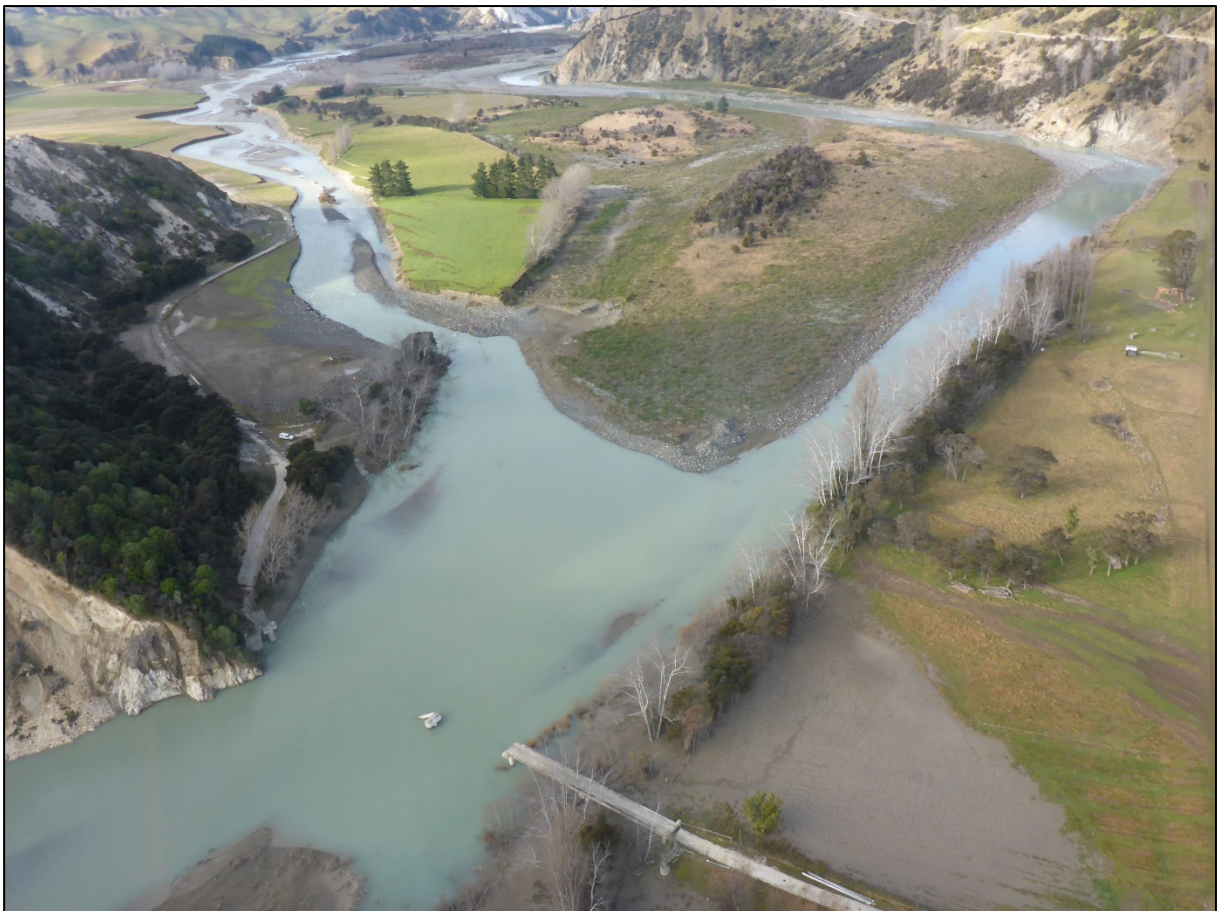
Figure 2-11: 18 July 2017 - Looking downstream from near the Clarence Valley Road Bridge to the new Waiau Toa/Clarence River channel running along the fault through farmland

High river flows destroyed part of the newly constructed stopbank at Woodbank Station (Figure 2-10). This allowed the Waiau Toa/Clarence River to further establish the new channel through farmland, along the boundary of the uplifted fault (Figure 2-11). Additional farmland became riverbed and the Clarence Valley Road bridge approaches were washed out.

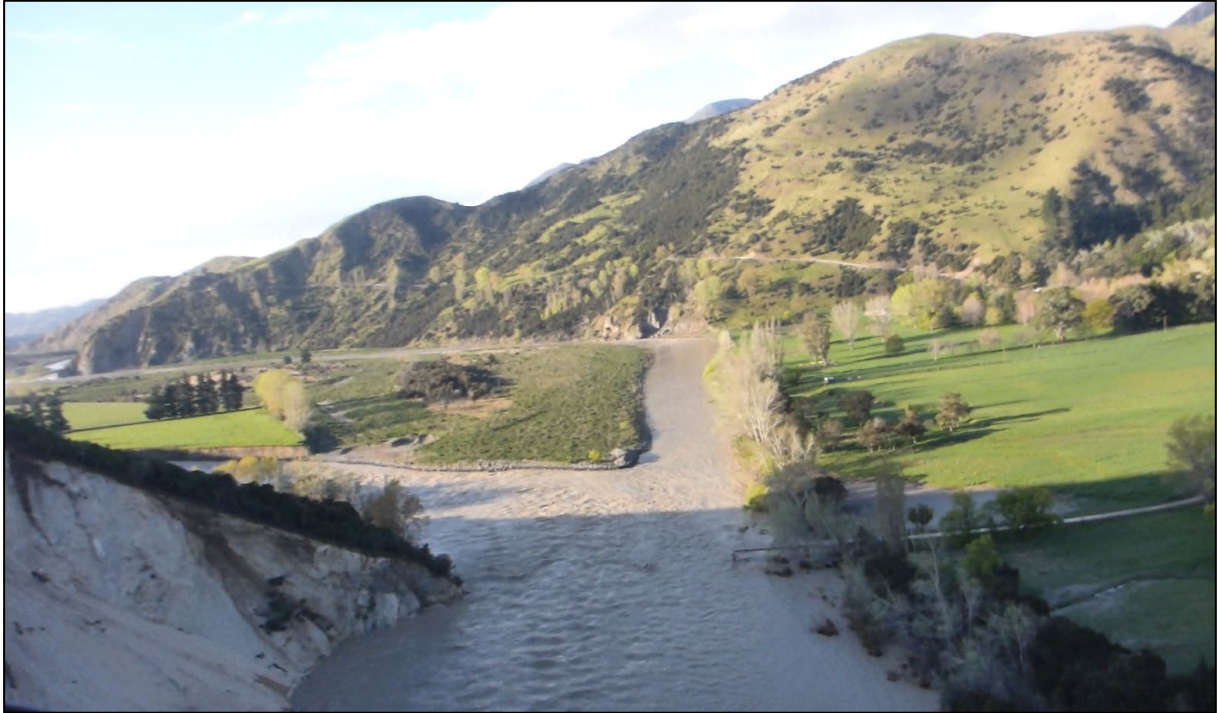
Figure 2-12: 27 September 2017 - Looking downstream at the destroyed Clarence Valley Road Bridge and new main Waiau Toa/Clarence River channel along the fault (left channel)

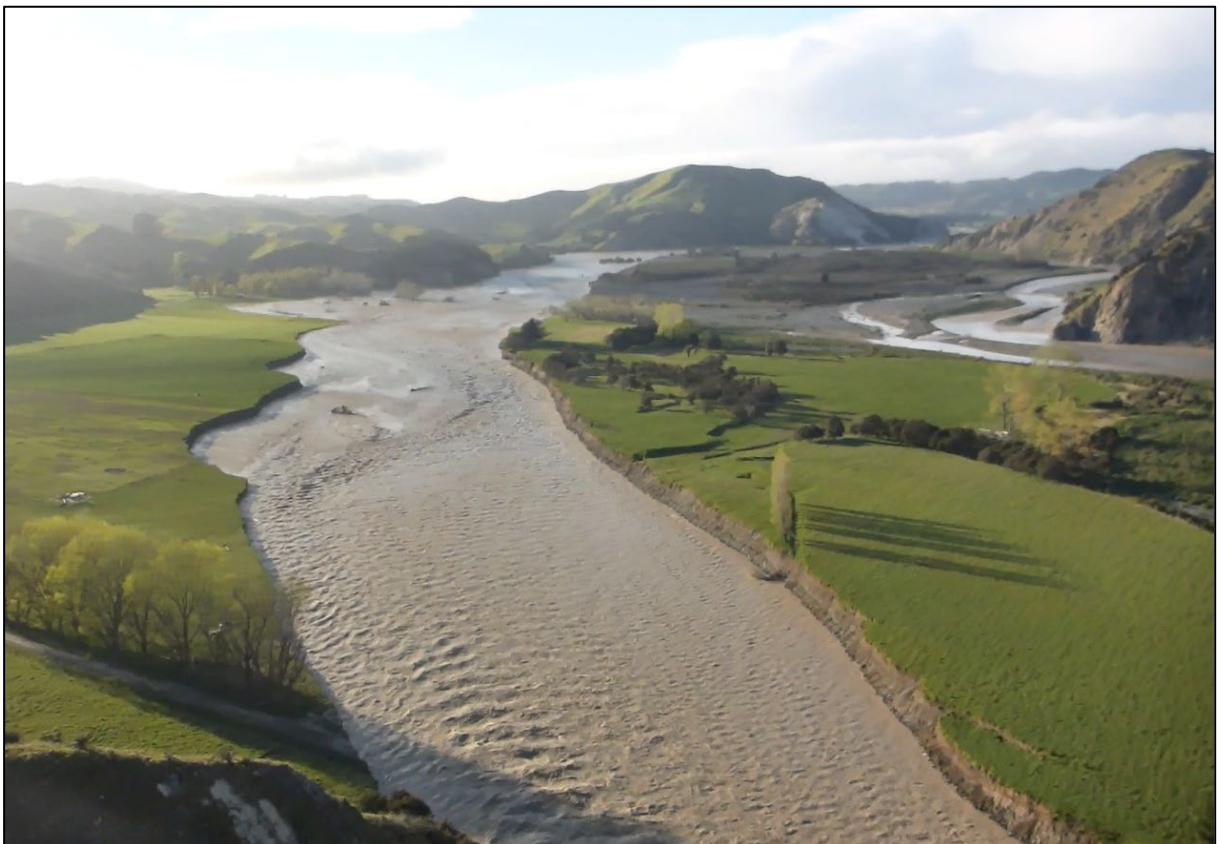
Figure 2-13: 27 September 2017 - Looking downstream from near the Clarence Valley Road Bridge at the new main Waiau Toa/Clarence River channel along the fault

During September 2017 there were two relatively small flood events around the 19th and 27th September. These high flows continued to scour and enlarge the new Waiau Toa/Clarence River channel, now flowing through farmland downstream of the Clarence Valley Road Bridge site (Figure 2-12 and Figure 2-13). The 4 m deep layer of gravel stored at the Wharekiri and Miller Stream confluence was also down-cut to the underlying rock shelf, raised during earthquake uplift (Figure 2-14). This down-cutting continued upstream along the Wharekiri and Miller Streams, to beyond the ford crossing, which now provides the only road access to the upper valley on this side of the river.

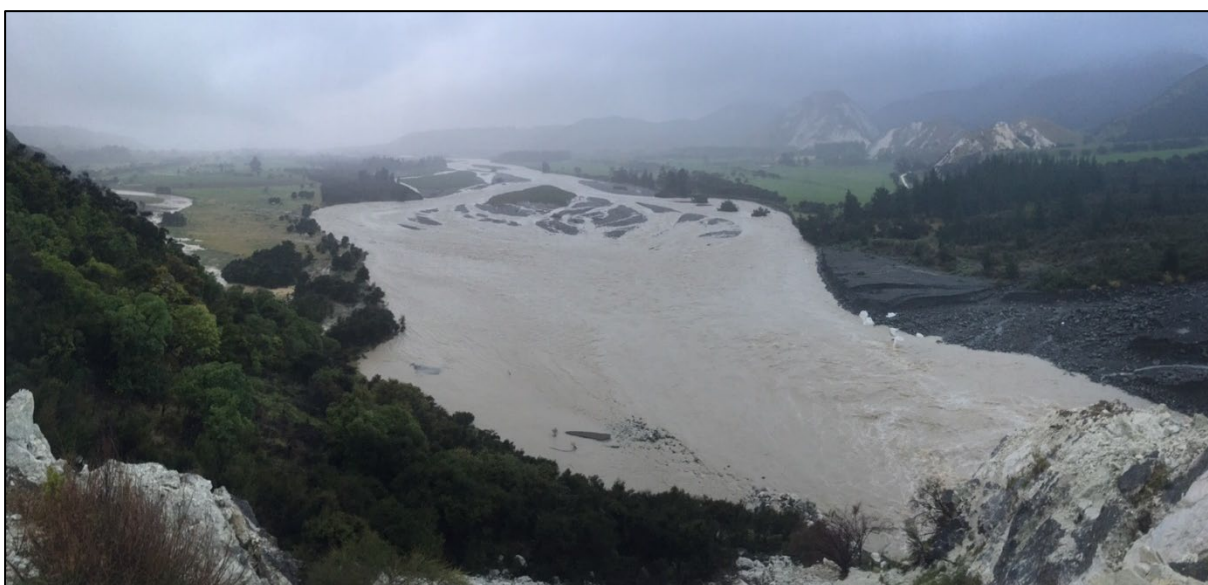
Figure 2-15: 22 September 2017 - Looking downstream from Corner Hill at the large island that formed in the Waiau Toa/Clarence River

Downstream of Corner Hill, much of the bed material from the Waiau Toa/Clarence River and the Wharekiri and Miller Streams was deposited in the Waiau Toa/Clarence River channel. This formed a central island that split the flow, directing flow towards both river banks (Figure 2-15). Vegetation was washed away and river banks were eroded. As the river flows receded, further deposition occurred in the channel, along with significant bank erosion (Figure 2-16).

Since the September 2017 flood events, gravel has been extracted from the beach below Corner Hill. A channel was also cut through the gravel island to direct flows back into the centre of the river, rather than toward the banks. Rock protection works, mainly in the form of small rock groynes, have also been placed along both banks downstream of Corner Hill (Figure 2-18). As there is no River Management Scheme in place, rock protection works have been funded by land owners. These rock protection works performed well in early July 2018, when flows around a mean annual flood passed along the river from the upper catchment.

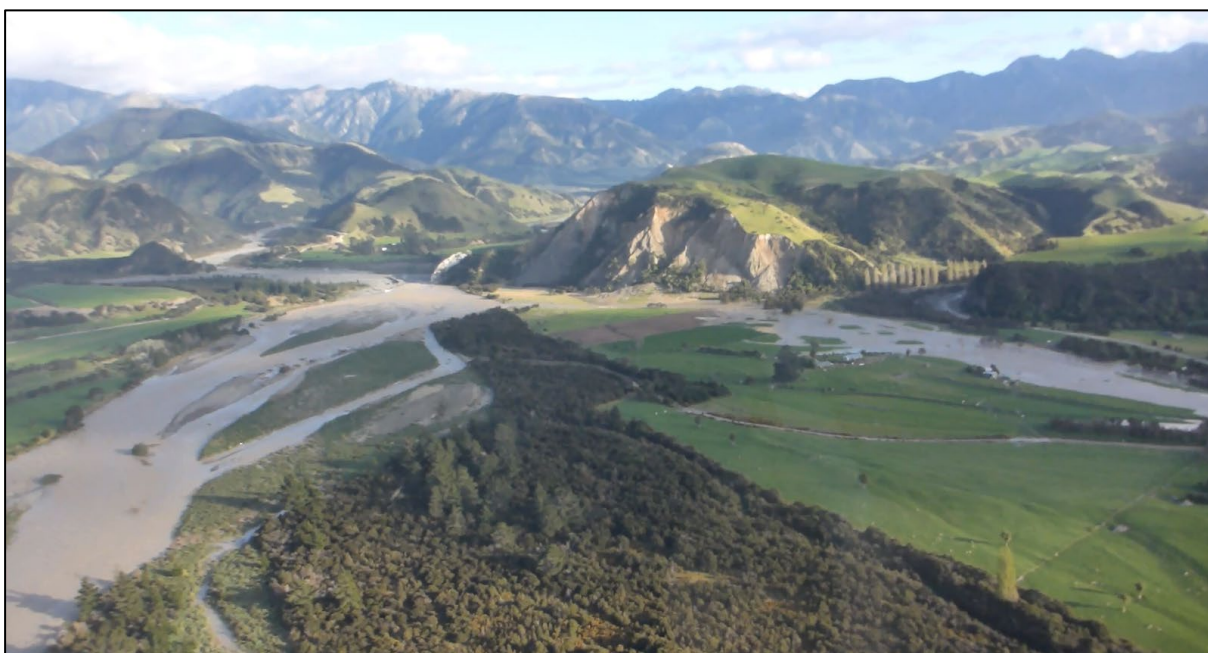
Figure 2-17: 27 September 2017 - Looking upstream towards Corner Hill at overflows over the northern (true left) bank

The combination of lower bank levels, and considerable aggradation in the river channel, encouraged further overflows into remnant river channels (through farmland) on the northern floodplain during subsequent high flows (Figure 2-17). The only residents located on this floodplain self-evacuated before access was compromised by the flows. Clarence Valley Road runs alongside one of the overflow channels, making it also susceptible to these overland flows.

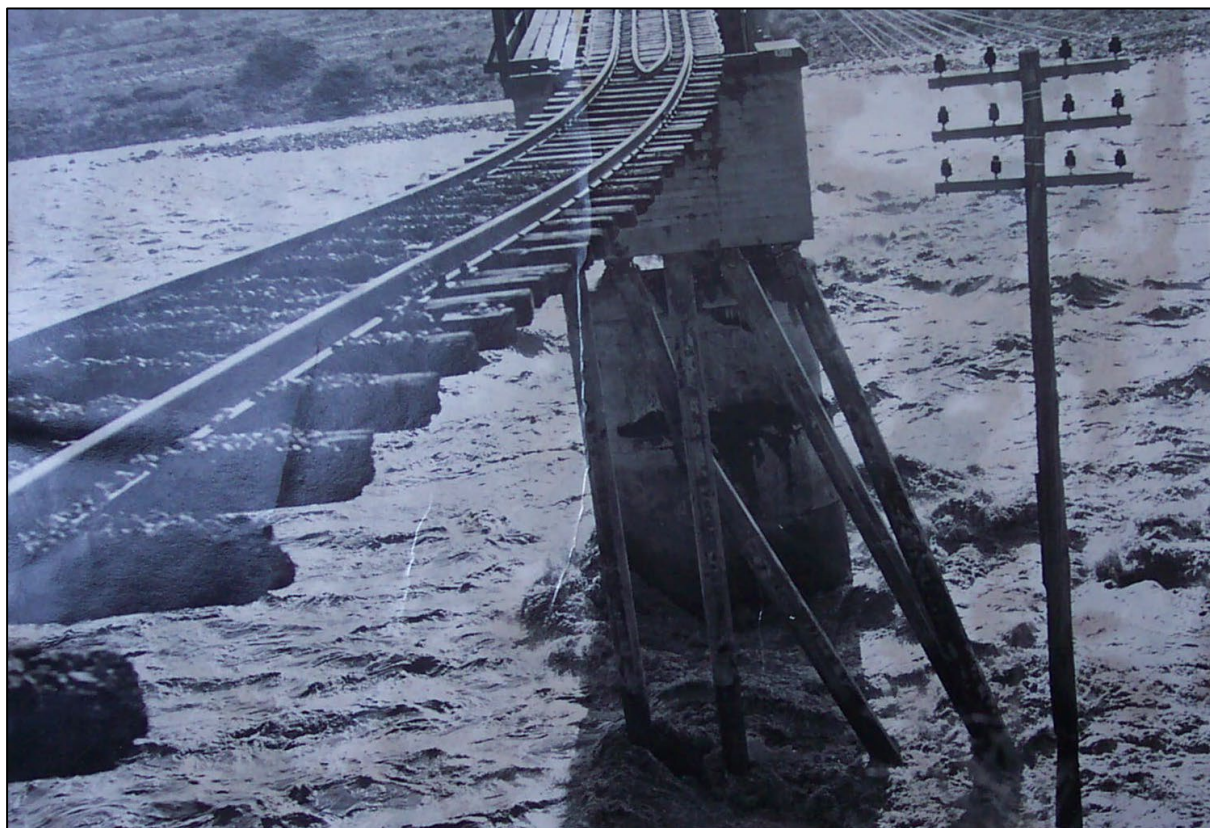
Figure 2-19: Washout of Waiau Toa/Clarence River south abutment of main trunk railway line in May 1966

The south abutment of the Waiau Toa/Clarence River railway bridge was washed out (Figure 2-19). It was the fourth time in 43 years that one of the bridge abutments had been washed out (Thomson, 1966).

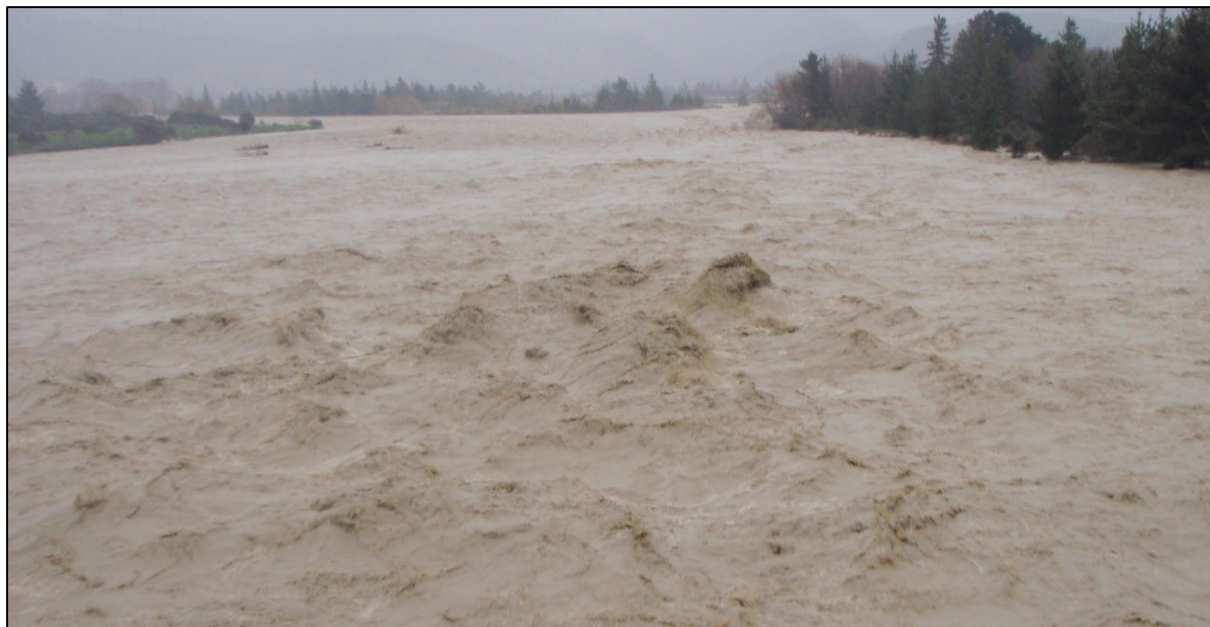
Figure 2-20: Looking upstream from the Waiau Toa/Clarence River road bridge during the July 2008 flood event

there is no information specifically relating to this river during the 31 July 2008 flood event, photographs show the Waiau Toa/Clarence River at high flows (Figure 2-20 and Figure 2-21).

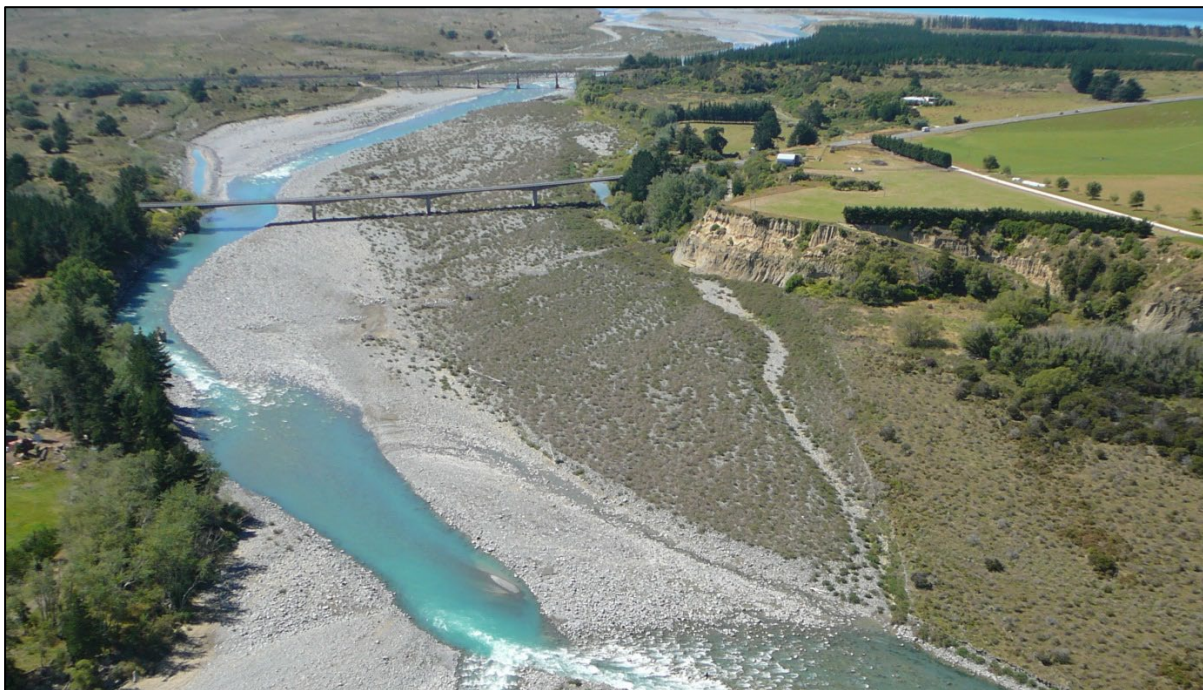
Figure 3-5: Looking downstream along the Waiau Toa/Clarence River to the SH1 road bridge and the railway bridge

The 1D model does not include the SH1 road bridge or the railway bridge (Figure 3-5). Under normal circumstances, these bridges have good clearance, and only produce local increases in water level (e.g. around the piers). The model assumes no significant blockage of either bridge.

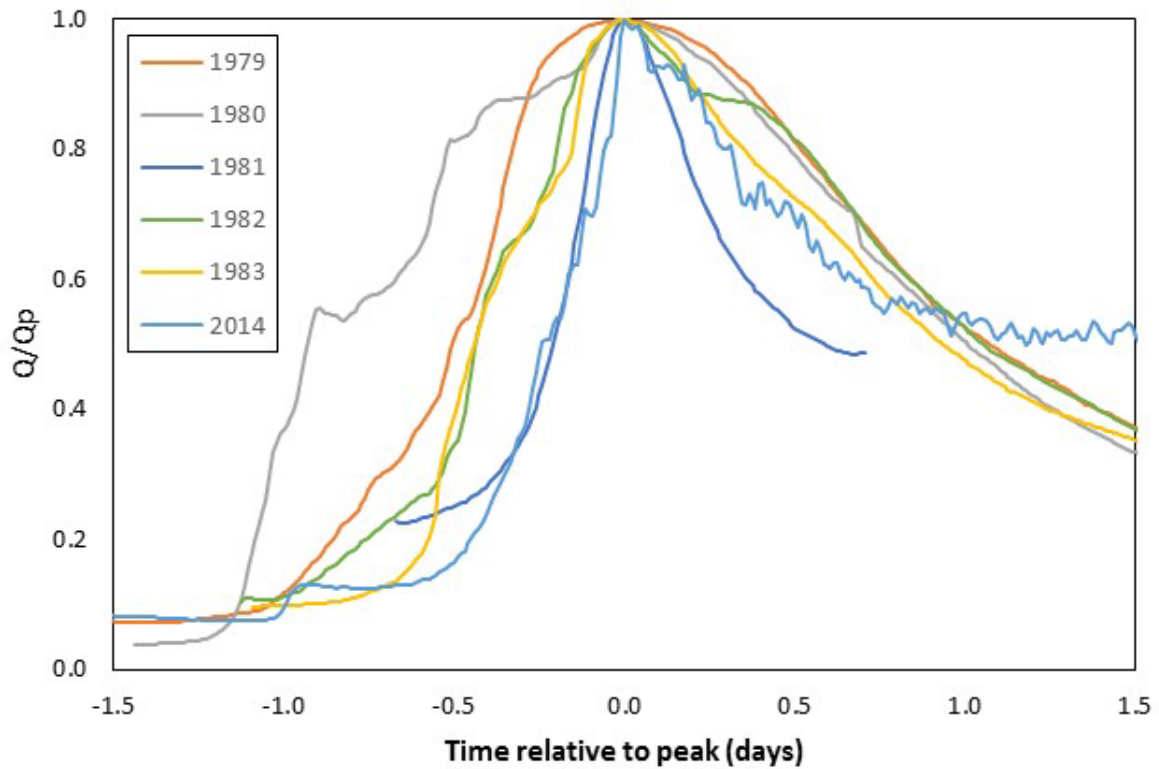
Figure 3-9: Non-dimensional hydrographs for the upper Waiau Toa/Clarence River catchment inflows

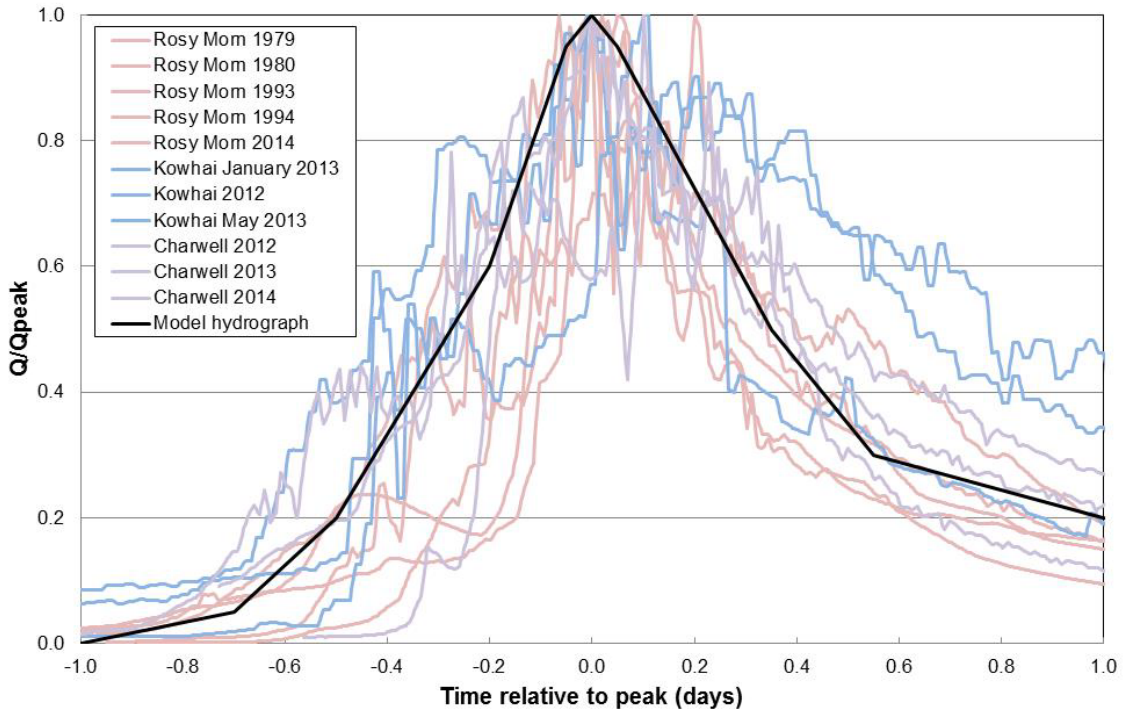
Figure 3-11: Non-dimensional hydrographs for the coastal tributaries of the Waiau Toa/Clarence River

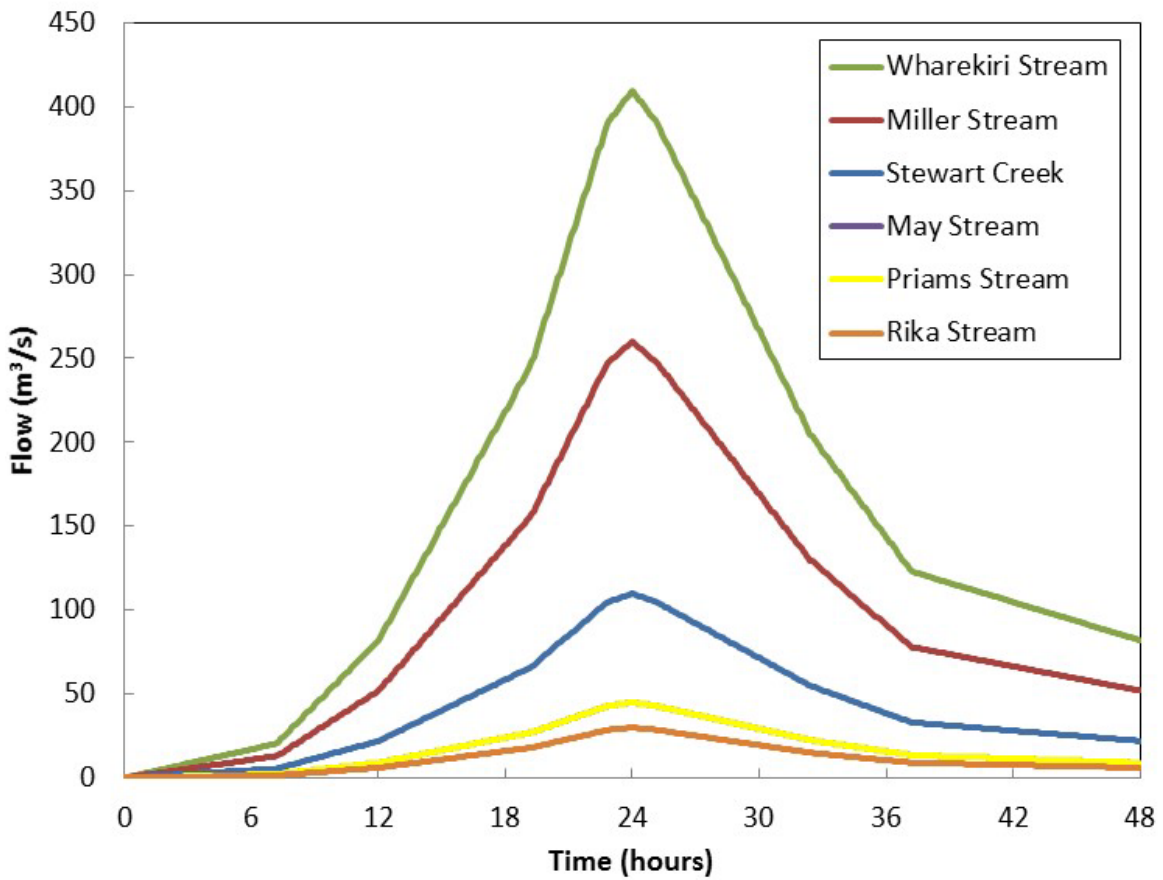
Figure 3-12: 500 year ARI design flows for the coastal tributaries of the Waiau Toa/Clarence River
