69 Inland Kaikōura Road. Preliminary and Detailed Site Investigation

Drones at Work Limited

Reference: J2021031

17 March 2022

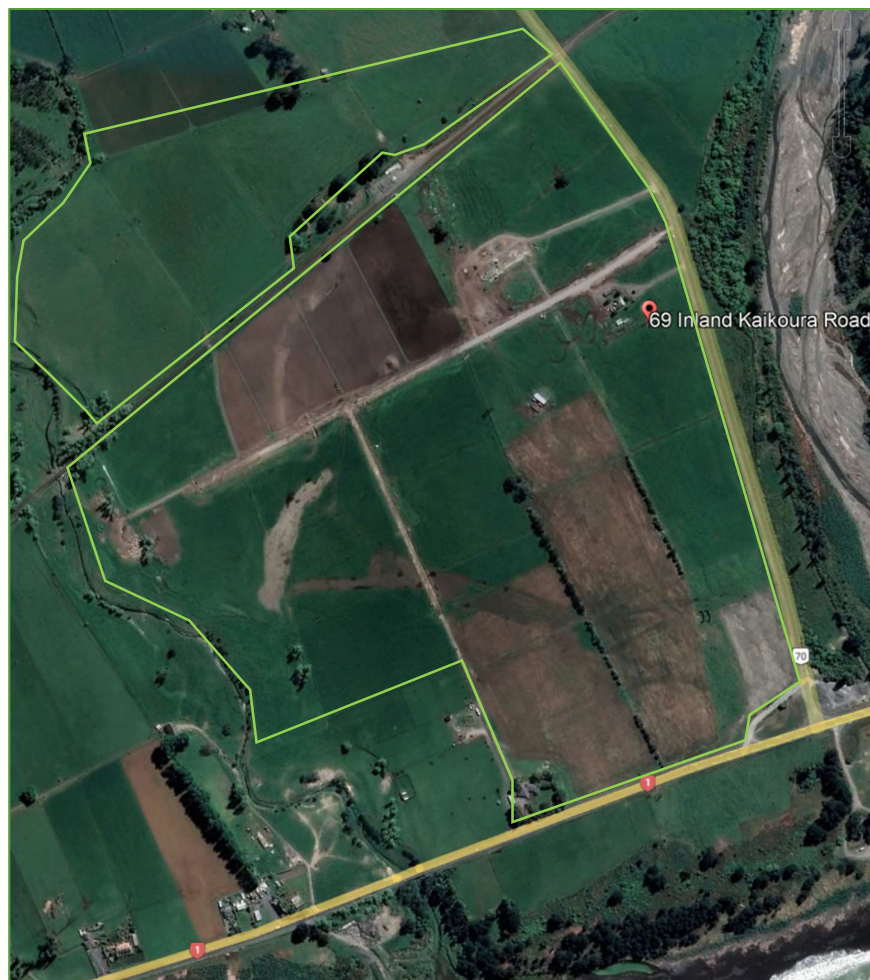
Figure 2 Site Layout Plan. Source: Google Earth Pro, October 2021. Site boundaries are approximate

- Earthworks occurring at multiple locations across the site with soil stockpiles evident within 60m of Stoney Creek.
- The milking shed area is largely open ground with few structures remaining.
- The milking shed wastewater pond has been removed.
- The dwelling at 69 Inland Kaikoura Road is still present but the trees surrounding its southwest and south-eastern sides have been removed.
- The new subdivision roads (Lots 100, 101 and 102) have been formed (currently unsealed).

The latest aerial imagery available from Canterbury Maps is dated 15 December 2016. A more recent but lower quality image (October 2021) sourced from Google Earth is presented in **Figure 2** due to the recent changes at the site caused by initiation of bulk earthworks which make the Canterbury Maps image out of date.

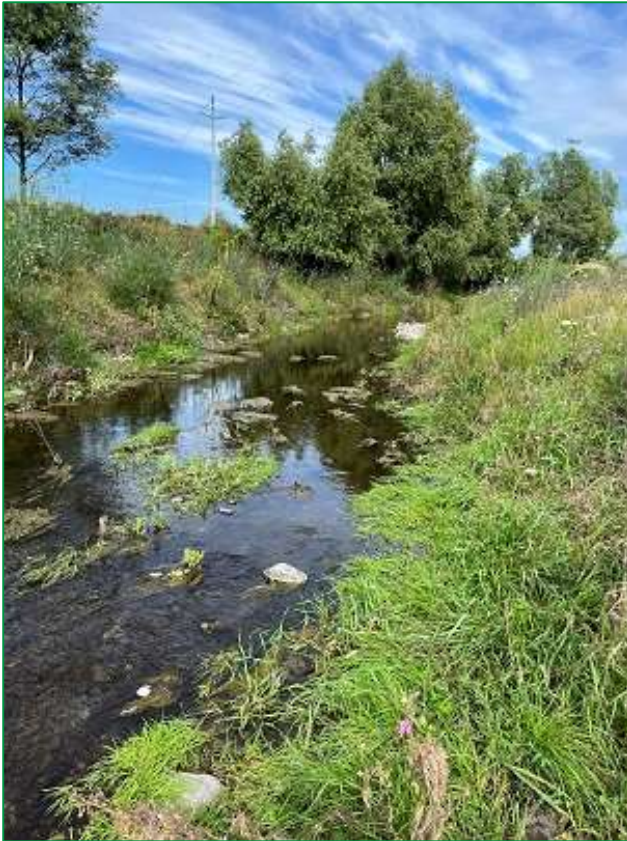
Photo 1 Stoney Creek looking northwest

Surface water is present to the west (Stoney Creek) and east (Ewelme Stream and Kowhai River) of the site, with the Kowhai River being the dominant surface water feature in the area. Stoney Creek (**Photos 1 and 2**) abuts the south-western boundary of the site.

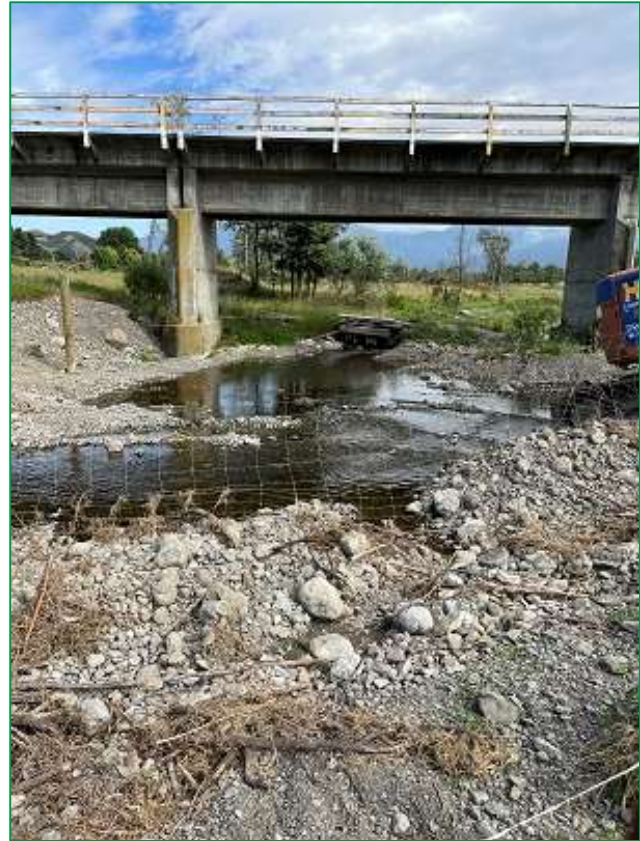
Photo 2 Stoney Creek at the railway bridge

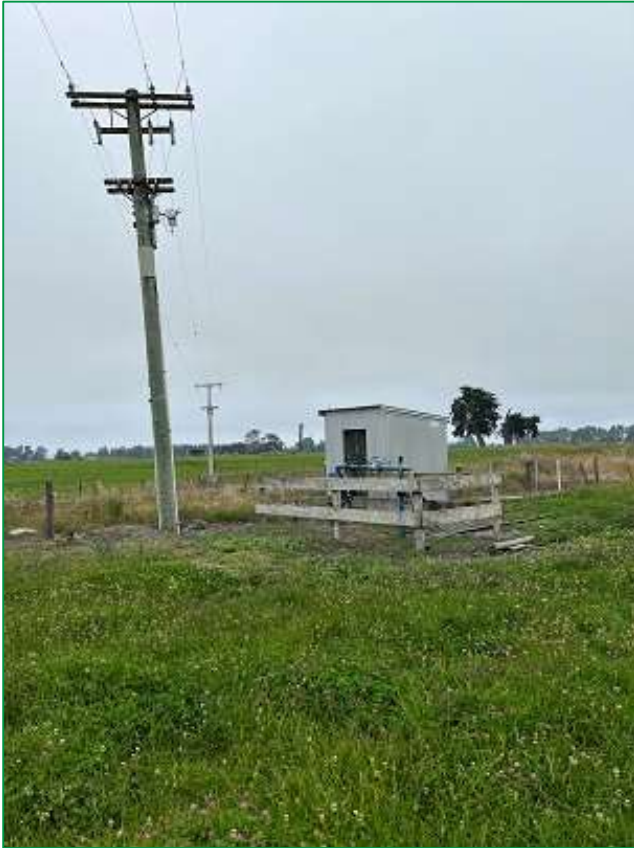
Photo 3 Well O31/0323 and pump house

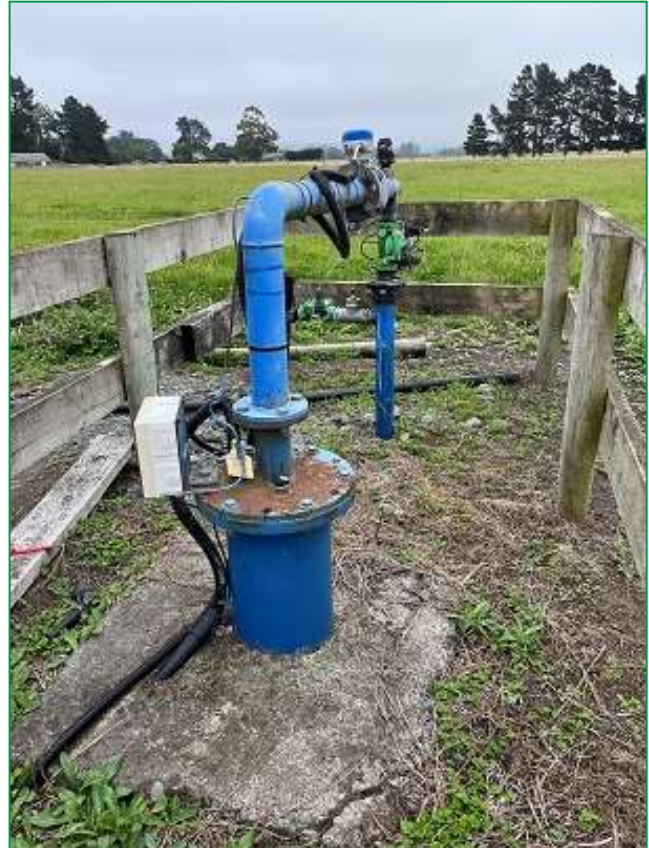
Photo 4 Well O31/0323

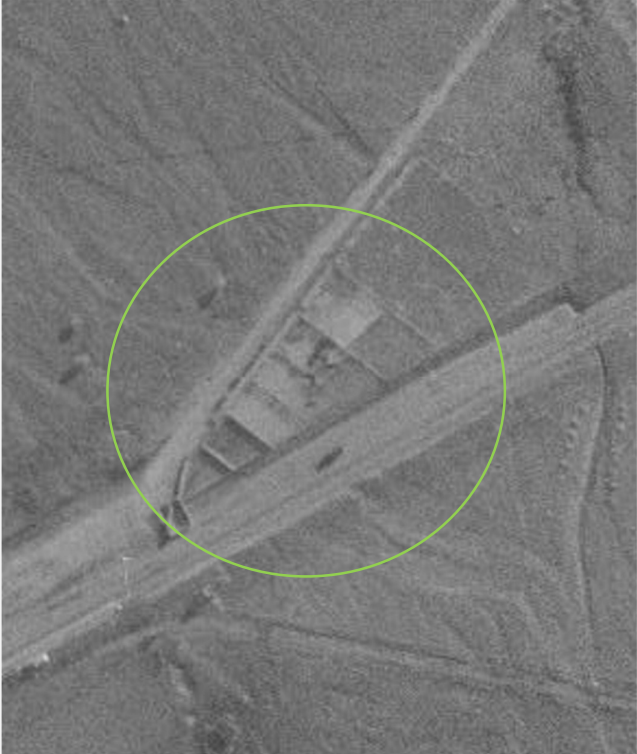
Aspect	Description
Image sourced from Retrolens (1950)

Location	<p>The stockyards (with potential for a livestock dip/spray area) are located directly to the north of the railway. On the Outline Plan (Appendix 2) this is referred to as 'Railway Block'. It is not part of the Kowhai Downs subdivision.</p>
Detail	<p>This area appears to have been used for gathering livestock in a series of corrals. Mr Watherston indicated that this area was historically used as a cattle yard. The yard was used to assist with the historical transport of cattle in wagons by railway.</p> <p>Mr Watherston indicated that there has never been a livestock dip on the site. The property was originally part of the Elms Station and there was a livestock dip associated with that station, located approximately 4km away from the site.</p> <p>The area was inspected by a site walkover and no structures associated with the corrals were evident. MfE's report entitled <i>Identifying and Managing Risks Associated with Former Sheep-dip Sites</i> (MfE 2006) indicates chemicals as detailed below (note that any dip/spray race/foot rot trough is more likely to have been used for cattle rather than sheep given the use of the farm for dairying).</p>

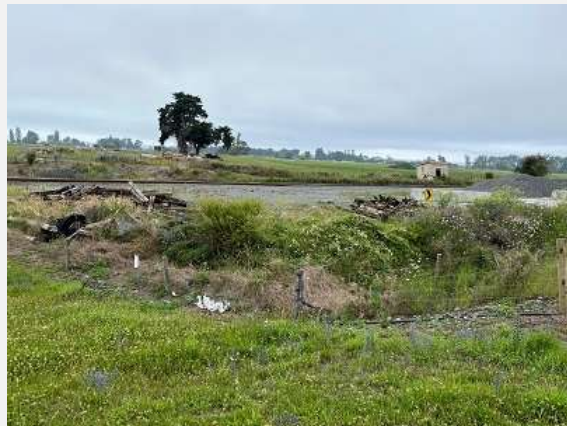
Quantities of railway related material were observed in the abutting railway land (not on the site) directly west of the potential livestock dip area (see image from site walkover below).

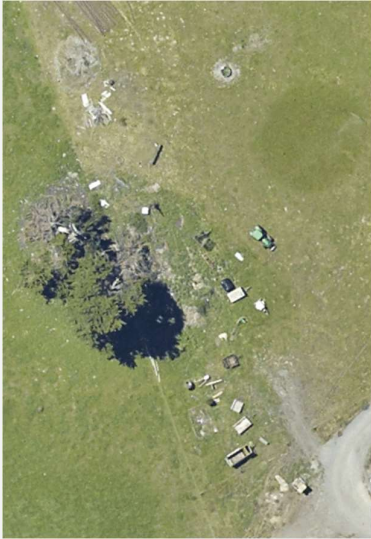
Aspect	Description
<p>Image sourced from Canterbury Maps (2016)</p> <p>Various waste items are visible at surface, but the exact footprint of the farm offal pit is unclear in all aerial images</p>

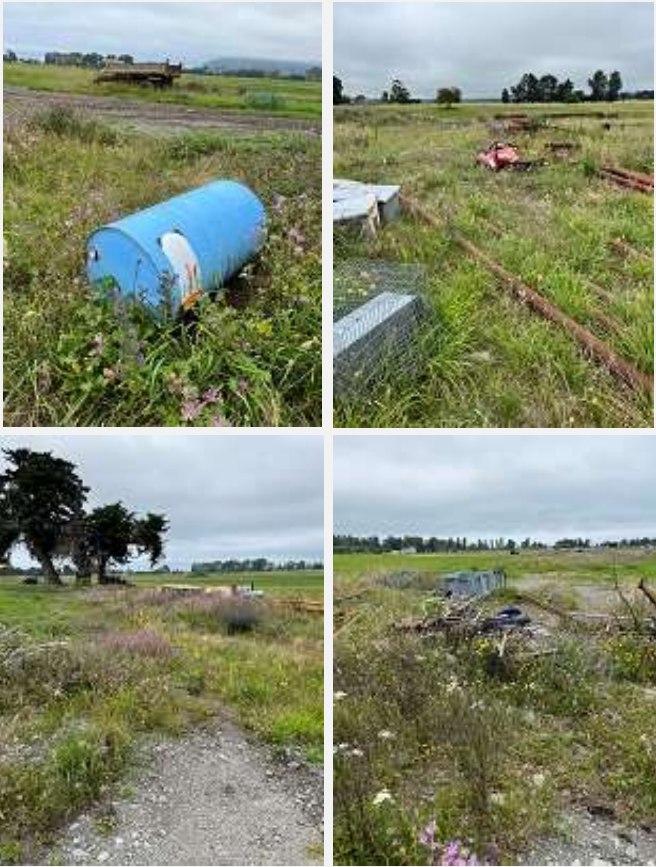
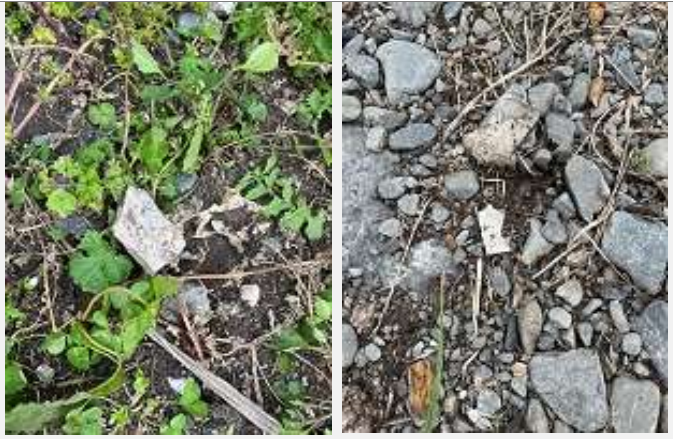
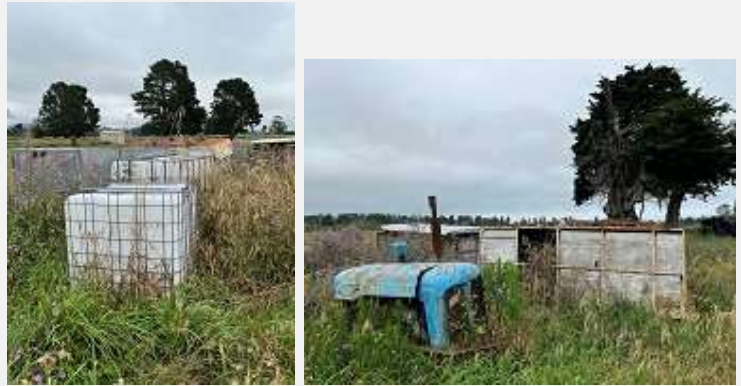
<p>Images sourced from site walkover</p> <ul style="list-style-type: none"> ■ 44 Gallon drum - molasses ■ Farm related waste ■ ACM ■ Intermediate Bulk Container (IBC)

Location	This area is within Lots 14 and 15 in the Outline Plan (Appendix 2).
Details	Mr Watherston indicated the farm offal pit was in this area but had been removed before he owned the farm. No evidence of removal was readily available. Mr Watherston indicated that the offal pit had been used for disposal of general waste as well as offal.
Proposed approach	Hand tools and a lack of information on the exact footprint of the offal pit prevent further investigation of this feature. Opportunistic sampling of PACM and soil to be undertaken in the area.

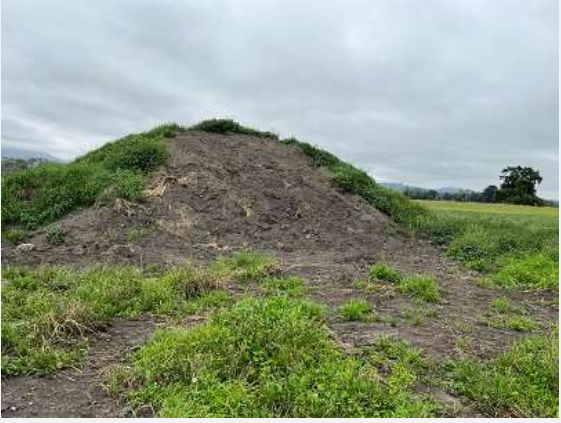
Location	The stockpile is located at the south-eastern end of Lot 12
Details	The stockpile was noted during the site walkover. Mr Watherston indicated that it originated from topsoil stripped during bulk earthworks and would be placed back on to lots when contouring was complete.
Proposed approach	Two grab samples collected for heavy metals and OCPs analysis.

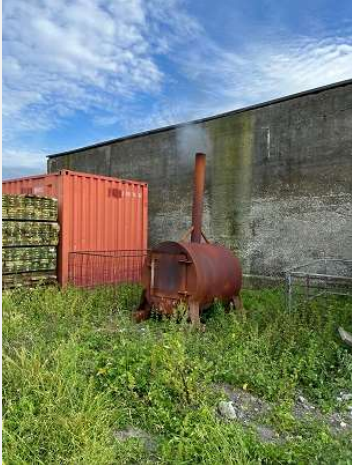
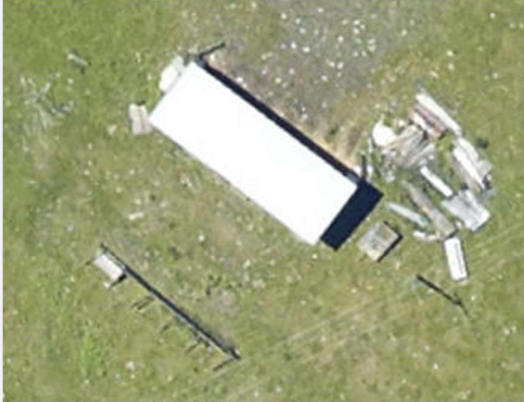
Location	<p>The incinerator is located on the southwest (closed) side of the hay barn. The Outline Plan (Appendix 2) indicates the location to be close to the boundary between proposed Lot 11 (Kowhai Downs) and Lot 20 (possible future commercial development).</p>
Details	<p>Mr. Watherston indicated that the incinerator had been recently installed. He also indicated that the previous owner had used the area between the open barn (north-east) and concrete wall (south-west) for storage of silage and other items.</p>

Proposed approach	<p>Opportunistic soil and PACM¹ samples collected from adjacent to the door of the incinerator.</p>

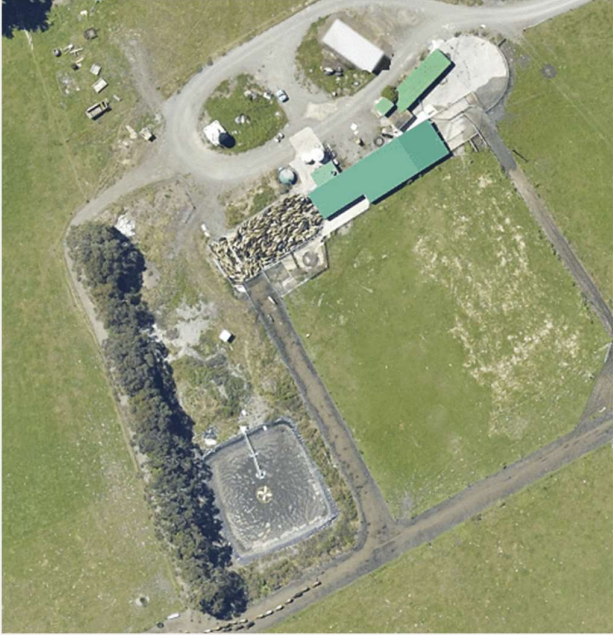
Aspect	Description
Image sourced from Canterbury Maps (2016)

Location	<p>This facility, and the associated milking shed infrastructure were located within future Lots 14 and 15 in the Outline Plan (Appendix 2).</p>
Detail	<p>Inspection of Google Earth historical imagery indicates that the wastewater pond was installed at some time between January 2014 and February 2015. It was removed sometime between November 2019 and October 2021, i.e., it was present on site for approximately five years. Mr Watherston confirmed removal of the pond and liner and the liner was observed during the site walkover (see below).</p>   <p>At the time of the site visit on 4 and 5 January 2022, the milking shed structures had recently been removed with the exception of the concrete pad at the entrance to the shed, which was being used for soil storage.</p> <p>Mr Watherston confirmed that the shed's power supply was electricity and there had not been above or below ground storage tanks for storage of fuel. The larger shed was used for milking and the shed at the northern end was used for calves.</p>

Proposed approach	<p>Collection of soil samples in the footprint of the wastewater pond and from the surrounding milking shed area. Samples will be collected from four locations and analysed for heavy metals. A laboratory composited sample will be analysed for OCPs.</p>

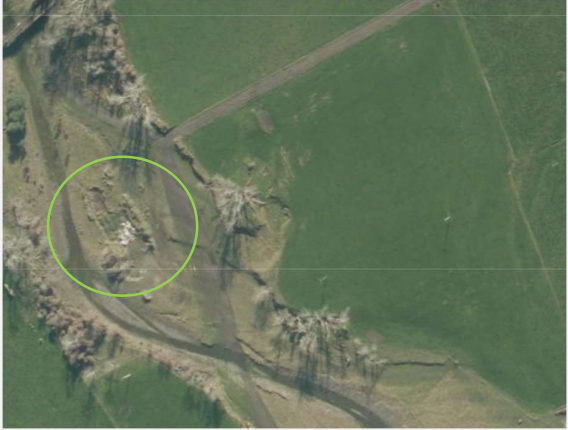
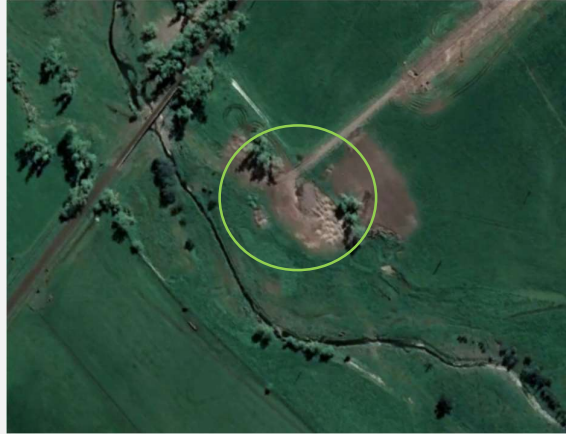
<p>Aerial images confirm the short-lived timespan of visually evident material at surface (first seen in image dated 1/2012 and gone by 1/2013).</p>
Location	Adjacent to Stoney Creek and west of the Kowhai Downs subdivision. Also see ECan image reproduced in Figure 4 .
Detail	The suspected landfill is located adjacent to Stoney Creek, which forms the western boundary of the site. This area is not proposed to be developed. A site walkover on 5 January 2022 did not identify evidence of landfilling in the suspect footprint. However, the area was overgrown making identification of visual evidence of landfilling difficult. At the time of the walkover, the area directly east of the potential landfill is being used for soil stockpiling.

The white coloured area observed by ECan is consistent with the local limestone geology, and the white material could be natural ground rather than anthropogenic waste. The latest aerial image sourced from Google Earth (October 2021) is shown below. The discoloured areas (similar to those in the 2012 image) are soil stockpiles.

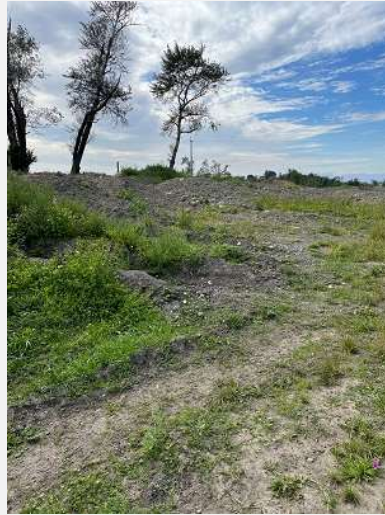
During the walkover in the potential landfill and wider area, ground disturbance and stockpiling was observed. A mechanical excavator was also present in the area. A photo taken during the site walkover is presented below. In summary, the riverbed area is highly modified and contains soil from other areas. There was no visual evidence of anthropogenic waste at the time of the walkover.

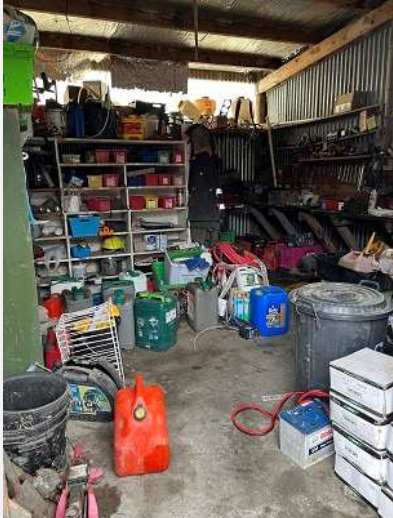
Location	The hazardous goods store is located directly west of the dwelling at 392 SH1. The store was viewed during the site walkover on 4 January 2022. The store is lockable and has a concrete floor.
Proposed approach	The store is not being removed and no action to address soil contamination is required at this stage.

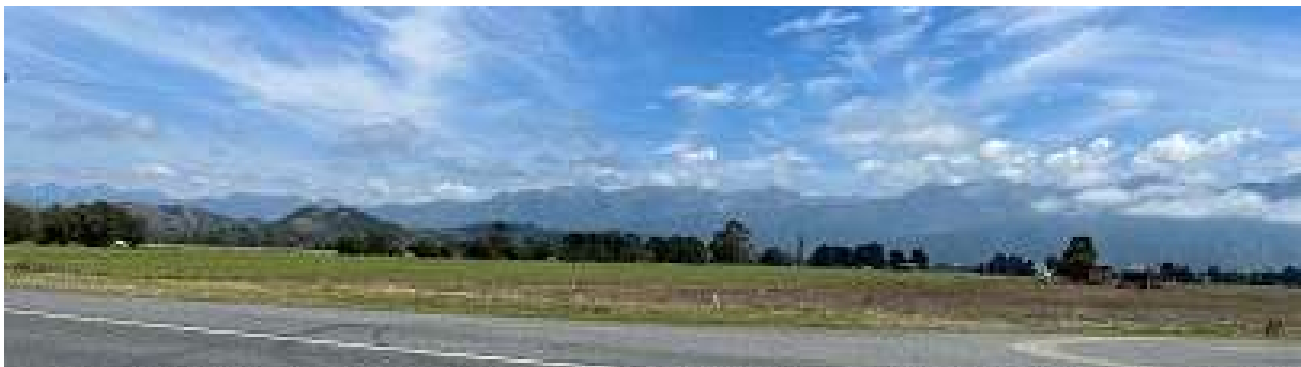
Figure 7. Profile of the site, viewed from SH1

The site is generally flat with some minor natural undulations (see **Figure 7**). The railway runs along a (presumably) man-made embankment.

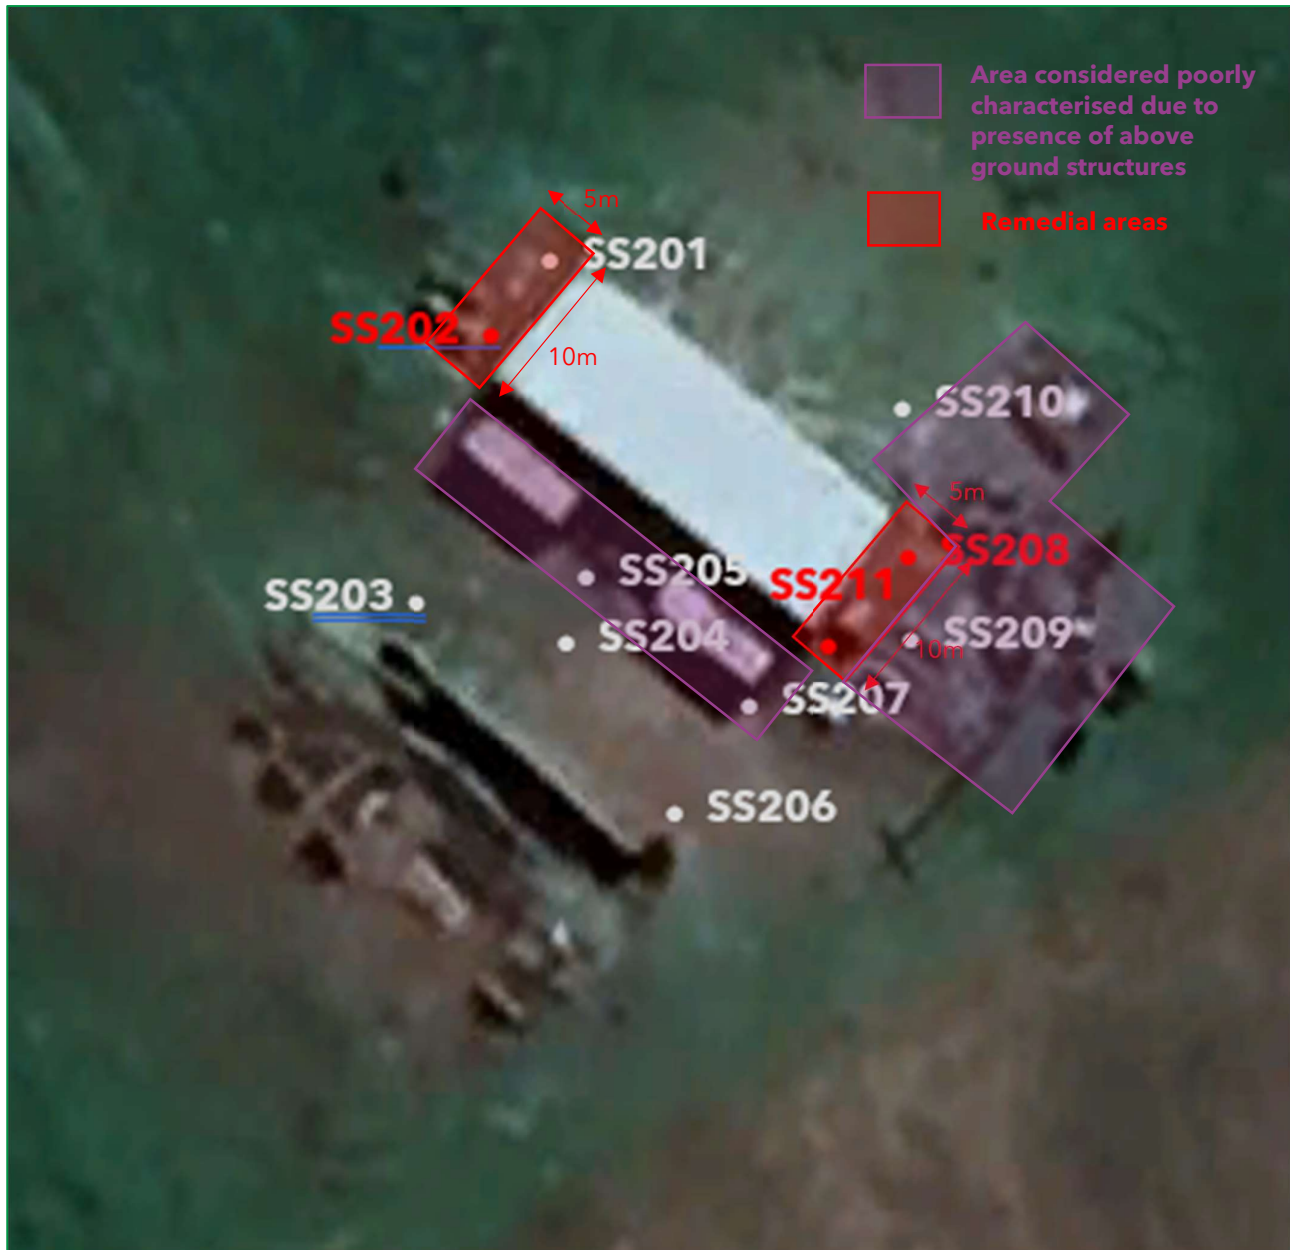
Figure 9. Area with Health Significant Asbestos Present to a Depth of Approximately 0.15m

Agon Solutions Ltd 2022: "The areas beneath the containers, timber pile, farm equipment and boulders could not be visually investigated."

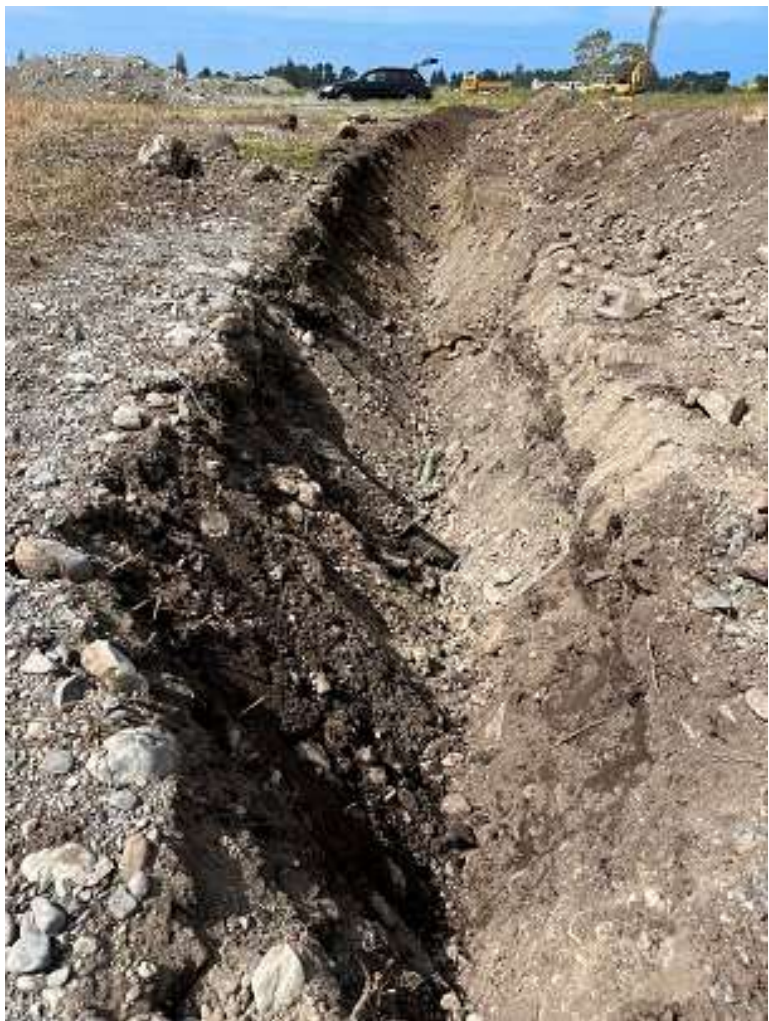
TRENCH DIMENSIONS	
LENGTH	20 METRES
WIDTH	1 METRE (REDUCING WITH DEPTH)
DEPTH	0.75 METRE

CLIENT	NOT FOR CONSTRUCTION	SCALE	TITLE	TRENCH IN ASSUMED OFFAL PIT AREA
Drones at Work Limited	FIGURE	FIGURE 9	REFERENCE	
	PROJECT	69 INLAND KAIKOURA ROAD	PROJECT	J2021031
			FIGURE NO	A5 - 9
			24/02/2022

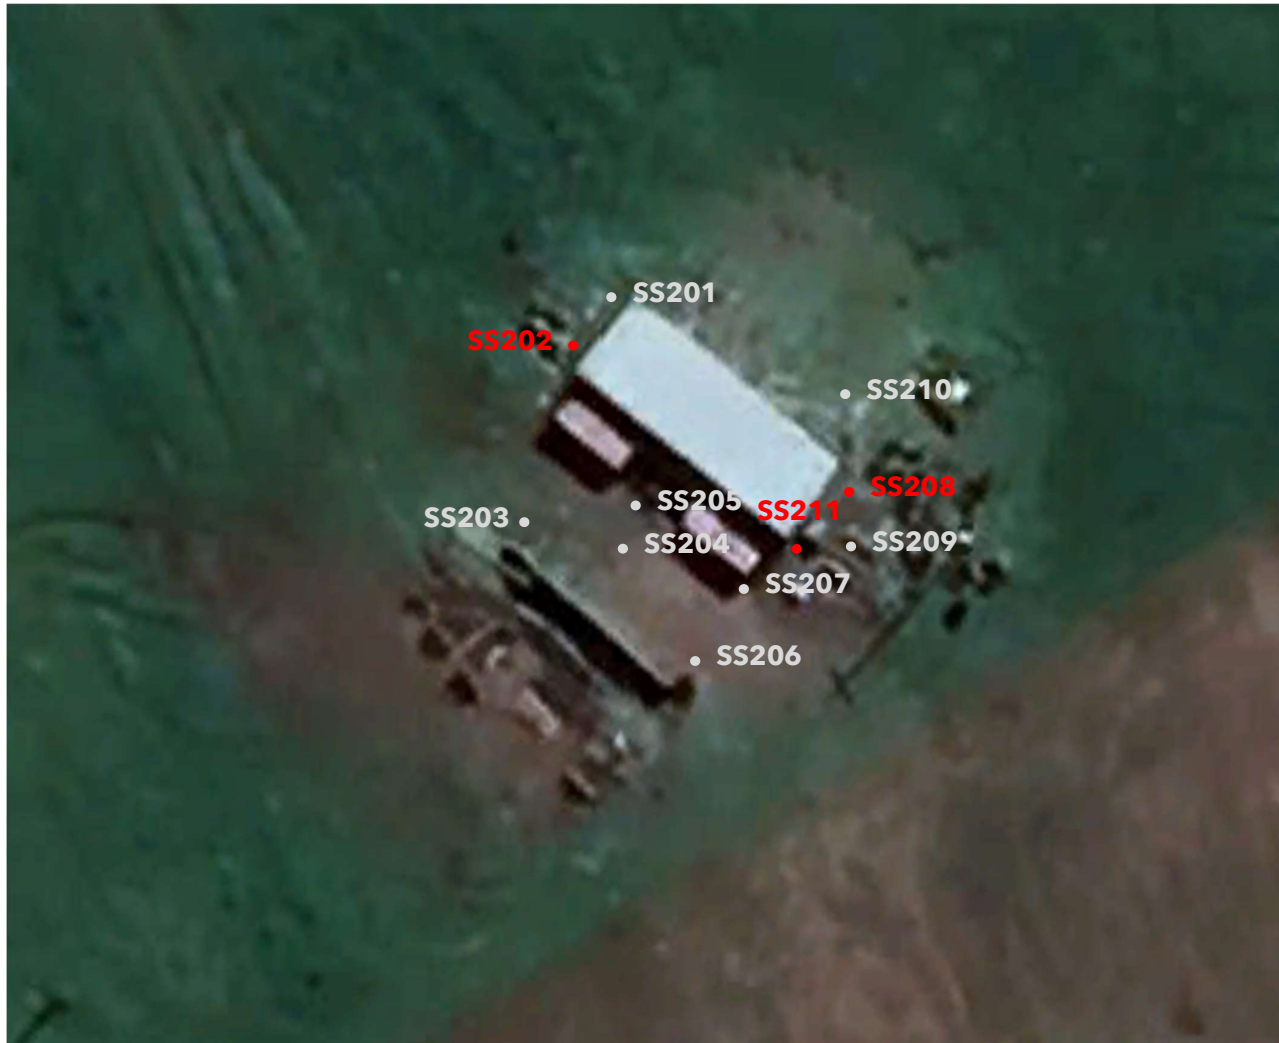
CLIENT	NOT FOR CONSTRUCTION		SCALE	TITLE	SAMPLING LOCATIONS INCINERATOR AREA - ASBESTOS RESULTS
	Drones at Work Limited	FIGURE	NTS	REFERENCE	
PROJECT		FIGURE 10	BY	PROJECT	J2021031
	69 INLAND KAIKOURA ROAD		HMD	FIGURE NO	A5 - 10
			CHECKED		
			NRP		
			DATE		
			24/02/2022

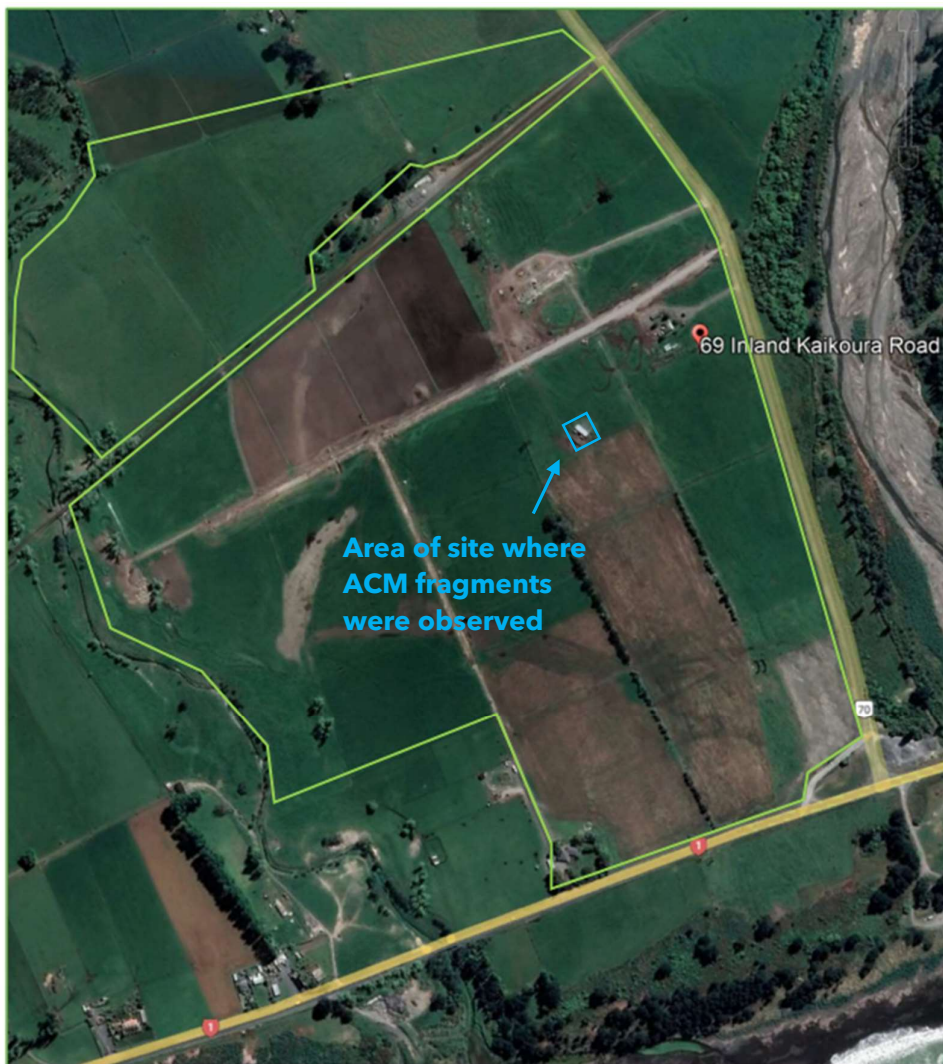
Figure 1. Location of ACM within the site at 69 Inland Kaikoura Road

The quantity of ACM was less than 1m² and was non-friable. As such, Helen Davies of CLS was able to remove it from site as unlicensed asbestos work, with no requirement to inform WorkSafe prior to the work. This memo described the removal that occurred.
