69 Inland Kaikōura Road. Contaminated Site Management Plan

Drones at Work

Reference: J2021031

23 March 2022

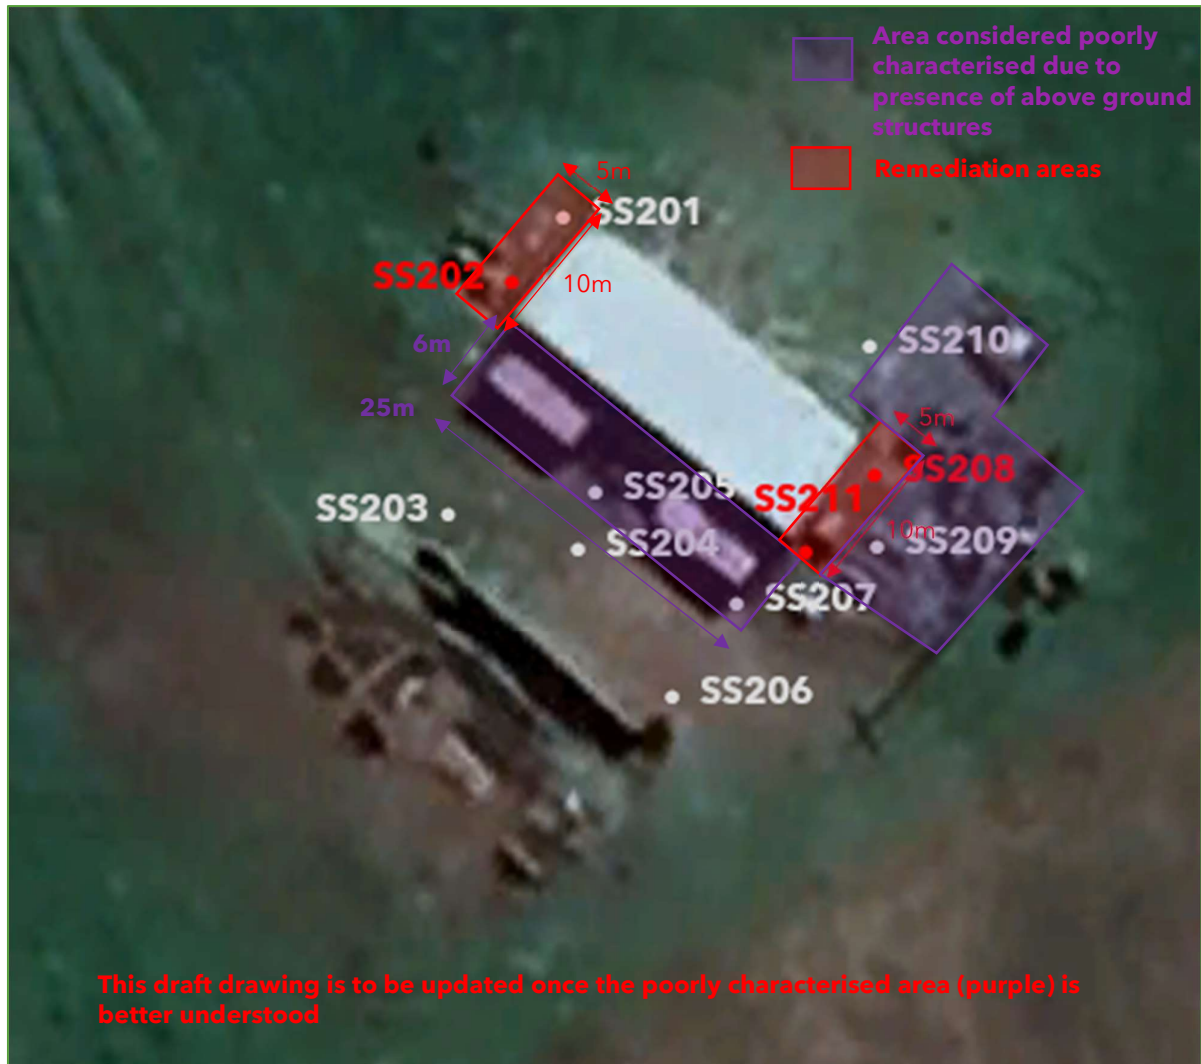
Figure 4. Draft Remediation Drawing #1 including Area Requiring Further Investigation - Incinerator Area (Lot 20)

Draft Remediation Drawing #1 (**Figure 4**), shows the two known areas requiring remediation due to the presence of health significant asbestos, and two areas that require investigation because above ground structures and equipment have prevented access to ground at the time of the DSI (CLS 2022).

A complete exposure pathway currently exists in the remediation area of Lot 20 associated with inhalation of asbestos fibres. The remediation goal is to break the identified complete exposure pathway to the extent that the risk to human health and the environment is acceptable. The asbestos remediation goals are defined in **Table 4**.

1. All above ground solid material to be removed, e.g., shipping containers, farm equipment, waste.
2. All visible ACM in the poorly characterised areas shown in purple in **Figure 4** removed by a competent person and validation sampling undertaken by a Suitably Qualified and Experienced Practitioner (SQEP).
3. Draft Remediation Drawing #1 (**Figure 4**) updated using the results of the removal and sampling.
4. The area defined in the revised Remediation Drawing #1 is to be excavated using processes defined by an Asbestos Removalist licensed by WorkSafe in their site-specific Asbestos Removal

Control Plan. The excavation will extend to a minimum depth of 150mm below ground level, or to a depth where the Asbestos Removalist confirms no visible ACM following completion of their clearance inspection. All excavated soil is to be placed in truck bins lined with 200 µm heavy-gauge polythene. The soil is to be transferred to a licenced disposal facility such as Kate Valley Regional Landfill.

In the context of this health and safety plan ‘the site’ is the incinerator area shown in **Figure 4**.
