69 Inland Kaikoura Road, Proposed Lot 20. Site Validation Report

**Kaikoura Business Park 2021**

Reference: J2021031

19 December 2022

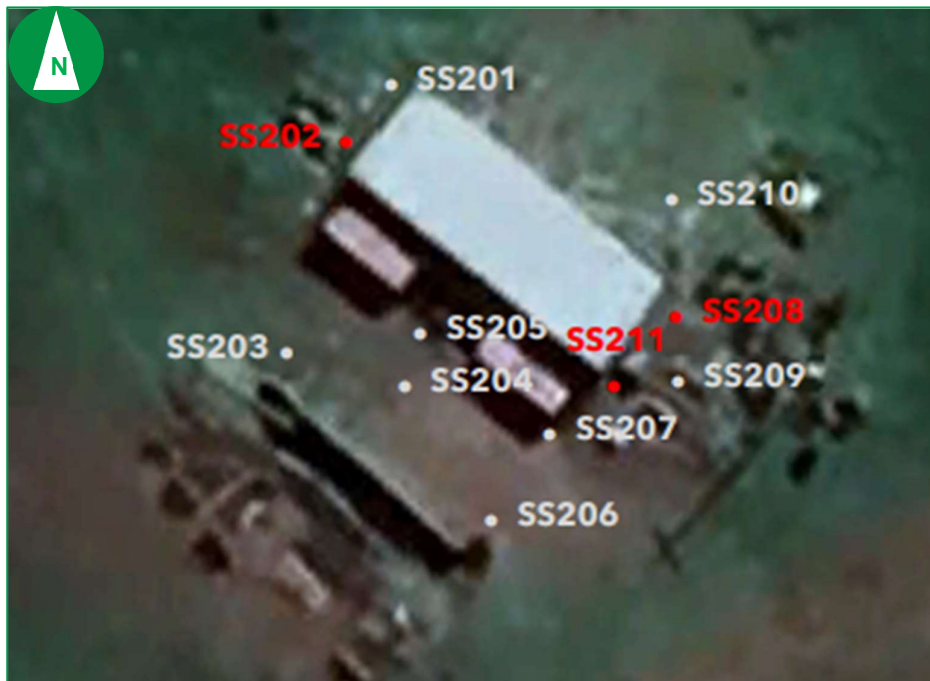
Figure 3. Sampling Locations used in DSI (CLS 2022a). Health Significant Results Shown in Red.

Eleven surface and three sub surface soil samples were collected in the DSI, and the results are presented in **Appendix 3**, with sampling locations shown in **Figure 3**. Asbestos was the only health significant contaminant in this area of the site. Additional ACM fragments were visually identified in the same area in a subsequent site visit, adding to the lines of evidence associated with asbestos contamination in the area.

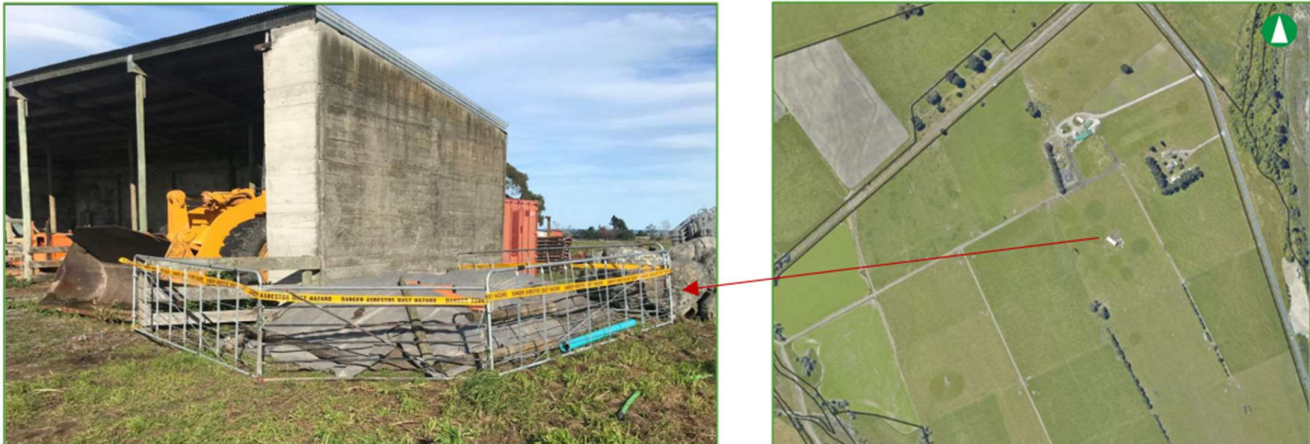
Figure 4. Temporary Stockpile of Asbestos Contaminated Soil at Northern End of Haybarn. Stockpile originating from the Historical Piggery Area in Lot 14. Basemap from Canterbury Maps

The stockpile was located at the northern end of the exterior of the haybarn, within the footprint of area 'HM&A' which is the subject of this report. Underlying soil in this area was known to be contaminated with asbestos, which is why it was deemed to be a suitable temporary location for the stockpile of soil originating from Lot 14. The stockpile was covered, as shown in **Figure 4**. The volume of soil was approximately 15m<sup>3</sup>.

Removal of this stockpile was included within the remediation of area 'HM&A' reported here.

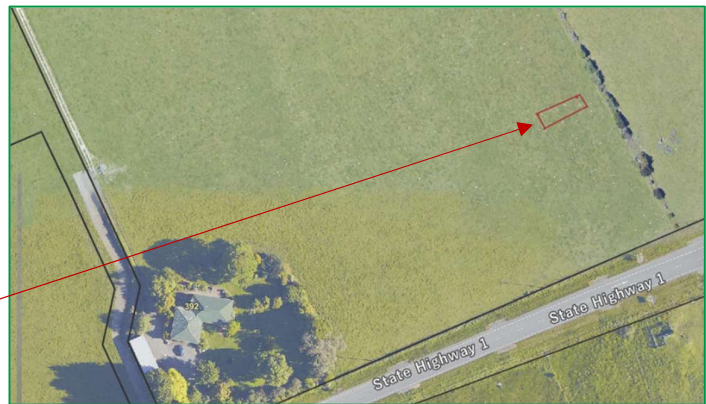
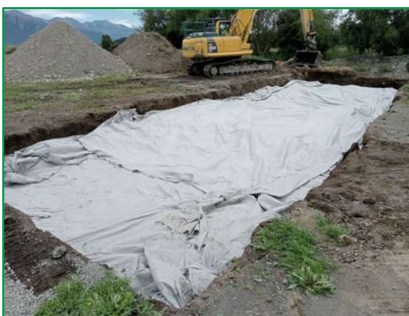
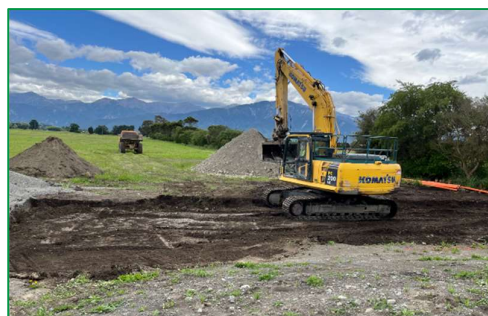
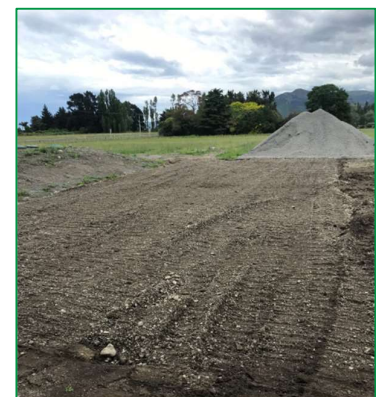
Figure 6. Containment Cell (red). Photographs show: 1. Geotextile layer on top of waste, 2. Topsoil on top of geotextile, 3. Gravel aggregate on top of topsoil. Basemaps from Baseline Group and Canterbury Maps

Depth	1.6m below ground surface
Width	6.3m
Length	19m
Capping details	Material was compacted, covered in geotextile, followed by 0.3m topsoil and a layer of gravel aggregate to bring the level the cell up to that of the surrounding area
Lined?	Yes, geotextile
Soil transfer details	7.5 truckloads transferred from the haybarn area to the containment cell. Total weight of soil transferred was estimated by Agon Solutions Ltd to be between 97.5 and 127.5 tonnes
Future identification and management of the cell	Per ongoing site management plan (Section 8.2). GPS coordinates of the cell location are provided in <b>Appendix 5</b>

The location of the containment cell is shown in **Figure 6**. Details of the containment cell are provided in **Table 3**.

- Identification of the cell (and this ongoing site management plan) in all site plans related to the wastewater treatment plant. GPS coordinates of the location of the cell are provided in **Appendix 5**;
- Annual inspection of the cap and replenishment of the gravel layer as required to prevent the underlying topsoil cap from being eroded;
- Inspection records to be provided to Kaikoura District Council;
- Care with the use of machinery/vehicles accessing the parking bay, particularly during wet/muddy conditions, to prevent damage to the cap.

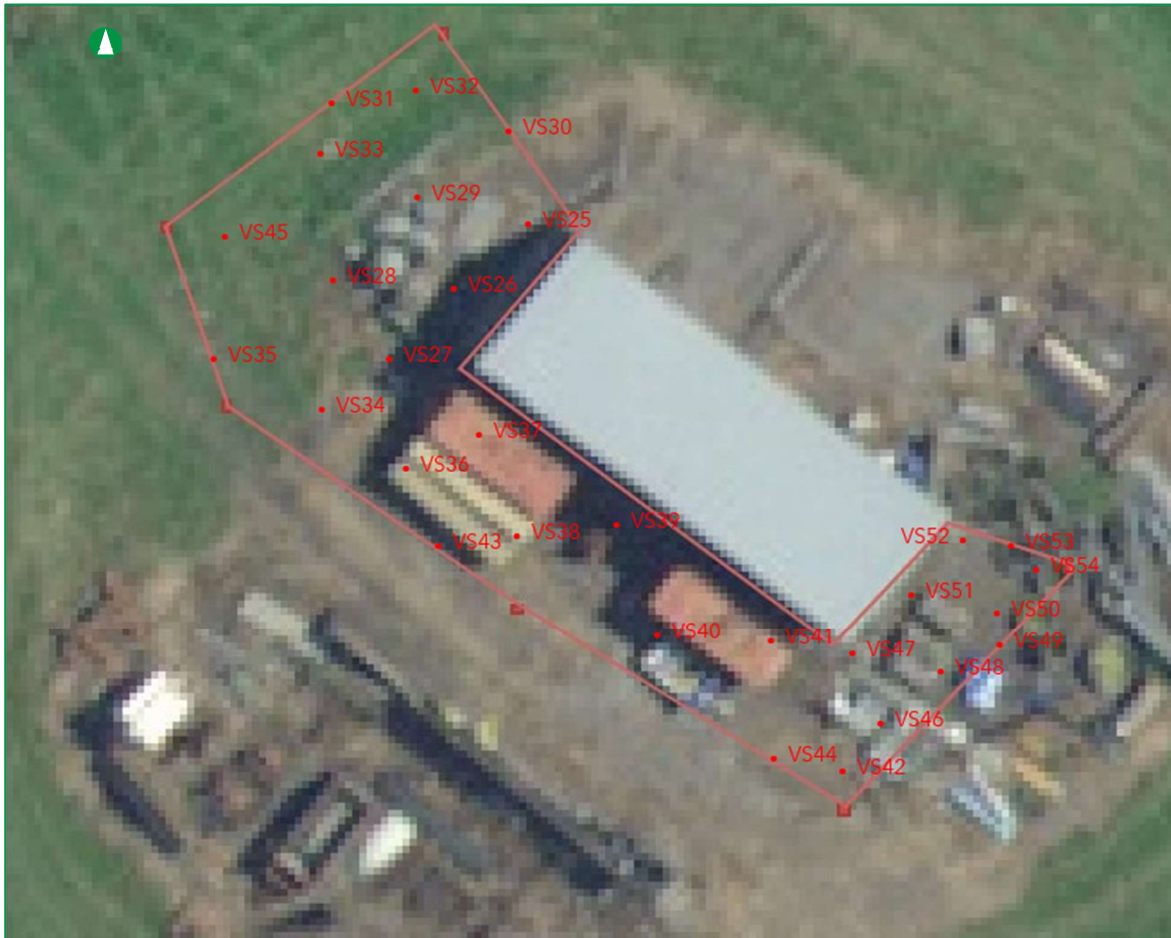
Figure 7. Final Remediation Area and Validation Sample Locations.

The asbestos results from thirty soil samples taken from the base and walls of the remediation excavation have been assessed against the remedial goals (**Table 2**).

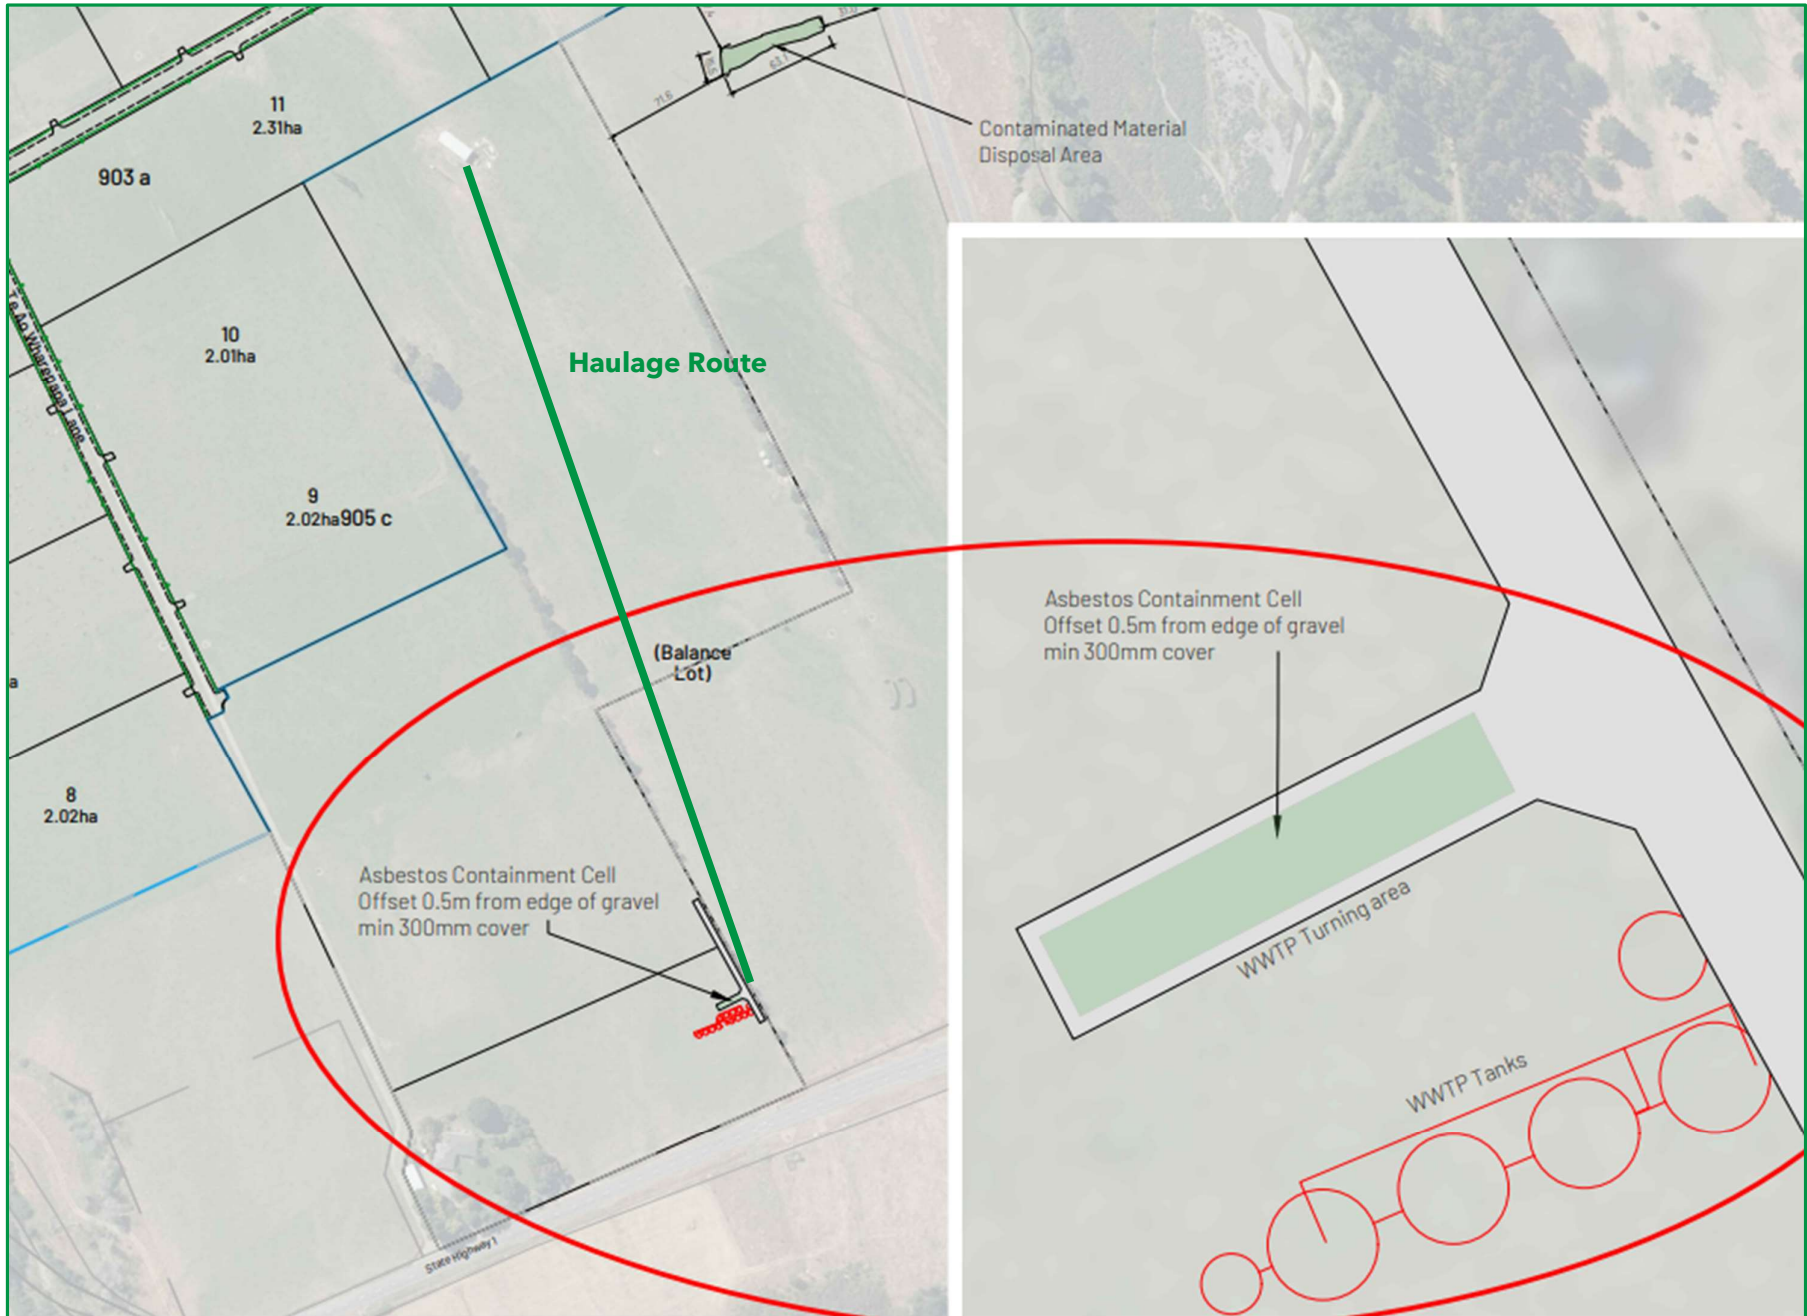
Erosion and  
Sediment Control  
Plan

Issue	Method
Timing of the works	<ul style="list-style-type: none"> <li>▪ Proposed for 30 November 2022. Completion in one day</li> </ul>
Weather forecast	<ul style="list-style-type: none"> <li>▪ Fine, then rain developing. Southwesterlies. Temperature: Min 13°C, Max 22°C, Precipitation: 1+mm, 70% probability, 10+mm 20% probability</li> </ul>
Method of remediation	<ul style="list-style-type: none"> <li>▪ CLS to mark out impacted area requiring excavation on Tuesday 29 November</li> <li>▪ Impacted area to be excavated to 0.15m (0.2m in some areas) and placed directly into truck under supervision of a licensed asbestos removalist (Matt Garrett)</li> <li>▪ Asbestos controls put in place by Matt Garrett, including water truck at excavation area and containment cell</li> <li>▪ Validation soil samples collected by CLS for laboratory analysis for asbestos</li> <li>▪ Excavated material transferred to containment cell along haulage route</li> <li>▪ Containment cell base to be above groundwater (groundwater is at approximately 3.5 - 10m bgl) and have capacity of 90m<sup>3</sup>, e.g. 1.5m depth x 5m wide x 15m long</li> </ul>

Fibre release, dust and sediment control	<ul style="list-style-type: none"> <li>▪ Soil may be moist from preceding day's predicted showers</li> <li>▪ Matt Garrett to supervise controls that prevent fibre release from soil into air</li> </ul>
H&S	<ul style="list-style-type: none"> <li>▪ Maximum speed on site restricted to 15km, truck/s covered during transit</li> <li>▪ Toolbox meeting with excavator operator and truck driver at start of work - Matt Garrett to lead discussion</li> <li>▪ PPE: Steel toe capped unlaced boots, gloves, hard hat, coveralls, respirator</li> <li>▪ No sampling to occur while excavator is operating, CLS staff to remain within visibility of excavator operator</li> </ul>
Environmental controls	<ul style="list-style-type: none"> <li>▪ Remediation to proceed in one direction to avoid cross contamination. Truck/s will not be leaving site during the work</li> <li>▪ Truck/s and other equipment to be decontaminated at the end of the work - Matt Garrett to arrange</li> <li>▪ End condition of remediated area to be addressed through the overarching erosion and sediment control plan for the site</li> </ul>

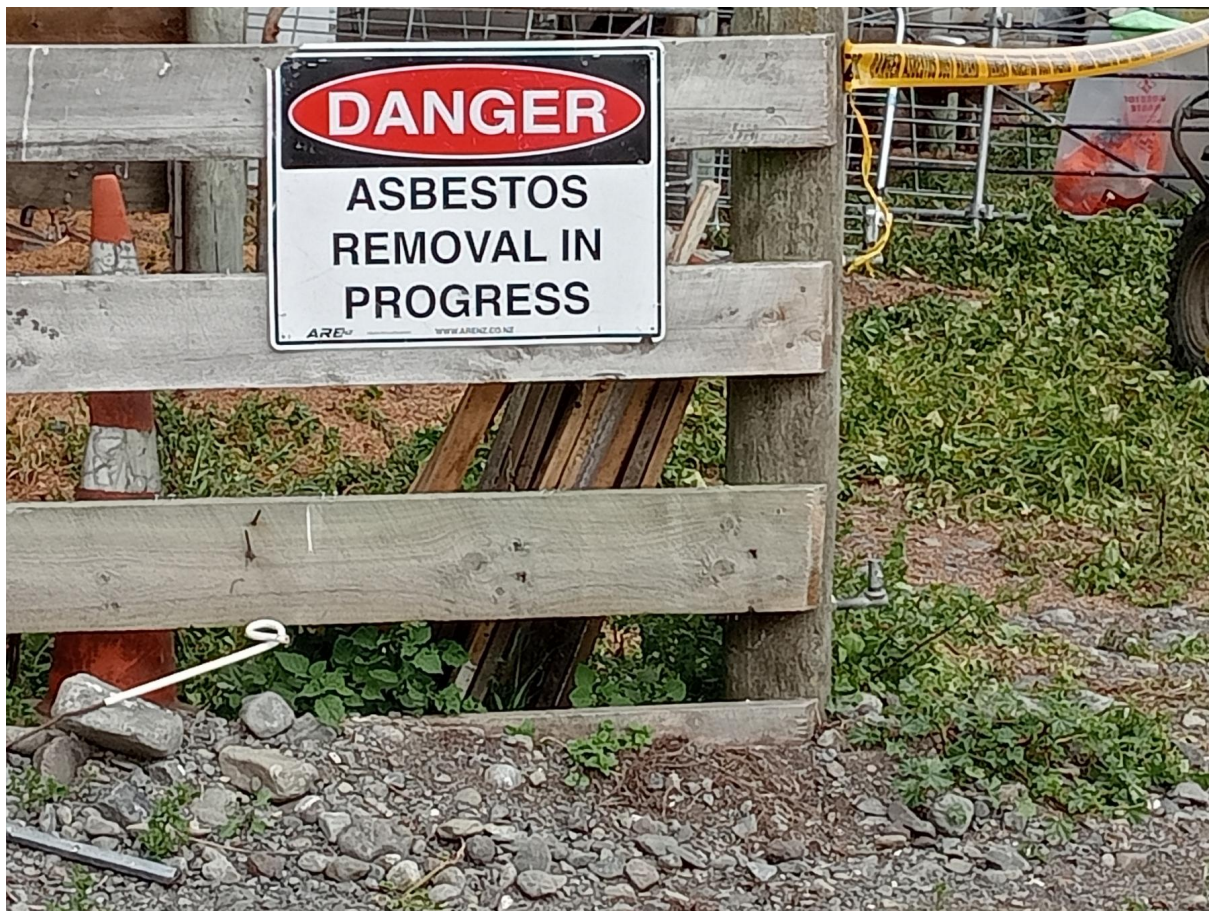
The area was approximately 80m<sup>2</sup> and was excavated to a depth of 150 to 200mm.

The estimated quantity of contaminated soil was between 97.5 and 127.5 tonnes.

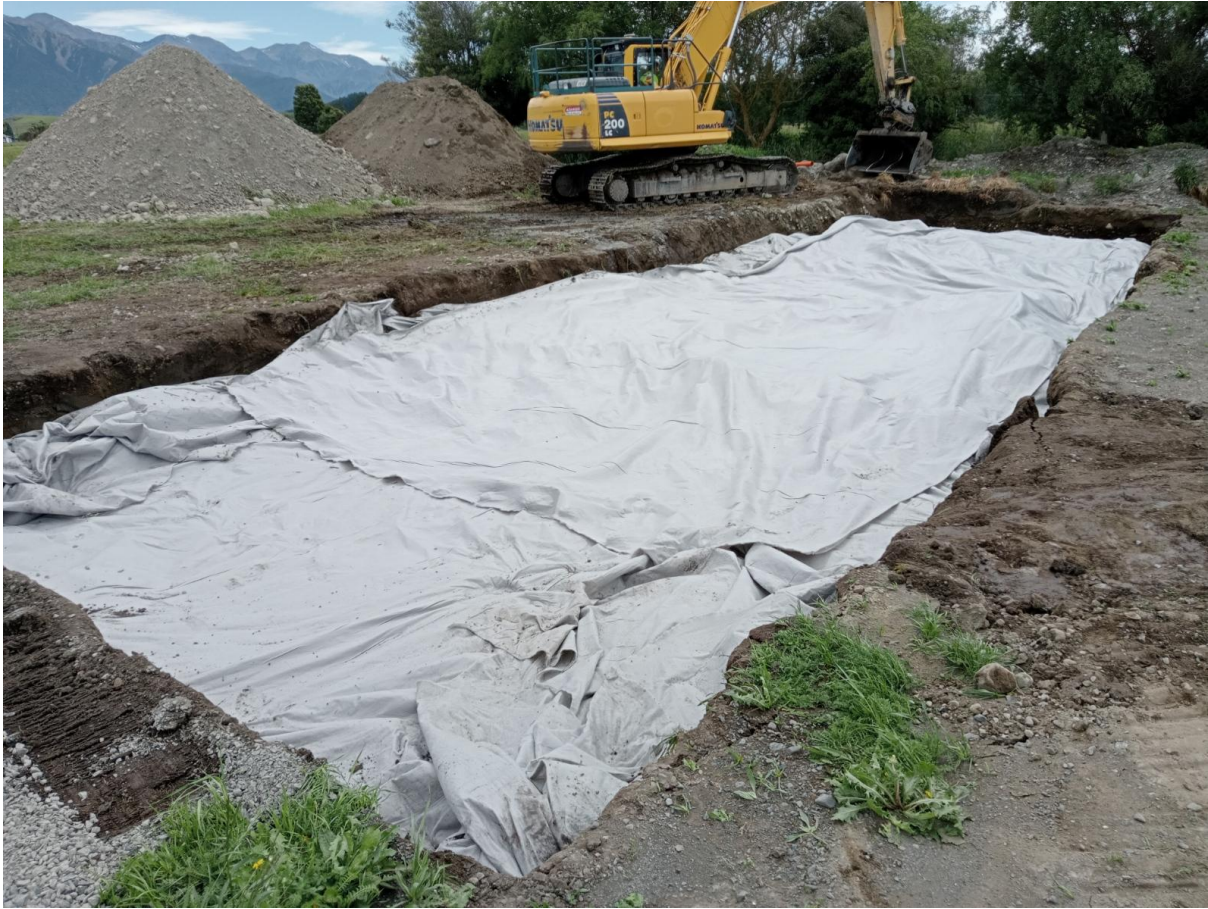
The contaminated soil was loaded into a truck then covered and placed into a containment cell that was lined with geo fabric (bidim) and then covered with clean fill.

The excavator bucket and truck deck were decontaminated.
