TECHNICAL REPORT Science Group

Kekerengu, Hāpuku and Oaro floodplain investigation

Report No. R19/04

January 2019

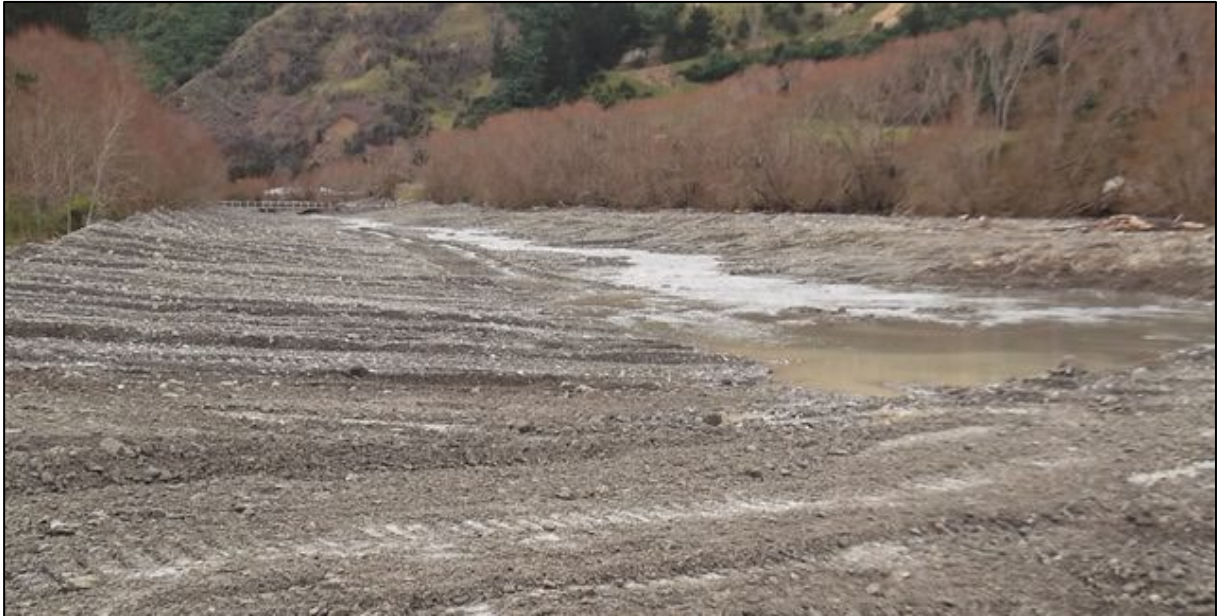
Following February 2008 flooding, Kaikōura District Council (KDC) carried out channel dishing in the river around the Wiffens Road bridges. Essenberg (2014) also noted that, at the time of the report, the council was undertaking significant works to raise the road immediately downstream of the Wiffens Road bridge, where the Kekerengu River was at approximately the same level as the road. Approximately 2800 m³ of material was taken out of the Kekerengu River as part of this work (Figure 2-2).

Figure 2-2: The Kekerengu River – looking upstream toward the Wiffens Road bridge, 1 July 2014

The June 2014 work was completed under a 30 year resource consent (CRC100846) that was granted to KDC and local residents on 24 December 2009, to carry out river maintenance and erosion/flood control works.

The area of river bed covered by the resource consent extends along the Kekerengu River for ~550 m upstream and downstream of the Wiffens Road bridge. It also includes Ben More Stream from the Kekerengu River confluence to ~620 m upstream of the Wiffens Road bridge.

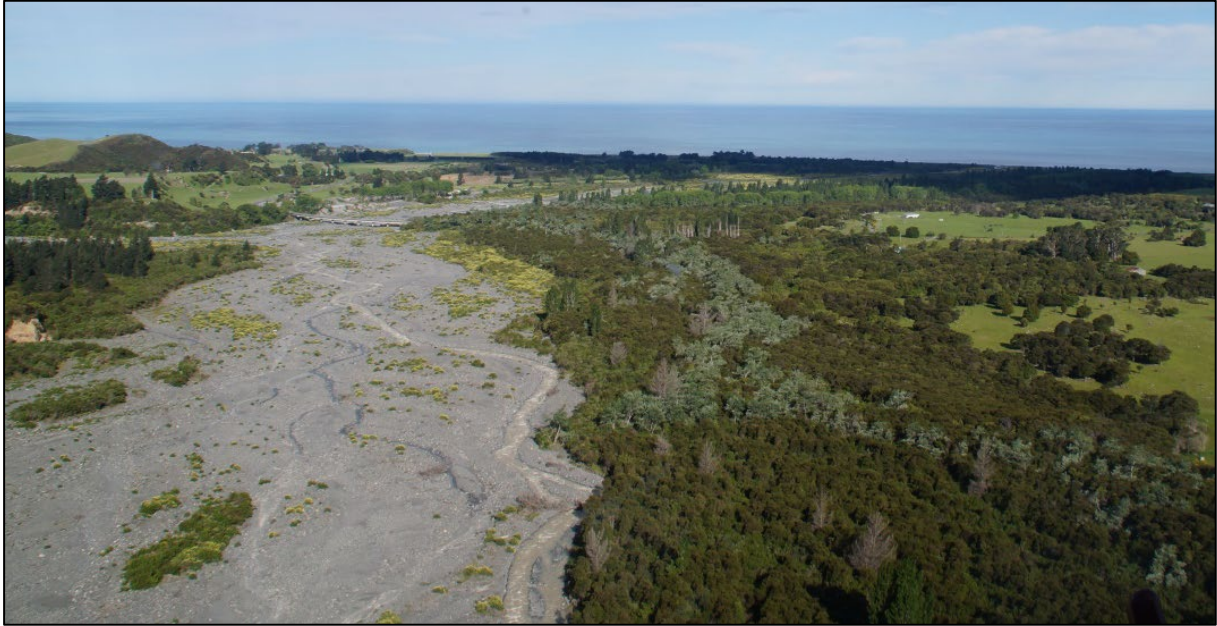
Near the coast, the river is incised into an older Hāpuku alluvial fan surface. This has occurred as a result of continued uplift of the Seaward Kaikōura Range (CRC, 1999). Flood flows are expected to be contained by these elevated terraces that are adjacent to the floodplain. Figure 2-4 shows the Hāpuku River, looking downstream towards the SH1 road bridge.

Figure 2-4: The Hāpuku River, looking downstream towards the SH1 road bridge (16 November 2016)

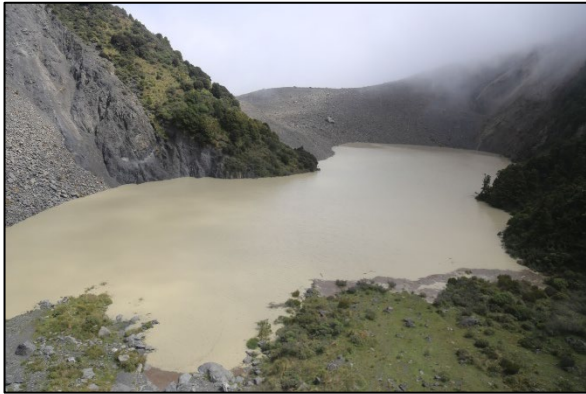
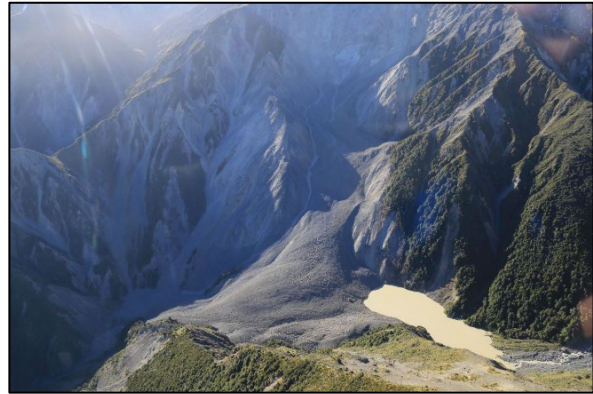
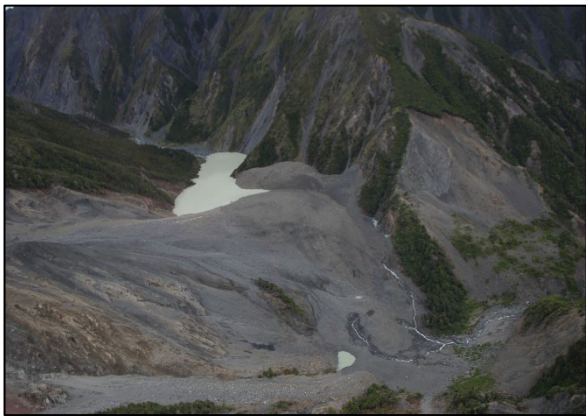
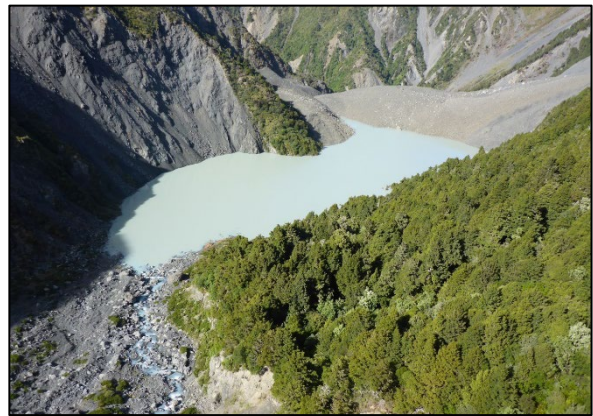
Soon after the 7.8 magnitude Kaikōura earthquake sequence, on 14 November 2016, a landslide dam was discovered on the Hāpuku River (Figure 2-3, Figure 2-5 to Figure 2-8). This dam (known as 'Hāpuku 740') formed when a landslide, from the north-western side of the valley, blocked the narrow river channel.

Figure 2-5: Hāpuku landslide dam on 19 November 2016 – looking downstream along the lake

Figure 2-6: Hāpuku landslide dam on 21 November 2016 – looking north-west toward the dam

Figure 2-7: Hāpuku landslide dam on 12 December 2016 – looking at downstream face of dam

Figure 2-8: Hāpuku landslide dam on 24 January 2017 – looking downstream at the lake

Because of the potential impact of the landslide dam breach on the downstream infrastructure, the New Zealand Transport Agency (NZTA) set up a water level site. This continuously monitored the landslide dam lake for sudden changes in water level.

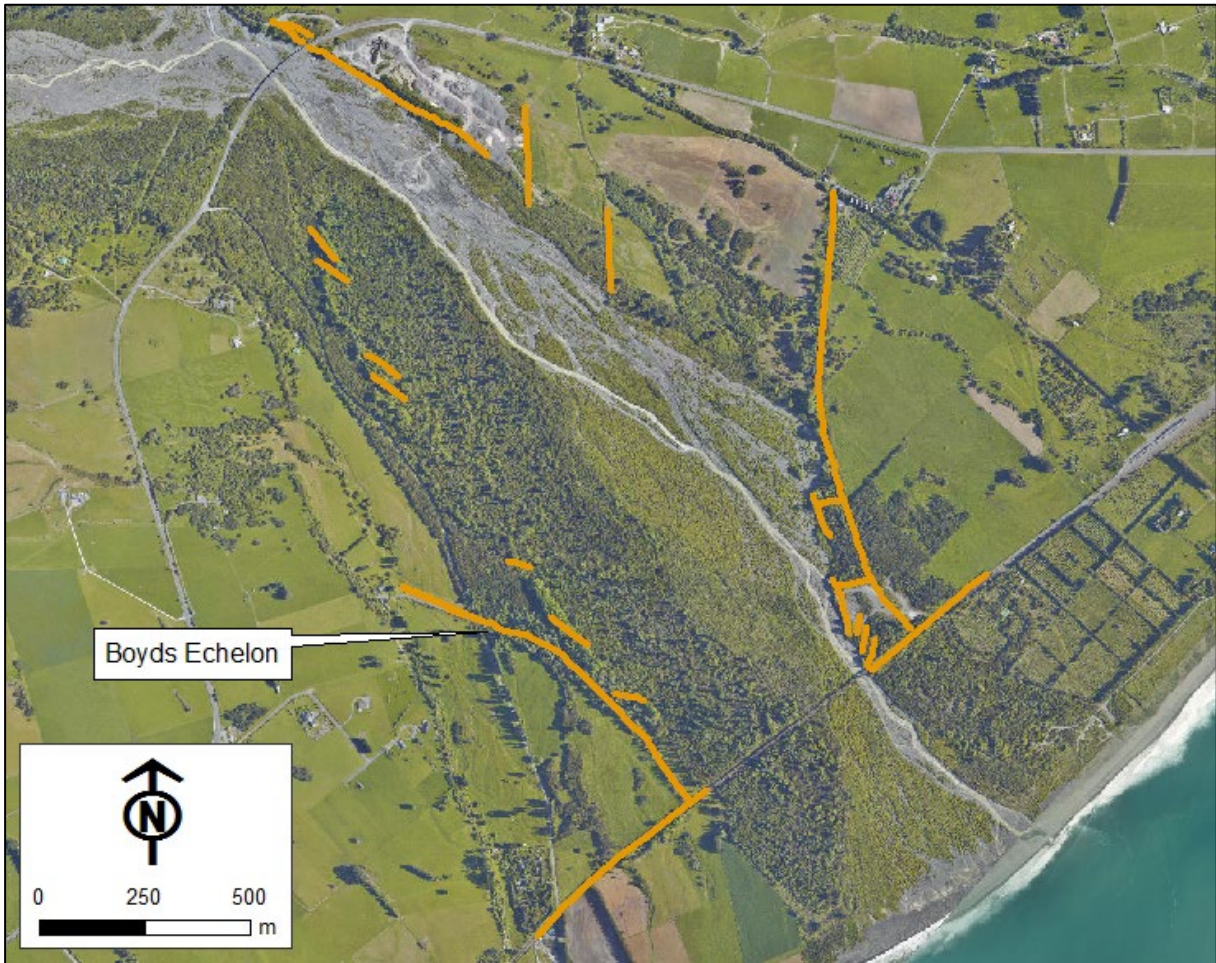
Figure 2-11: Hāpuku River flood protection works (SH1 to the sea)

Following flood damage in May 1966, extensive river control works were put in place along the Hāpuku River. During a flood around 1983, some of the river control works on the northern bank of the Hāpuku River were washed out. Consequently, rock armouring is periodically replenished in this area (which includes small groyne structures).

Local river bed constrictions include the State Highway (SH1) Bridge and the downstream railway bridge. Upstream of the railway bridge, river control works reduce the width of the active river bed to protect adjacent farmland and the railway embankment. Boyds Echelon (a stopbank directing flows back towards the main channel and railway bridge) and the railway embankment also provide some protection for the river mouth settlement of Hāpuku (Figure 2-11). Figure 2-12 shows the constricted section of river at the SH1 road bridge.

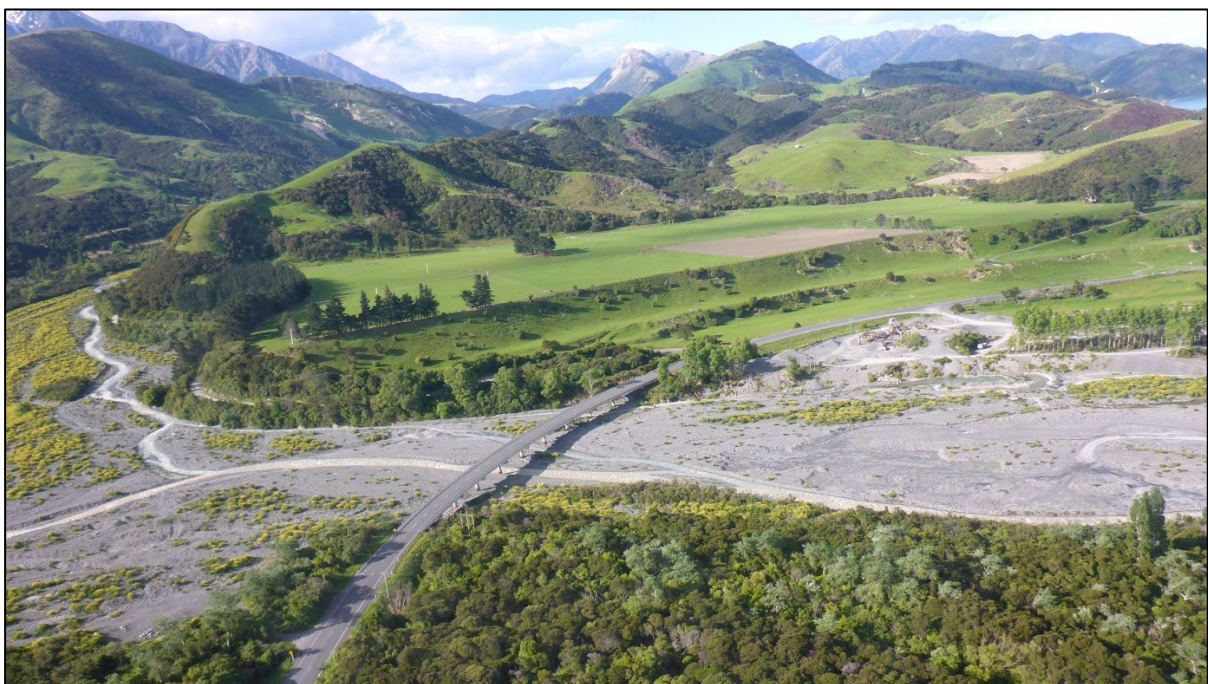
Figure 2-12: Hāpuku River flood protection works, elevated terraces and SH1 road bridge (16 November 2016)

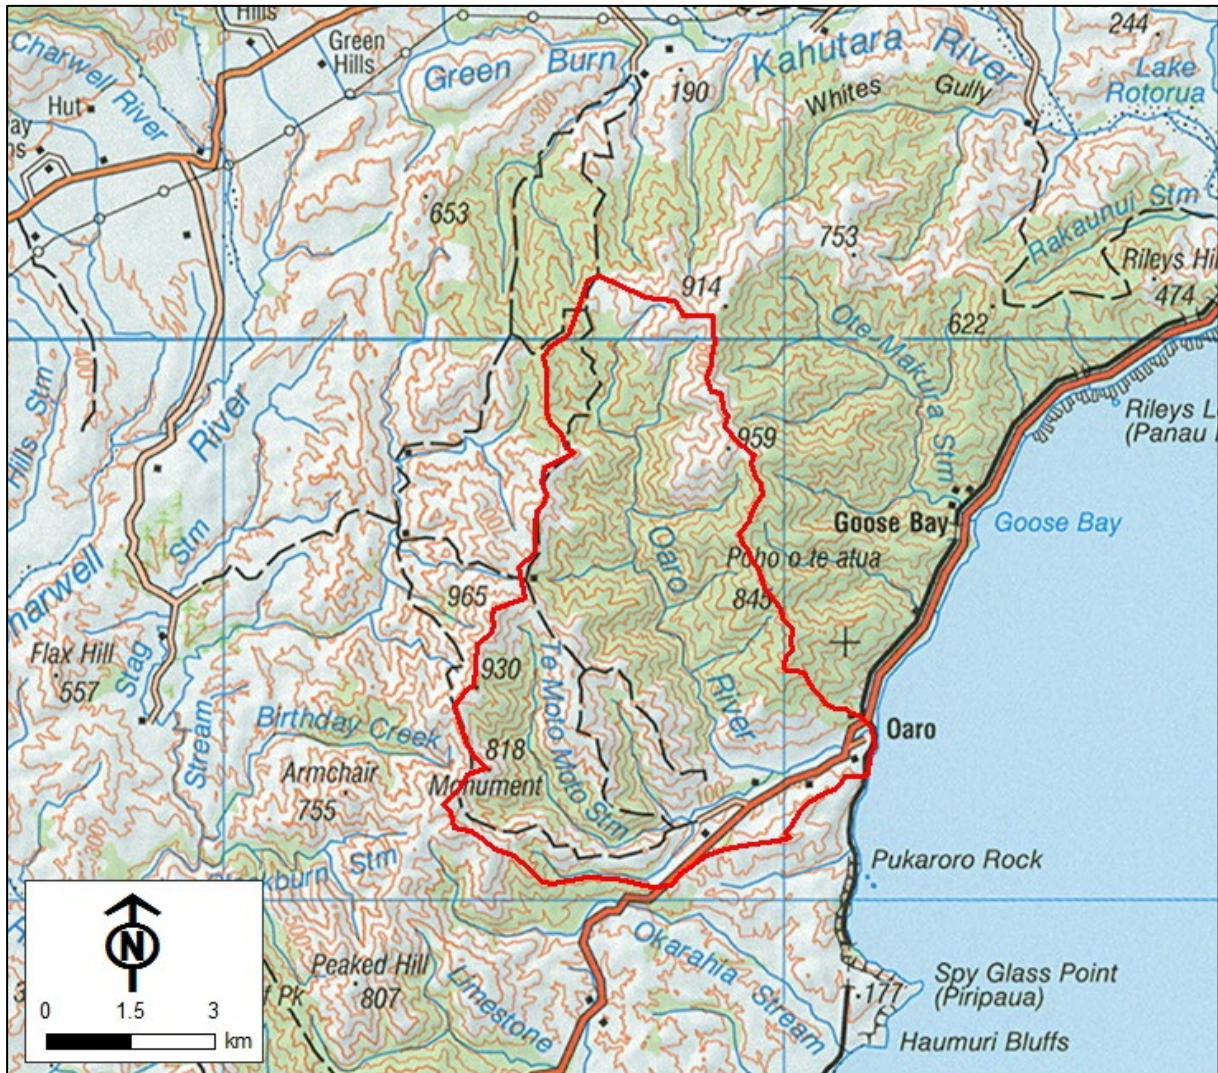
Figure 2-13: Oaro catchment

The Oaro River has a catchment area of 46 km² at SH1. The catchment extends ~8 km inland, into the Hundalee Hills, with the main tributary, Te Moto Moto Stream, entering the Oaro River ~2 km upstream from the coast (Figure 2-13).

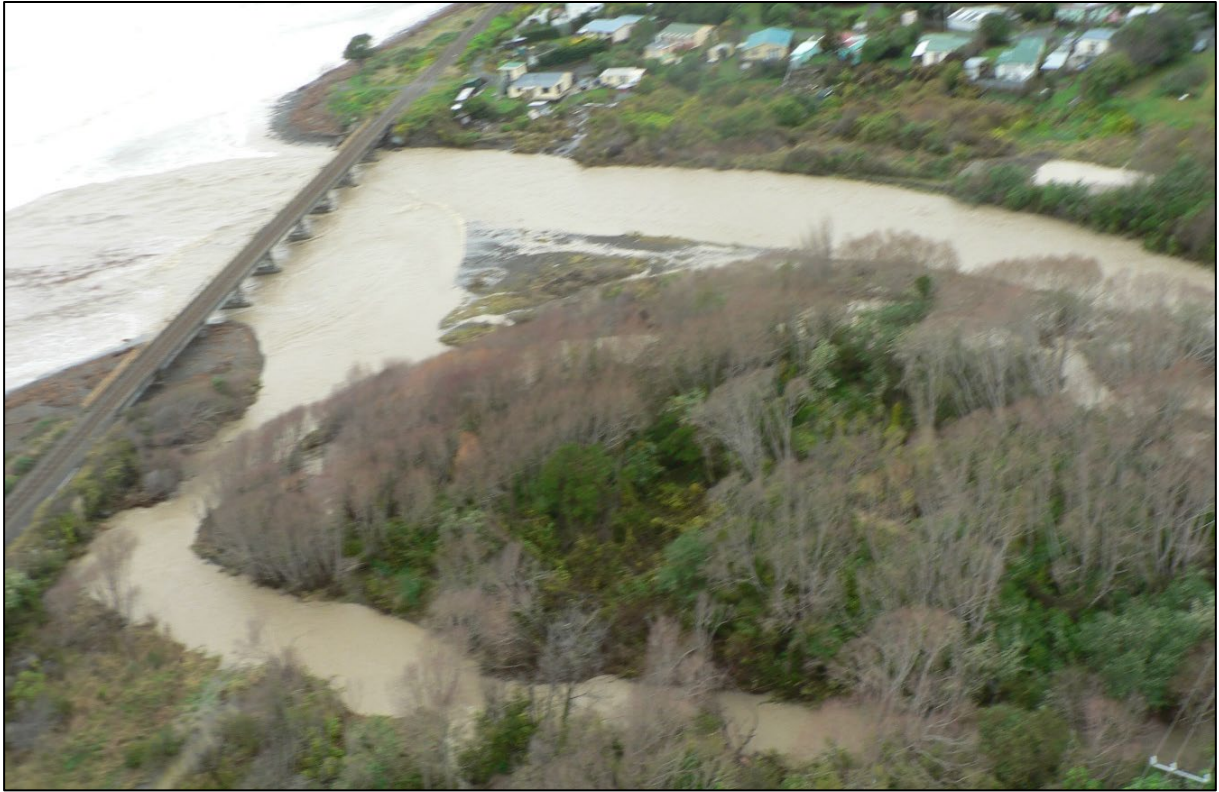
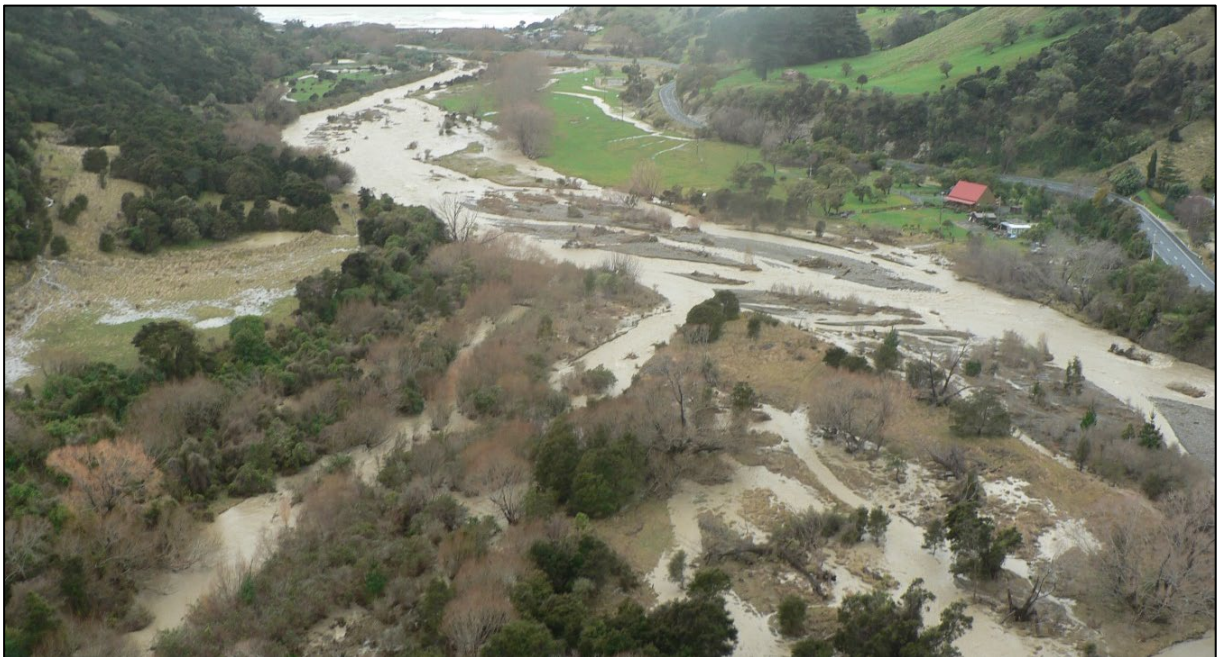
Most of the properties in the Oaro settlement, are on elevated land. Figure 2-14 and Figure 2-15 show the Oaro River and upstream floodplain during a flood event in July 2008.

Figure 2-14: Oaro river mouth – 31 July 2008

Figure 2-15: Oaro River looking downstream towards SH1 Bridge – 31 July 2008

Erosion works were required after flooding in 2014, to protect properties closest to the river. Changes around the Oaro River mouth area in 2014 included:

- flood waters scoured out part of the railway access road which ran between the Oaro Settlement and the Oaro River;

- river engineering works were completed to place gravel and willows along the true right of the river to protect the Oaro Settlement from future floods;
- large areas of vegetation (native and exotic) were removed from within the river bed (either from flood flows or subsequent works by river engineers to keep the middle of the river bed clear of vegetation).
