69 Inland Kaikoura Road, Proposed Lot 14. Site Validation Report

Kaikoura Business Park 2021

Reference: J2021031

7 September 2022

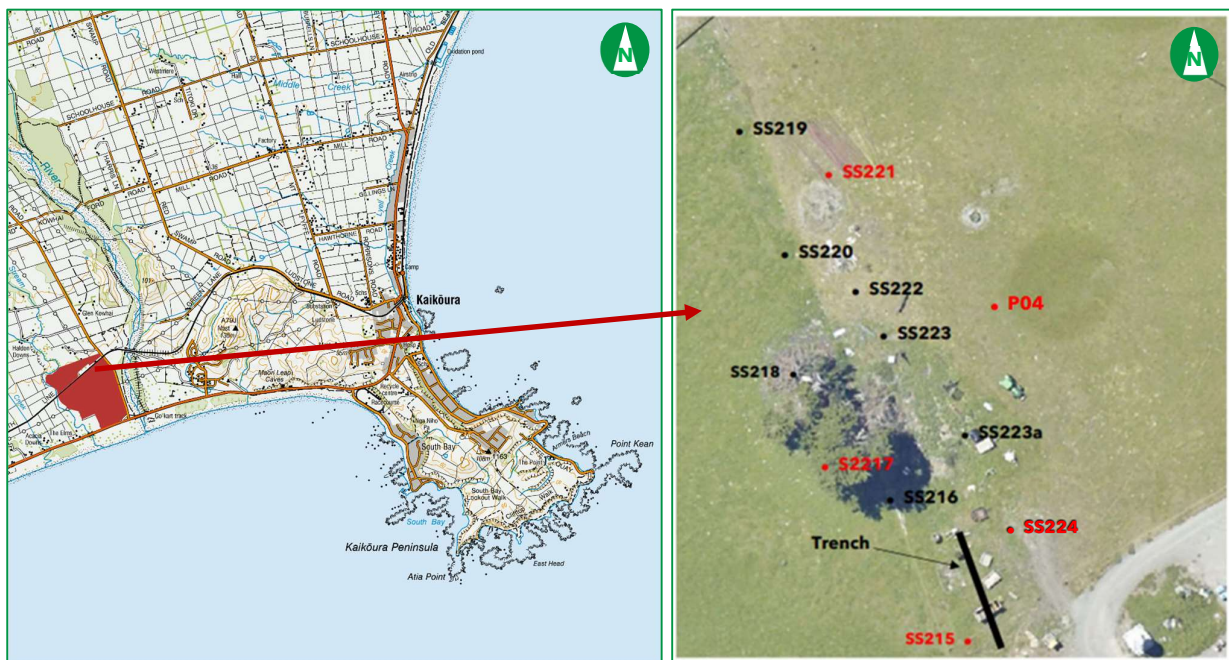
Figure 1. Site Location (Left Figure: Entire Site, Right Figure: Area HM1). Source: Canterbury Maps NZ LINZ Topographic Layer

Asbestos, arsenic, cadmium and lead were identified above the Ministry for the Environment's rural residential Soil Contaminant Standards (SCSs) in analytical results from samples collected from surface in an area referred to as 'HM1'. This area is located in the proposed Lot 14 (see **Figure 2**).

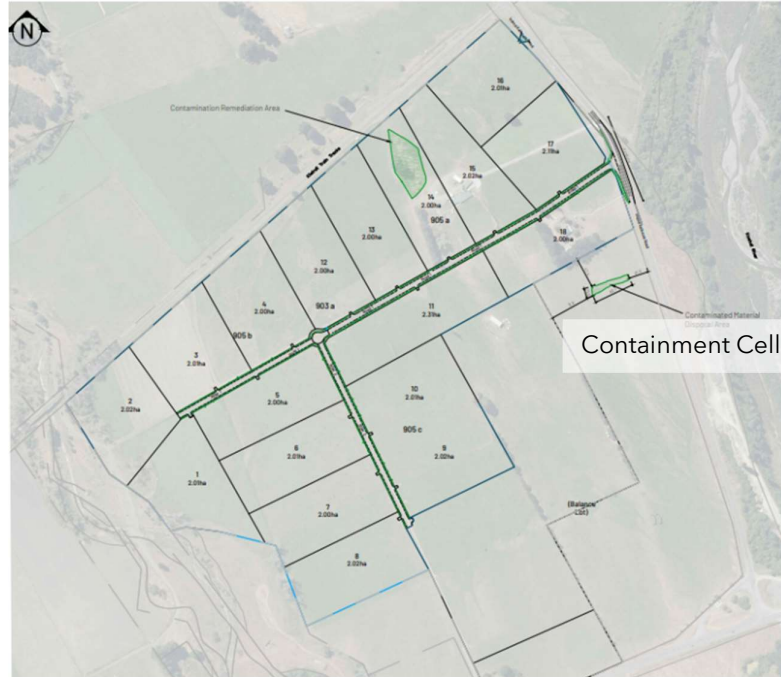
Figure 4. Location of Containment Cell (green). Right hand figure sourced from Baseline Group

The location of the containment cell is shown in **Figure 4**. Details of the containment cell are provided in **Table 4**.

Depth	1.5m below ground surface
Lined?	No
Weight/volume of soil transferred from area HM1 to the cell	546 tonnes / 320 m3 (approximate based on 39 truckloads, each being approximately 14 tonnes). Material compacted but left unsealed pending development of the site and proposed sealing of the area with hardstand

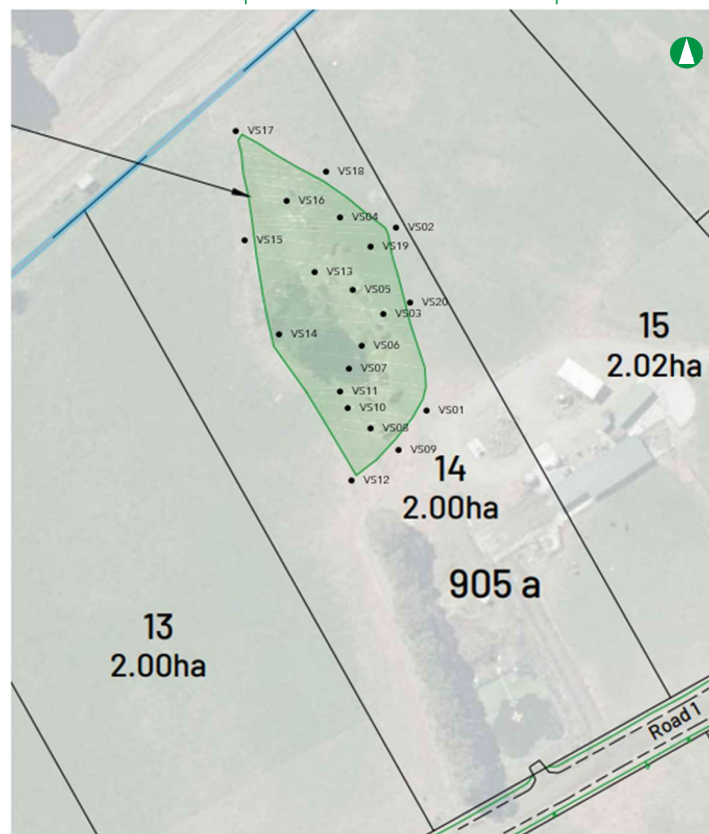
Figure 8. Final Remediation Area and Validation Sample Locations (Arsenic, Cadmium and Lead).
Basemap Sourced from Baseline Group

- At the end of the remediation earthworks: Collection of twenty soil samples from the base and sides of the excavation (as shown in **Figure 5**) for IANZ accredited laboratory analysis of total recoverable arsenic, cadmium and lead concentrations. Each sample was given a unique identification number and collected using decontaminated equipment/clean nitrile gloves and placed into a laboratory supplied container. All samples were placed into a chilly bin directly after collection and transferred to the laboratory following completion of the remediation. Sample results are presented in Table A4, **Appendix 3**, and the laboratory report is also provided in **Appendix 3**.

There was no pattern associated with the locations of these results (see **Figure 8** for their location), and one was located beyond (south of) the remediation area.

Following the failure of validation samples VS11 and VS12 to meet the remediation goals for asbestos, further remedial work has been conducted and validation samples VS21 - VS24 collected. These samples returned results below the remediation goals.

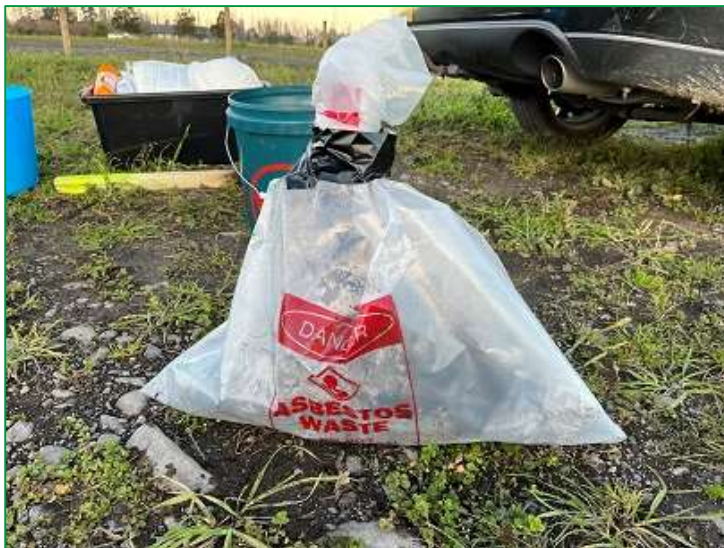
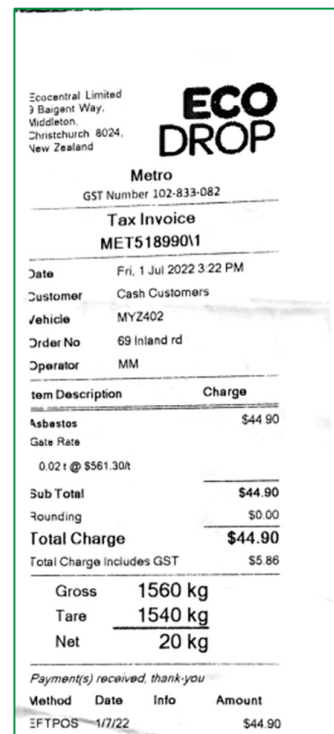
Disposal of asbestos

The asbestos hand-picked on 29 June 2022 was transferred by CLS to the EcoDrop facility in Christchurch for disposal to Kate Valley Landfill.

The New Zealand Guidelines for Assessing and Managing Asbestos in Soil (BRANZ 2017) indicate that, while the quantity of affected soil is likely to be low, removal will be classified as Class B removal work. For this reason, CLS recommends that an asbestos removalist be engaged to conduct the work. CLS will guide the collection of revalidation samples at the end of the process and will supply the required containers and equipment for this task.
