**General distribution and characteristics of active  
faults and folds in the Kaikoura District, North  
Canterbury**

D. J. A. Barrell

**GNS Science Consultancy Report 2014/210**

**Environment Canterbury Report No. R15/23**

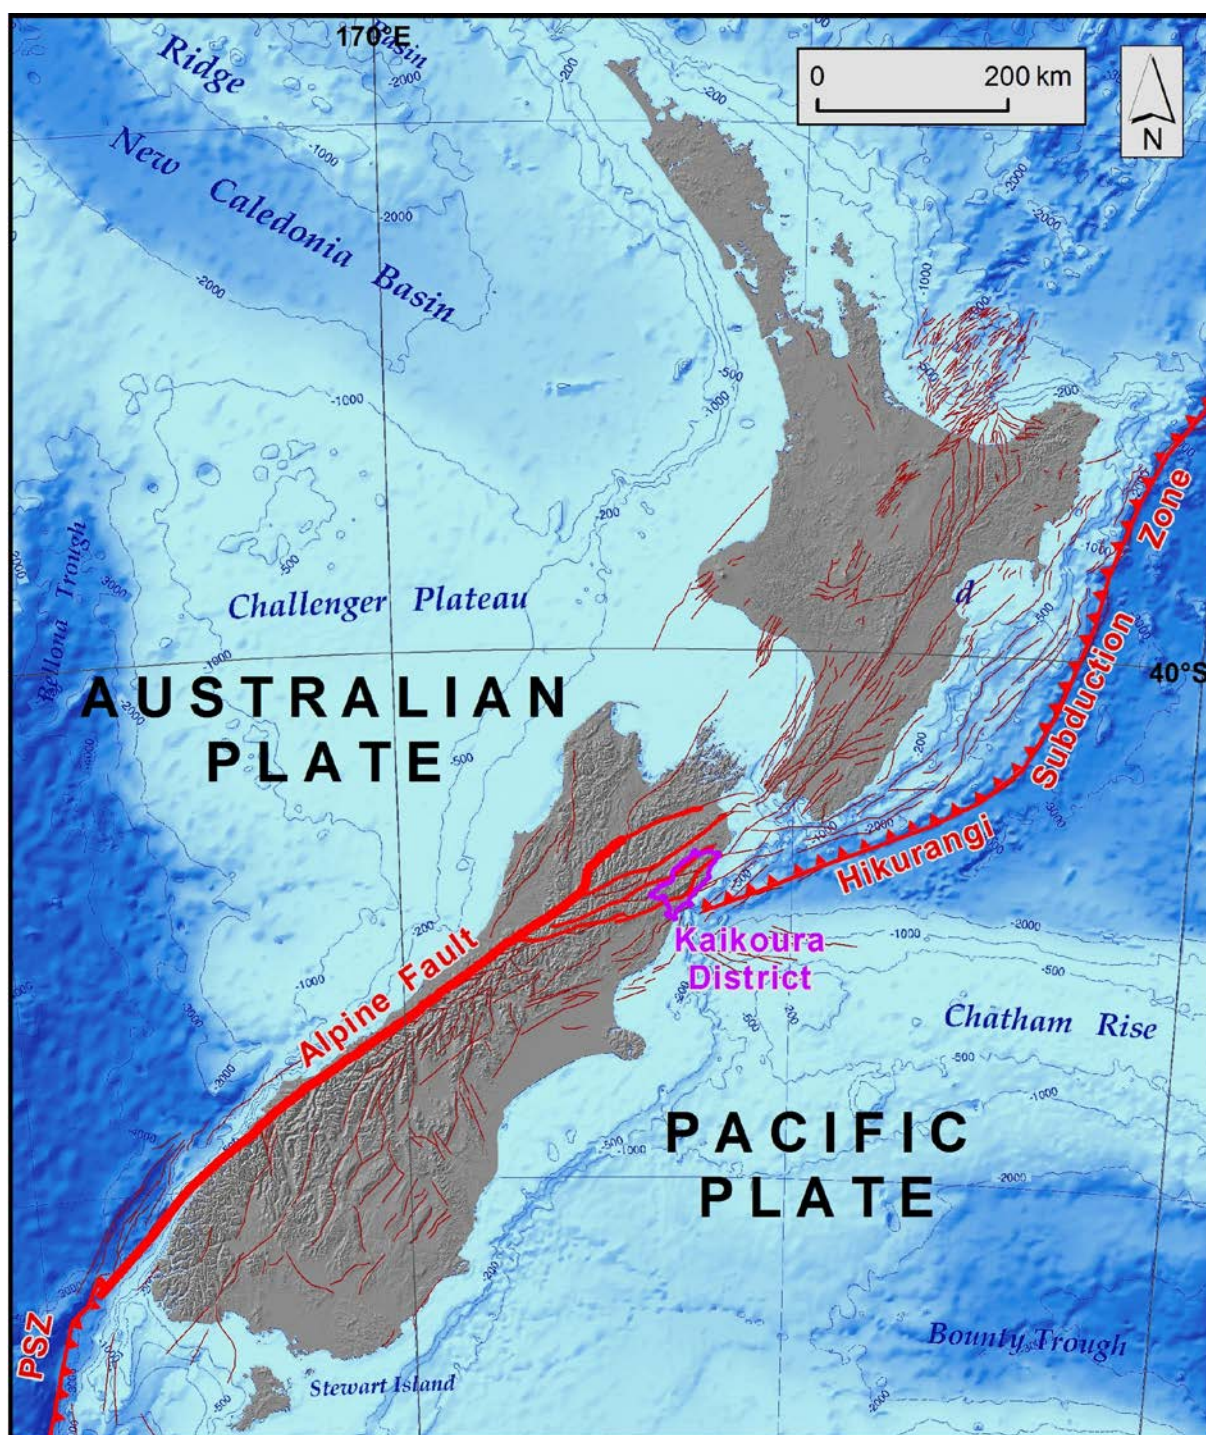
**Figure 1** The tectonic setting of the Kaikoura District. The junction between the Australian and Pacific plates of the Earth's crust passes through New Zealand, with the Pacific Plate pushing westward against the Australian Plate. At the Hikurangi Subduction Zone, the rocks of the Pacific Plate slide west under the North Island, while at the Puysegur Subduction Zone (PSZ), the rocks of the Tasman sea floor slide east under the southwestern South Island. In between is a sideways tear, the Alpine Fault (thick red line). Although much of the plate movement is concentrated at the subduction zones and the Alpine Fault, there is a wider zone of deformation. Of particular note is the Marlborough Fault System (medium red lines) which transfers motion between the Alpine Fault and the Hikurangi Subduction Zone. The Kaikoura District lies in the midst of this wider zone of tectonic deformation. Other active faults, taken from Litchfield et al. (2014), are shown by thin red lines. The offshore image is the New Zealand Continent map (GNS Science) showing shallower water in light blue and deeper water in darker blue. Bathymetric contours are in metres below sea level.

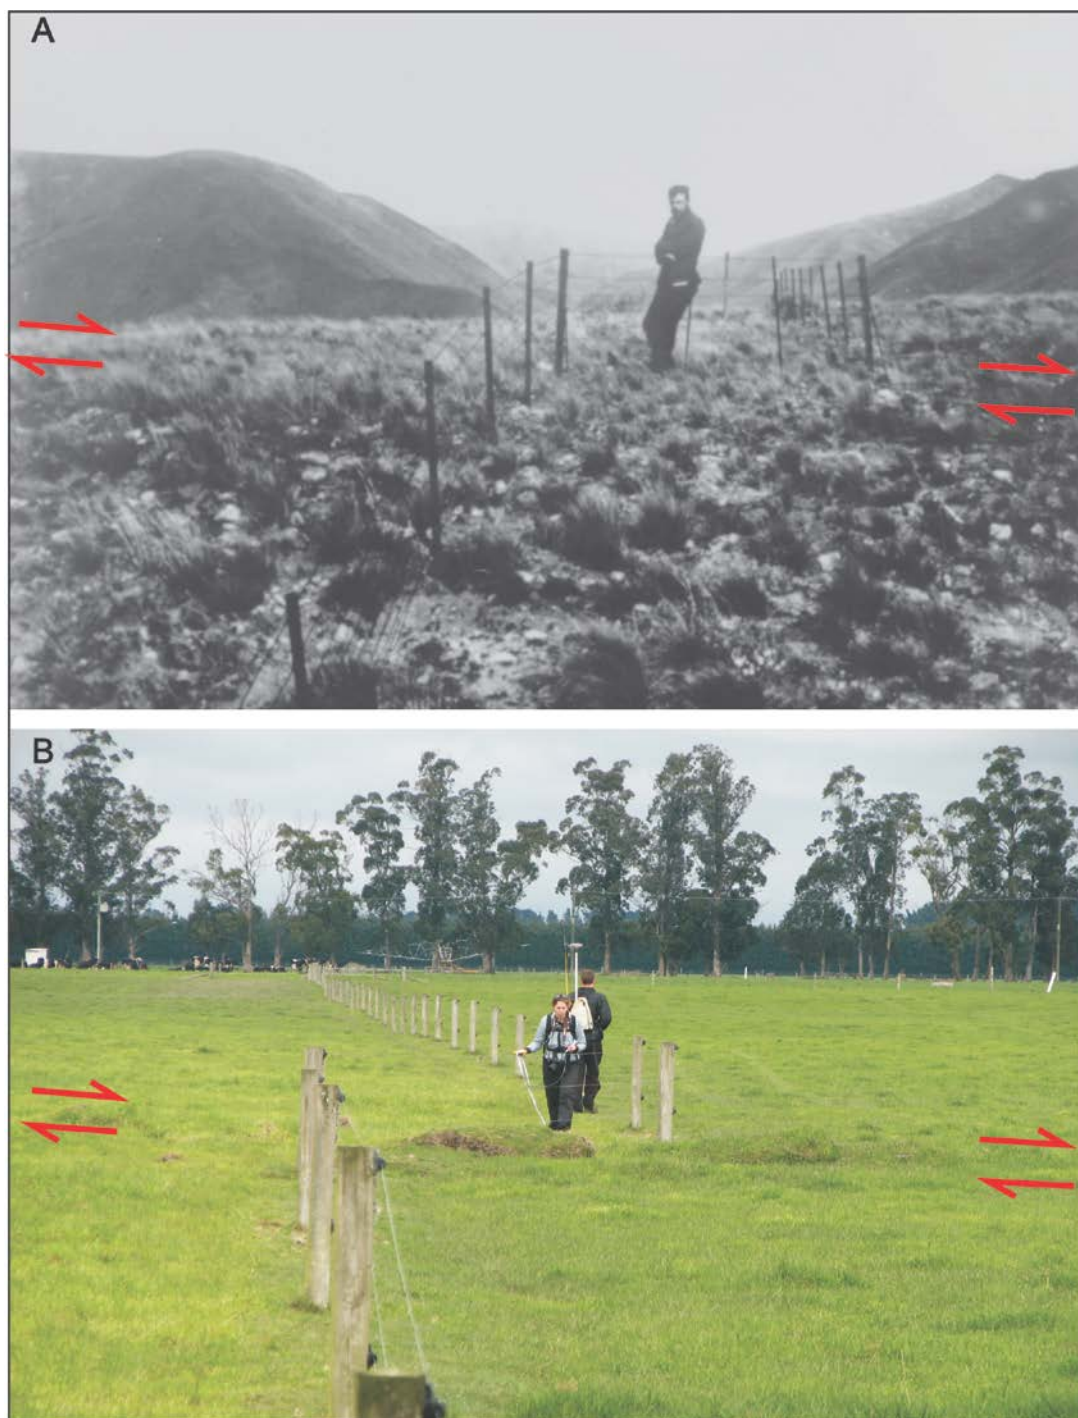
**Figure 2** Illustrations of fault surface rupture offset. A: A fence offset sideways by ~2.4 m of strike-slip rupture on the Hope Fault at Glynn Wye during the 1888 North Canterbury Earthquake (Photo: A. McKay, GNS Science CN4852). B: A fence offset sideways by ~4.5 m of strike-slip rupture on the Greendale Fault during the 2010 Darfield Earthquake (Photo: N. J. Litchfield). Half-arrows either side of the fault indicate the direction of movement. In both cases, the movement is 'right-lateral', sometimes called 'dextral'. This means that to an observer, the ground on the far side of the fault has shifted sideways to the right. The effect is the same regardless of which side of the fault the observer is standing. The other type of strike-slip movement is 'left-lateral', sometimes called 'sinistral', but is not common in New Zealand.

Although the movement along the plate boundary is continuous over geological time, and can be measured by ground and satellite (GPS) surveying, rock of the Earth's crust is remarkably elastic and can accommodate a lot of bending before letting go and breaking suddenly (rupturing) along a fault, causing an earthquake. On large faults, the break may be big, and extend up to the Earth's surface, causing sudden offset and breakage (faulting), and/or buckling and warping (folding), of the ground surface, accompanied by a large earthquake. The 2010 Darfield Earthquake provided a good example of the nature and effects of a large, ground-surface-rupturing earthquake on a geological fault (e.g., Barrell et al., 2011) (Figure 2).

The key evidence for recognising active faults or folds is the offset or buckling of landforms or young geological deposits. This is seen most clearly on old river terraces or river plains, where the original channel and bar patterns of the former riverbed are 'fossil' landforms dating from when the river last flowed at that location. Topographic steps or rises that run across such river-formed features could not have been created by the river, and therefore result from subsequent deformation of the ground. As long as factors such as landsliding can be ruled out, these topographic features may confidently be attributed to fault or fold movements (e.g., Figure 2 and Figure 3).

Figure 2, Figure 5 and Figure 10 illustrate examples of the types of ground-surface deformation hazards associated with active faults or active monoclines, noting that at any location, elements of both faulting and folding may be present within a deformation zone. In general, faults and monoclines present the most focused forms of ground deformation, in regard to direct rupture or significant tilting of the ground surface. Such effects may occur in a sudden event. Active anticlines or synclines are likely to present a much lesser level of ground surface deformation hazard with regard to buildings, but may pose relevant hazards to developments such as canals or power stations (e.g., by tilting the ground). Furthermore, the presence of active folds suggests that there may be an underlying active fault at depth that may potentially generate a local, large, shallow earthquake, were it to rupture.

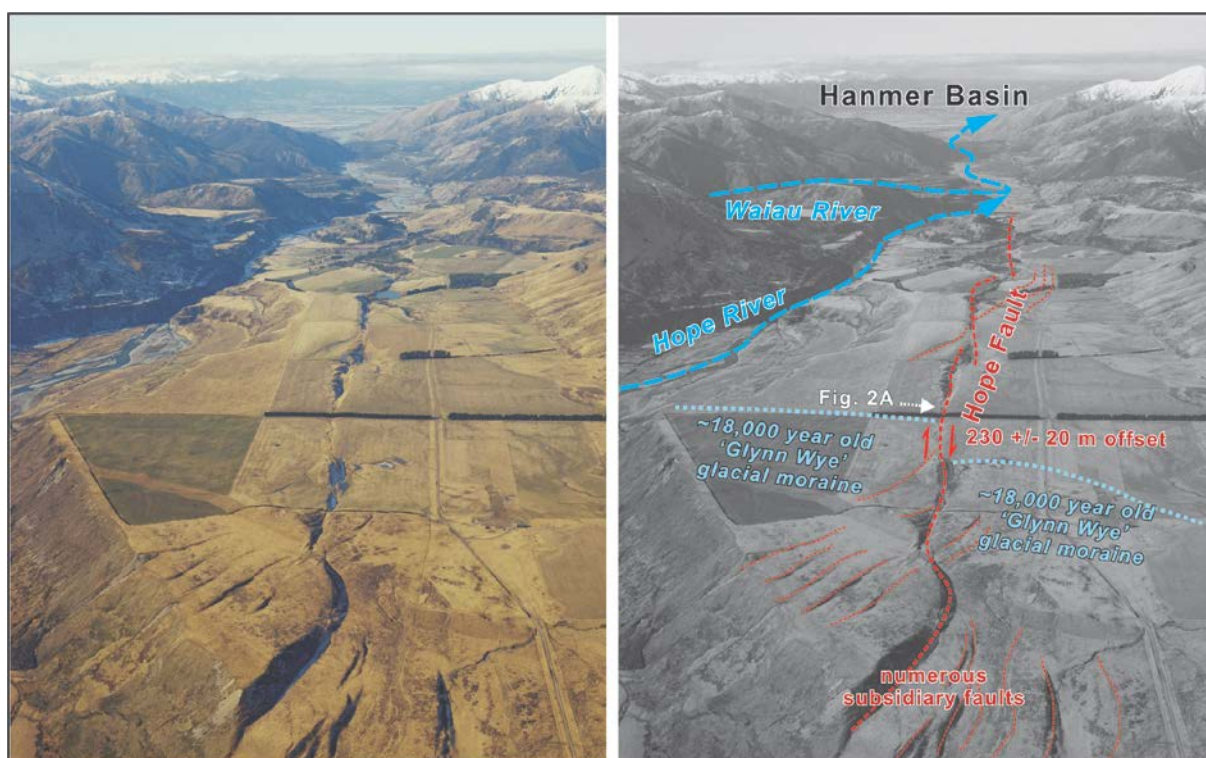
**Figure 3** Aerial view looking east along the Hope Fault Zone at Glynn Wye, Hope River valley, Hurunui District. The fault trace is accentuated by a dusting of snow persisting on shaded areas along the fault. After stepping across the Hanmer Basin, the Hope Fault Zone continues northeast into the Kaikoura District (Photo: D.L. Homer, GNS Science CN3602/26).

The fault and fold styles illustrated in Figure 5 are idealised examples. They do not show the full range of variations and complexity that may exist (for example, see Figure 3). Indeed, to find such simple examples in nature would be an exception rather than a rule. The steepness of inclination (dip) of the fault may vary considerably (Figure 5). Where a fault has a gentle dip (i.e., is closer to horizontal than vertical), each successive movement commonly results in the upthrown side 'bulldozing' outward, over-riding the ground and encroaching over anything in its immediate vicinity. The destroyed building in the upper panel of Figure 5 attempts to convey some impression of the bulldozer effect.

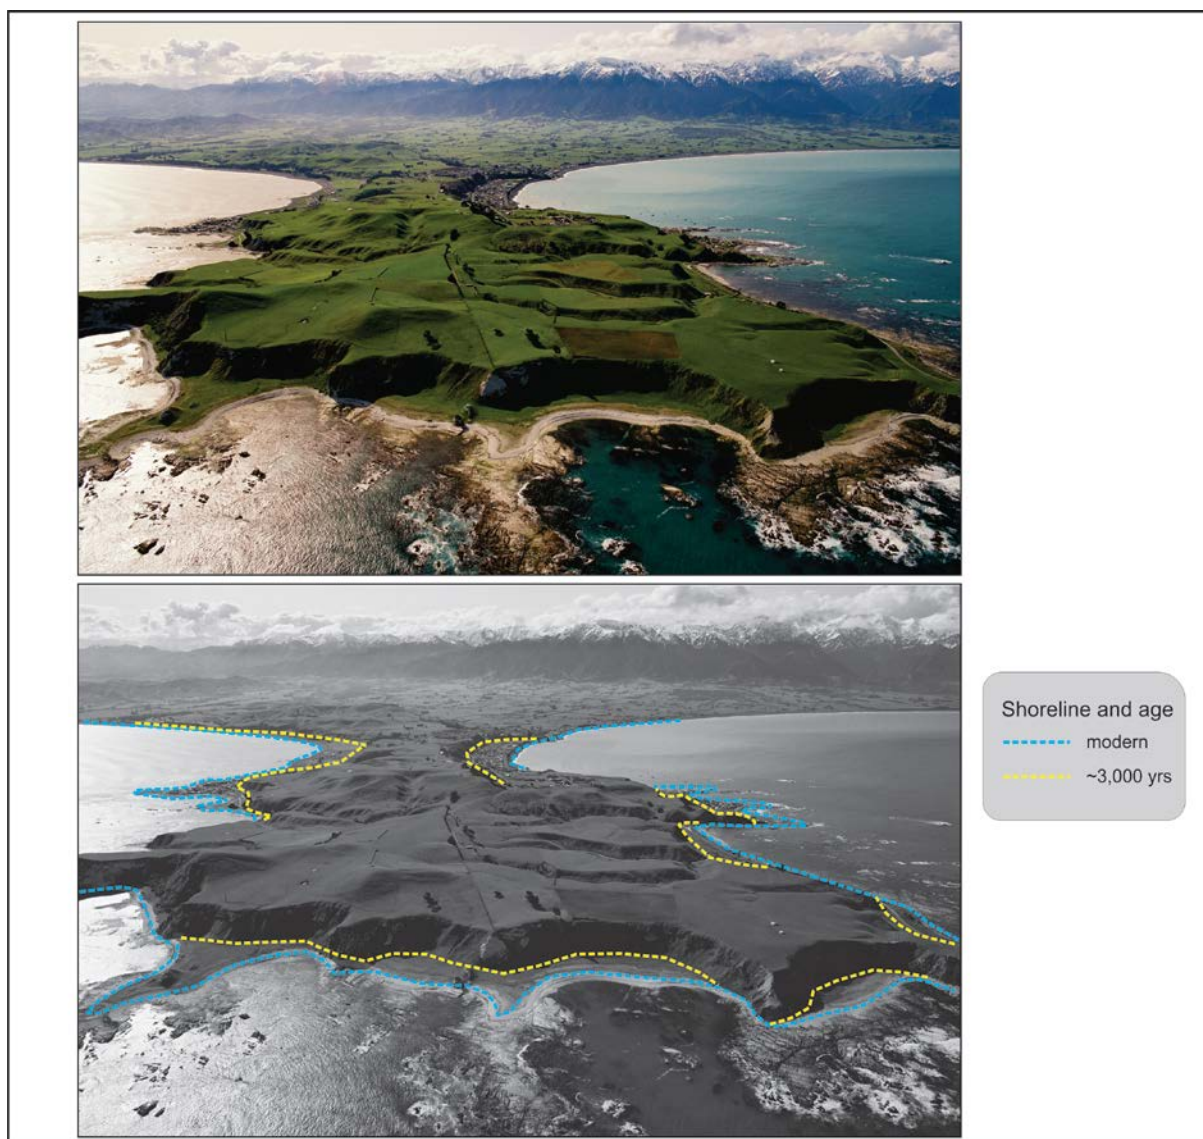
**Figure 4** A view northwest looking along Kaikoura Peninsula towards the Seaward Kaikoura Range. Prominent in the foreground is an abandoned shoreline (marked as ~3,000 years) backed by a now inactive sea cliff. These features relate to uplift of the land, suggested to have occurred in at least three uplift events, of at least 1 m each, with an average of about 1,000 years intervening between each event (see Appendix 2). In most places the sea no longer reaches the old cliff line, but as coastal erosion continues, the old cliff is starting to become reoccupied (e.g., far left). Much of Kaikoura township lies on this young raised coastal platform. The surface of the peninsula comprises an array of broad terraces at differing elevations. These features are marine terraces that were formed by wave erosion during the last interglacial period, between about 60,000 and 105,000 years ago. Since then these terraces have been raised well above sea level by ongoing tectonic uplift. The uplift is thought to be resulting from movement on an active fault that underlies the peninsula, and projects up towards the sea floor about 2 km offshore from the southeast margin of the peninsula (Kaikoura Peninsula fault; Figure 8). Each uplift event is likely to be accompanied by a large earthquake centred as shallow depth under the peninsula. Photo: D.L. Homer, GNS Science CN23908/19.

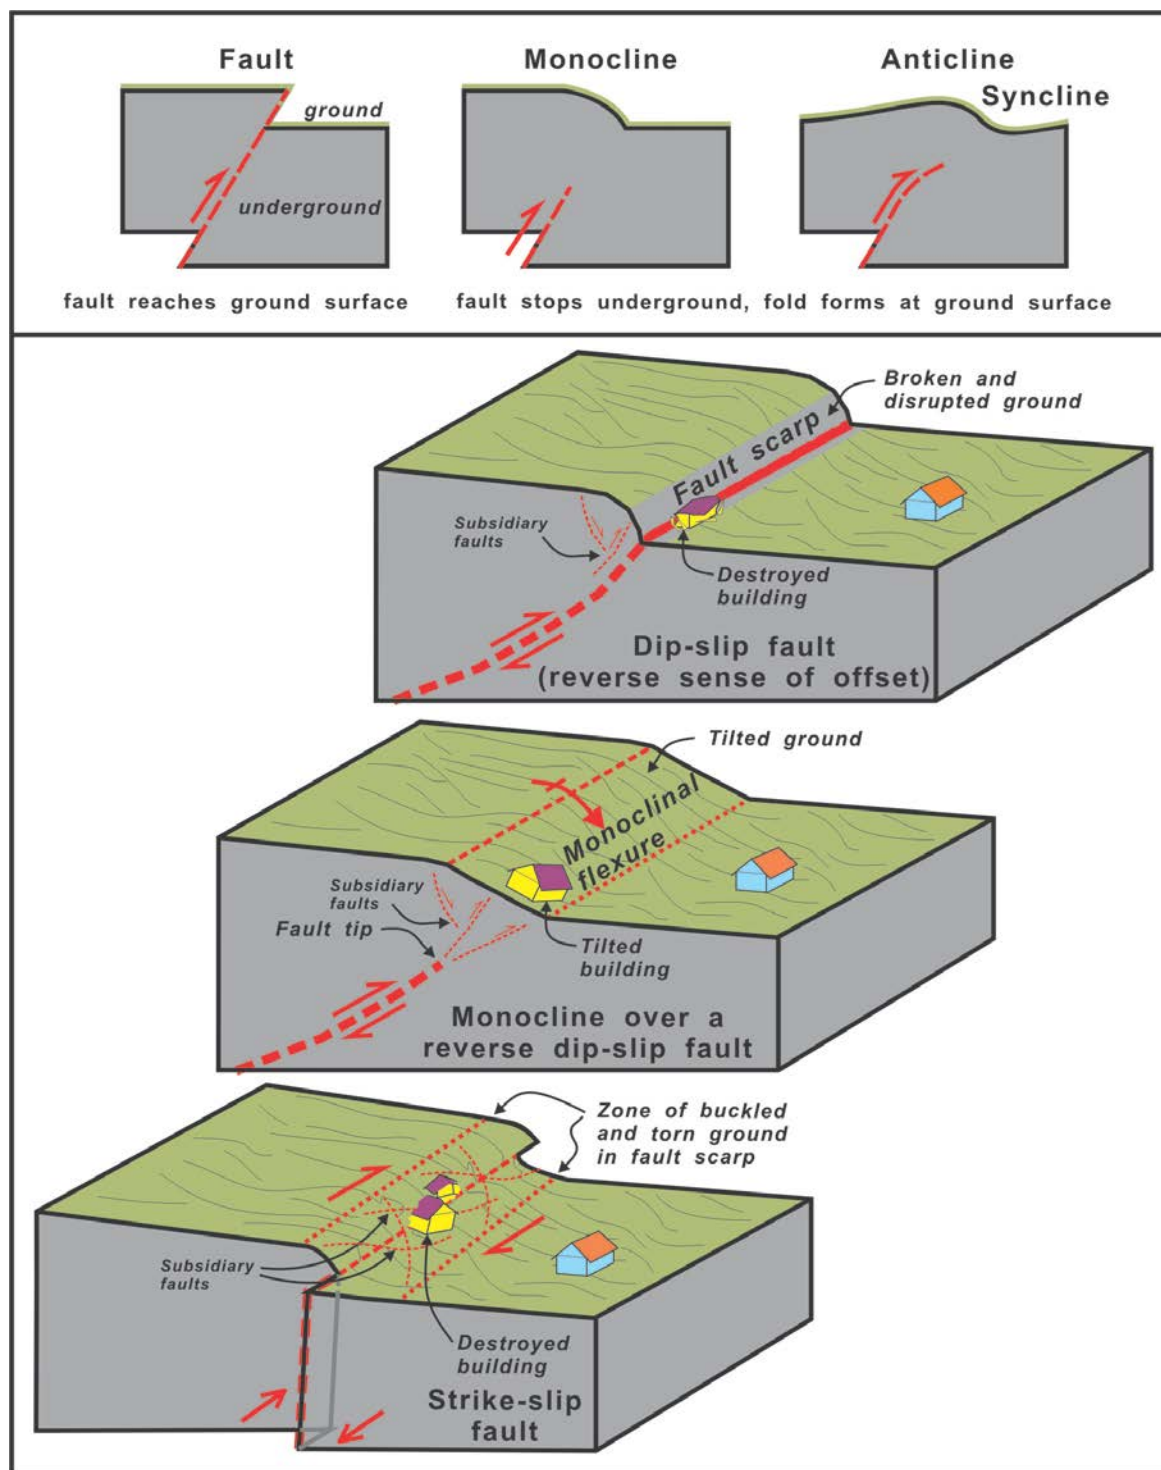
**Figure 5** Diagrams illustrating styles of active faults and folds. The diagrams illustrate general concepts rather than actual details, and are not drawn to an exact scale. Upper panel: Cross-section (vertical slice) diagrams illustrating an active fault, active monocline and active anticline and syncline. Most folds are, as shown here, thought to have formed over faults whose ruptures have not made it all the way to the ground surface. Lower panel: perspective block diagrams showing typical ground-surface expressions of faults and monoclines. The diagrams include hypothetical examples of effects on buildings of a future fault rupture or monocline growth event. See text for further explanation.

In this report, and the accompanying GIS dataset, we distinguish between the style of active deformation, whether predominantly by **fault** offset of the ground (fault scarp), or whether by folding (buckles, tilts or flexures) of the ground. Folds are subdivided into ‘one-sided folds’, or **monoclines**, and ‘two-sided folds’, either up-folds (**anticlines**) or down-folds (**synclines**) (Figure 5).

Two end-members of fault type are shown in Figure 5; a dip-slip fault which has up-down movement, and a strike-slip fault which has horizontal (sideways) movement. In practice it is not uncommon for a fault to display a combination of both types of movement; such faults are called 'oblique-slip', and have movement that is partly up-down and partly sideways. Most dip-slip faults are inclined (i.e., are not vertical), and there are two basic types of movement. Where the rock on the upper side of the inclined dip-slip fault shifts upwards along the fault, it is called a reverse fault, and results from compressional forces. Where the rock on the upper side of the inclined dip-slip fault shifts downwards along the fault, it is called a normal fault, and results from tensional forces.

There is rarely an exact distinction between a fault and a monocline at the ground surface. Fault scarps are commonly associated with some buckling of the ground and near-surface layers, particularly on the upthrown side of the main fault scarp (Figure 5; also see Figure 6 and Figure 7). In some cases, part of the fault movement may have broken out on a series of smaller subsidiary faults in the vicinity of the main fault. In the case of monoclines or anticlines, subsidiary faults may also occur over buried faults that underlie these folds, resulting in small ground surface offsets (e.g., Kelson et al., 2001). The important message is that on any active fault or fold, there commonly are elements of both faulting and folding close to the ground surface. The amount of deformation due to faulting, relative to the amount expressed as folding, may vary over short distances.

In practice, where the zone of ground deformation is quite narrow, we interpret it as a fault, and where it is broad, we interpret it as a fold (e.g., monocline) (see Figure 5). The only way to determine the accuracy of this interpretation is to excavate a trench across the deformed zone to see whether, or to what extents, the near-surface deposits have been offset, or merely folded. Sometimes, natural exposures in stream banks provide the necessary information. This highlights a key issue; without detailed work involving examination of what lies within the first few metres beneath the ground surface, we can at best only make informed guesses about the exact locations, form and likely future consequences of fault or fold activity.

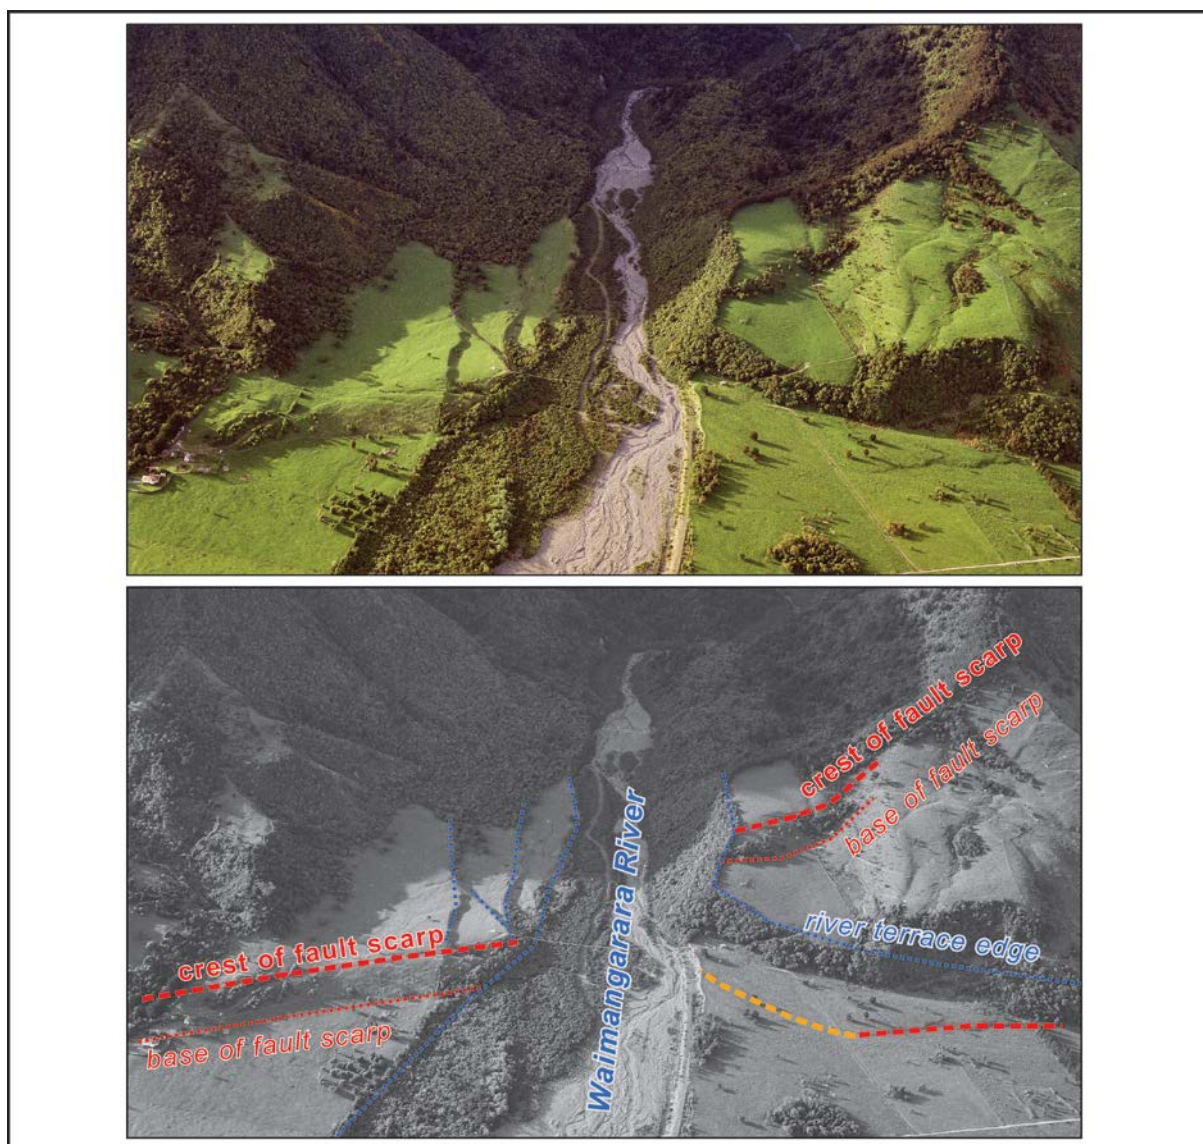
**Figure 6** A view north-northwest up the valley of the Waimangarara River where it crosses the Hope Fault Zone at the foot of the Seaward Kaikoura Range. On the lower duplicate image, the edges of river-cut terraces are marked in blue, while fault scarps are shown in red and a monocline is shown in orange. The fault and fold scarps are 'definite' and are classified as 'well expressed'. A lidar map, and topographic profiles, of this area are presented in Figure 7. West of the river channel (left in photo), the prominent fault scarp is 18 m high (Van Dissen, 1989). The fault scarp on the high terrace on the east side of the river is 26 m high. The fault scarp on the river plain in the right foreground is as much as ~4 m high (Van Dissen, 1989), west of which is a monocline, newly identified using lidar survey data. Due to their relatively small sizes, both are shown just using the 'crest' symbol. Collectively, these features illustrate the considerable degree of complexity that occurs in some places along the Hope Fault Zone. Photo: D.L. Homer, GNS Science CN11015/28.

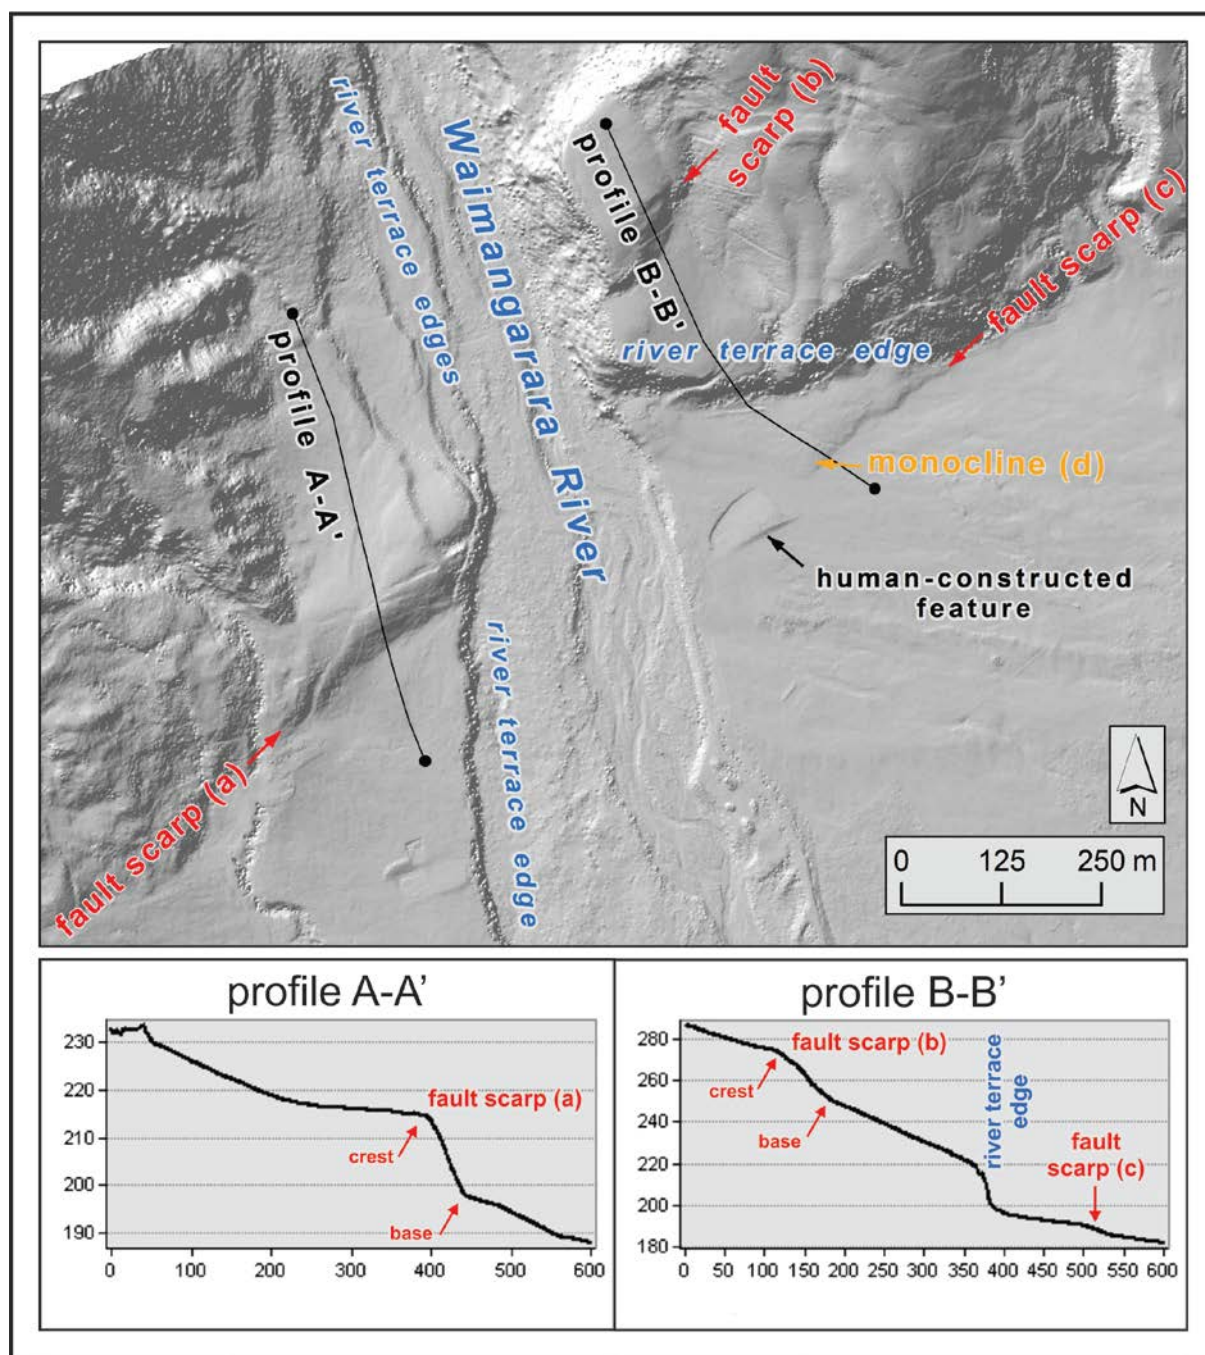
**Figure 7** A lidar digital elevation model of the area shown in Figure 6, illustrating the precise topographic information revealed by the aerial laser scanning method. Areas of rough or lumpy terrain are clothed in trees. The topographic profiles are generated from the lidar data. Note the prominent backtilt on the upthrown side of the fault scarp in profile A-A'. Also note that on the lidar map, to the right of the A-A' profile, several light coloured linear troughs along the crest of the fault scarp; these mark subsidiary faults that have disrupted the overall fault scarp (see Figure 5).

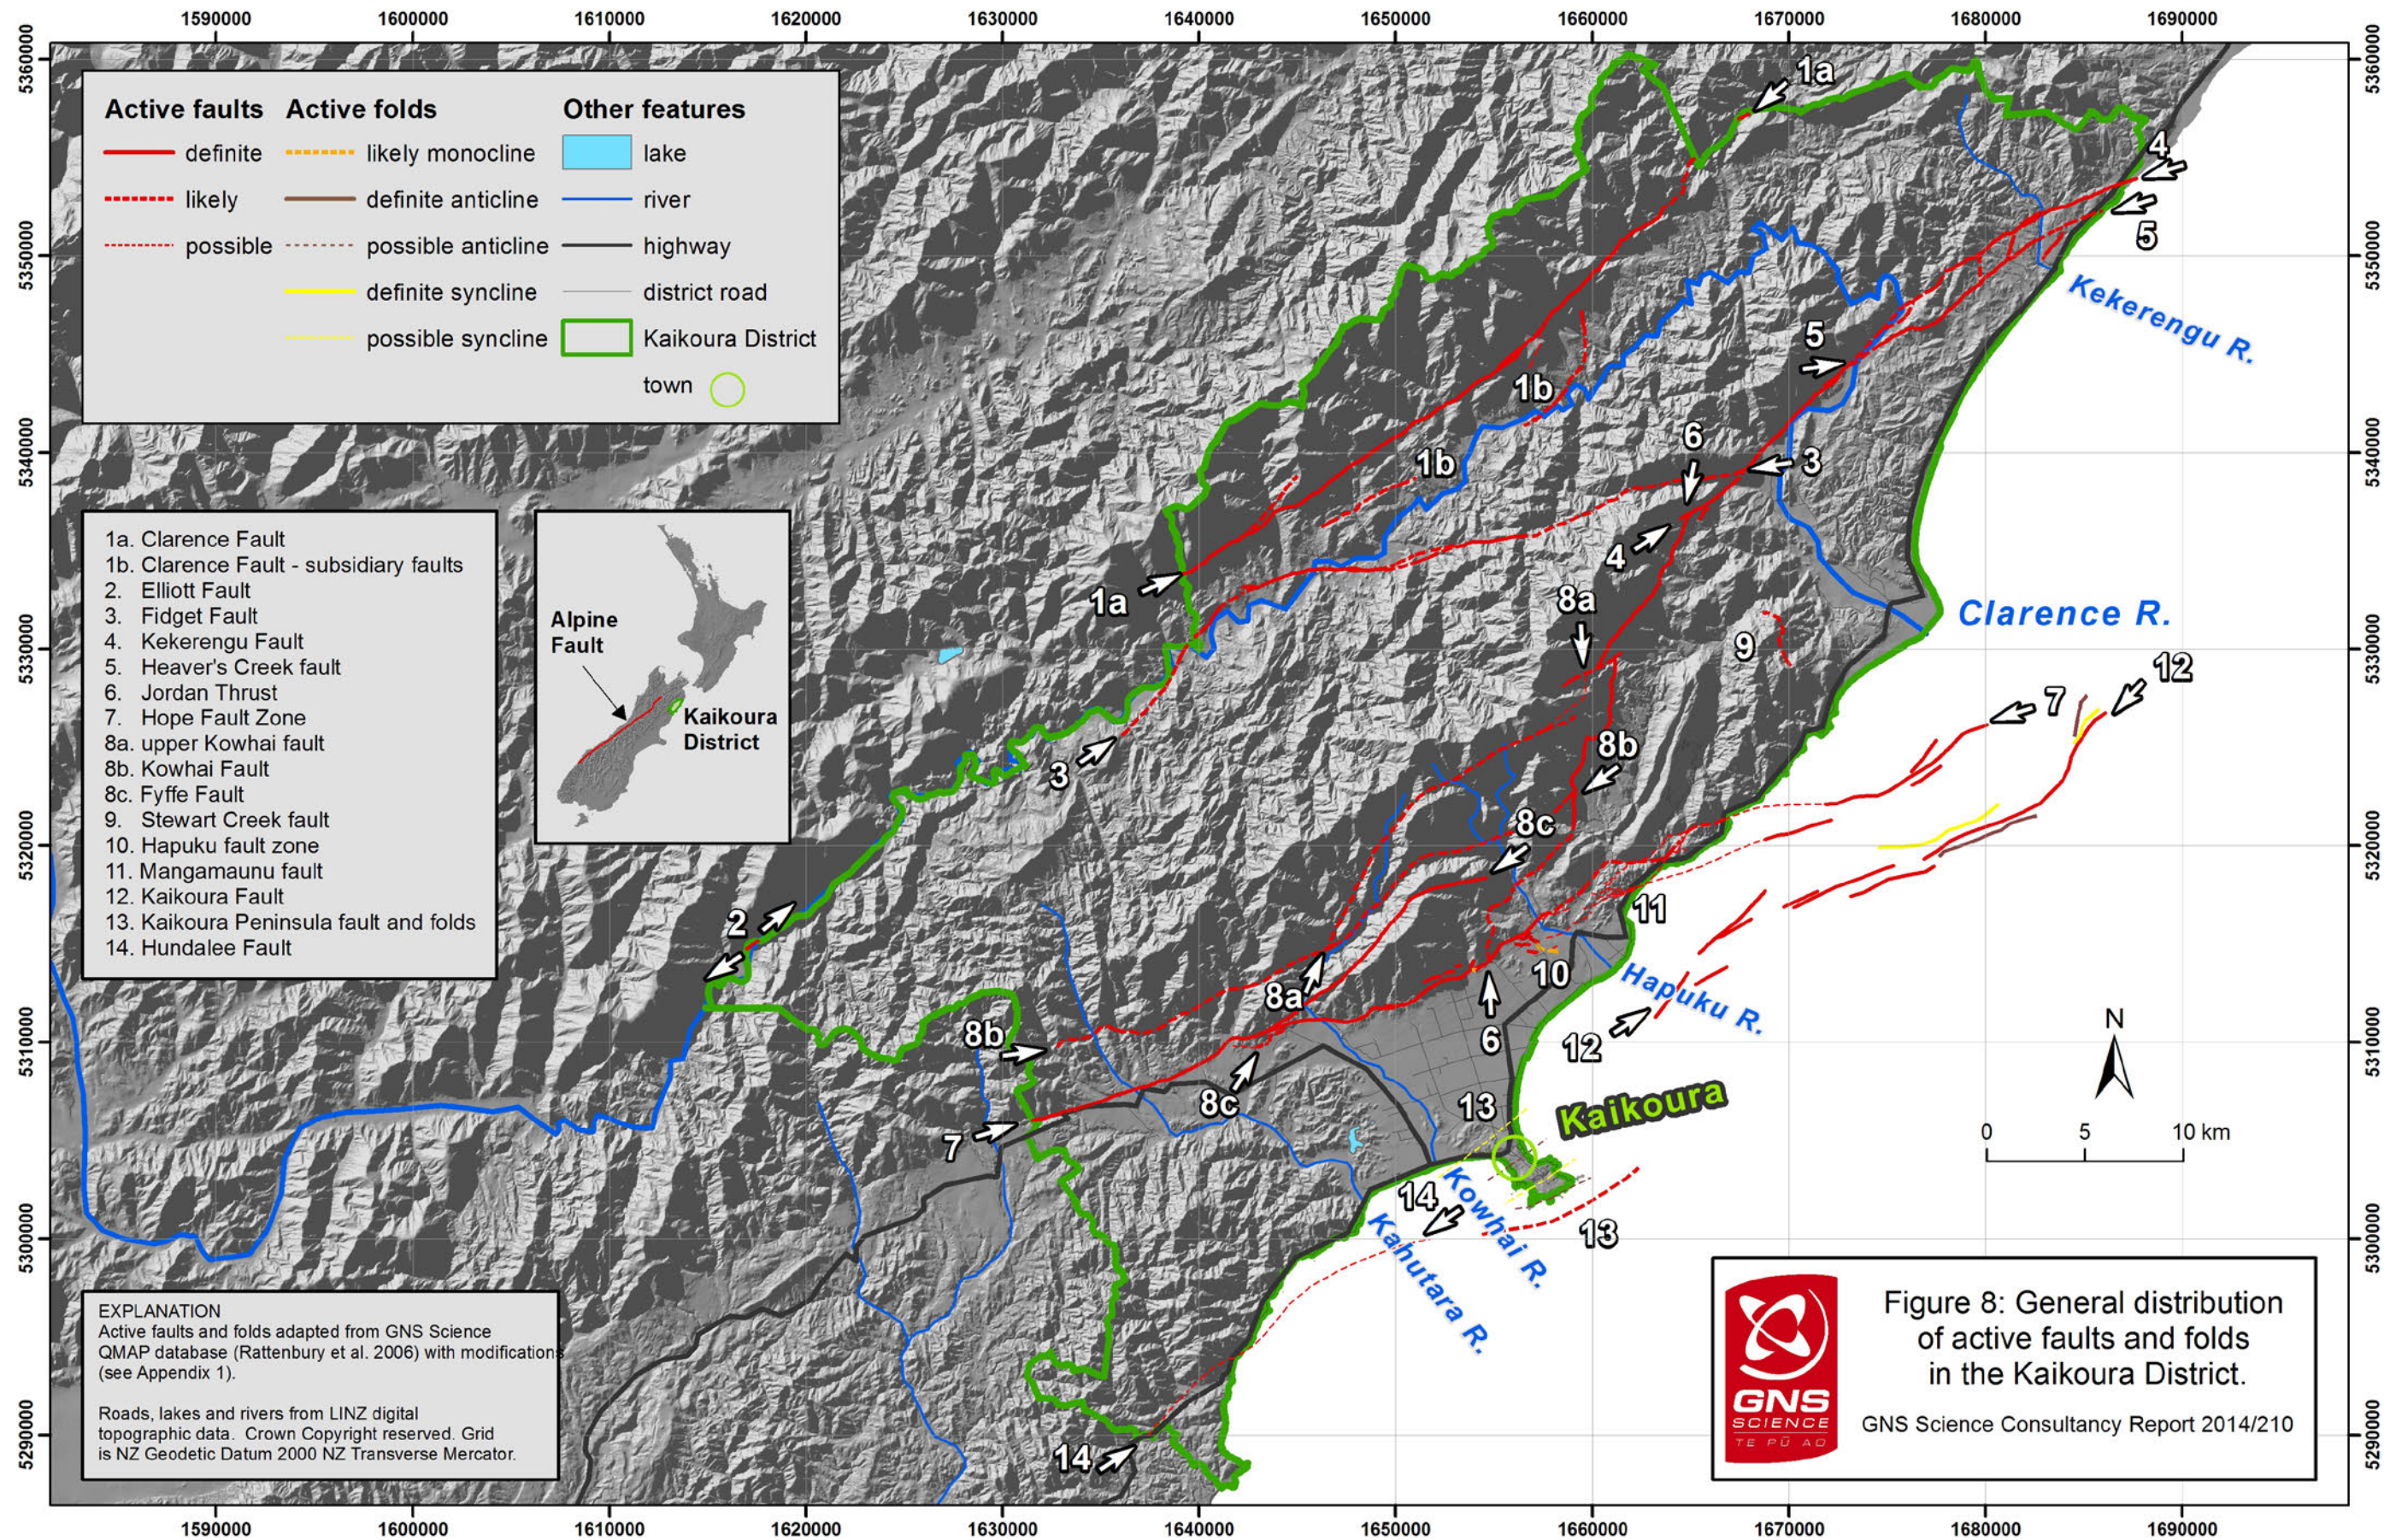
**Figure 8** General distribution of active faults and folds in the Kaikoura District.

For the purposes of illustration and discussion, in places where several active fault or fold features lie close to one another, they have been grouped together under one name. In total, 14 individual or grouped active fault/fold features have been delineated (Figure 8).

The Kaikoura District, due to its proximity to the plate boundary, has a large number of active faults and folds. Most of the active faults, including the Clarence (Figure 9), Elliott, Fidget, Hope and Kekerengu faults (Figure 8), have predominantly strike-slip movement. These sideways-moving faults have a right-lateral sense of movement. This means that to an observer standing on one side of the fault, the other side of the fault has moved to the right (e.g., Figure 2). The Jordan Thrust has a notable component of reverse movement. There are several faults about which not much is known, including the newly recognised Hapuku fault zone, and the Kaikoura Peninsula fault, which is inferred to be responsible for the uplift of Kaikoura Peninsula.

The two main active fault/fold systems identified close offshore in the Kaikoura District are identified by Barnes & Audru (1999) as the offshore continuation of the Hope Fault and the Kaikoura Fault (Figure 8). There are many more faults and folds identified offshore than are shown in the dataset accompanying this report, wherein just the major structures with reasonable evidence for along-strike continuity, are included. Note that in the northeast corner of the district, the Kekerengu Fault also projects offshore, but its offshore projection is not included in this dataset because it lies in the offshore sector of the Marlborough District.

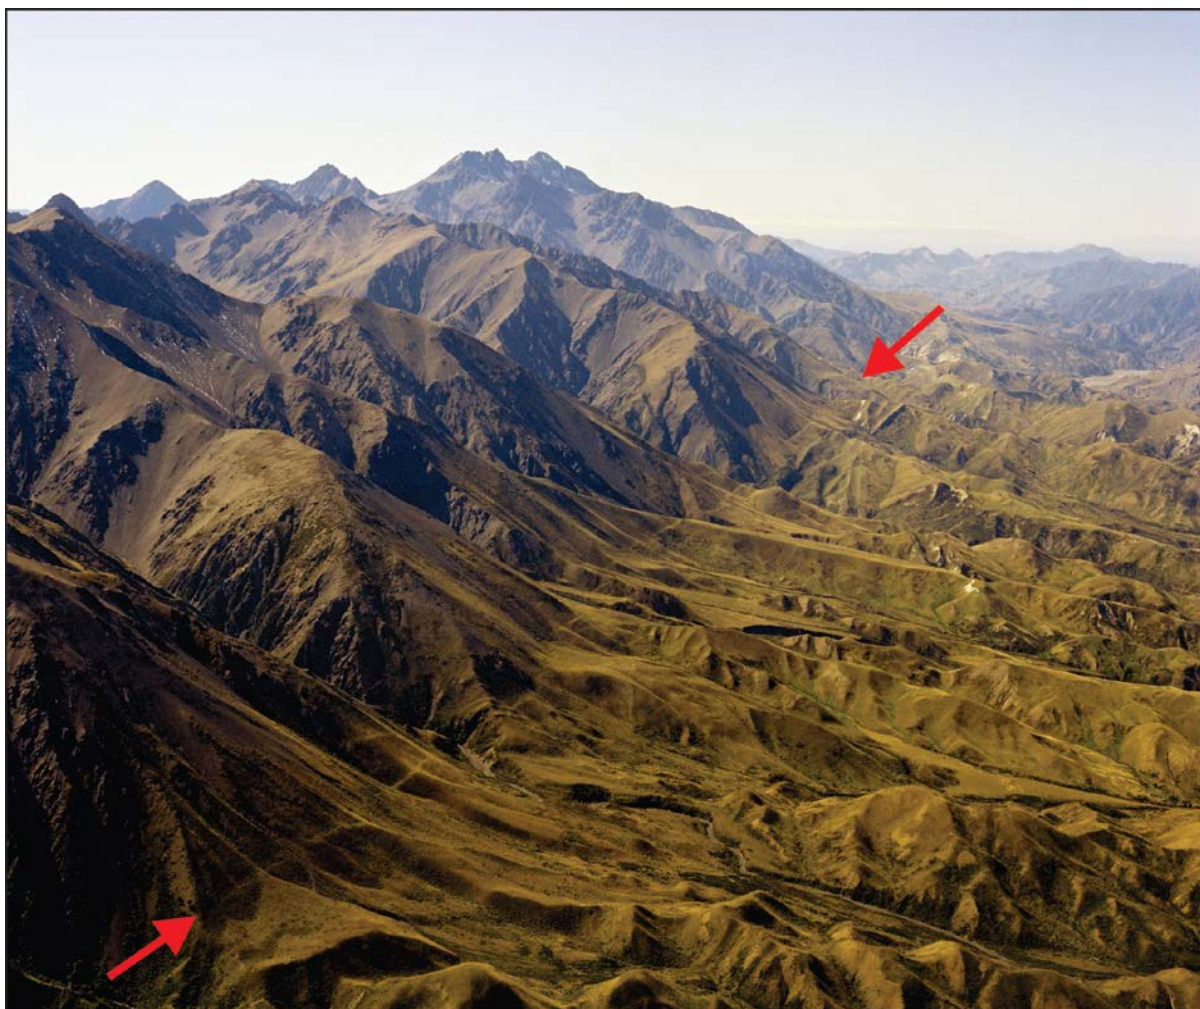
**Figure 9** A view northeast along the Clarence Fault, which lies at the southeastern foot of the Inland Kaikoura Range (at left). Red arrows highlight light-coloured linear features running along the foot of the range. These features are the surface offset scarps of the Clarence Fault. Cover rocks underlie the basin floor southeast (lower right) from the fault, whereas basement rock has been uplifted to form the Inland Kaikoura Range, and its former blanket of cover rocks has been stripped off by erosion. In the foreground from centre left to bottom right is Red Hut Stream, which forms the southwestern boundary of Kaikoura District at this location (i.e., the bottom left of the photo is outside the Kaikoura District). Mt Alarm and Tapuae-o-Uenuku, both a little over 2800 m above sea level, are the highest peaks. Photo: D.L. Homer, GNS Science CN4938/5.

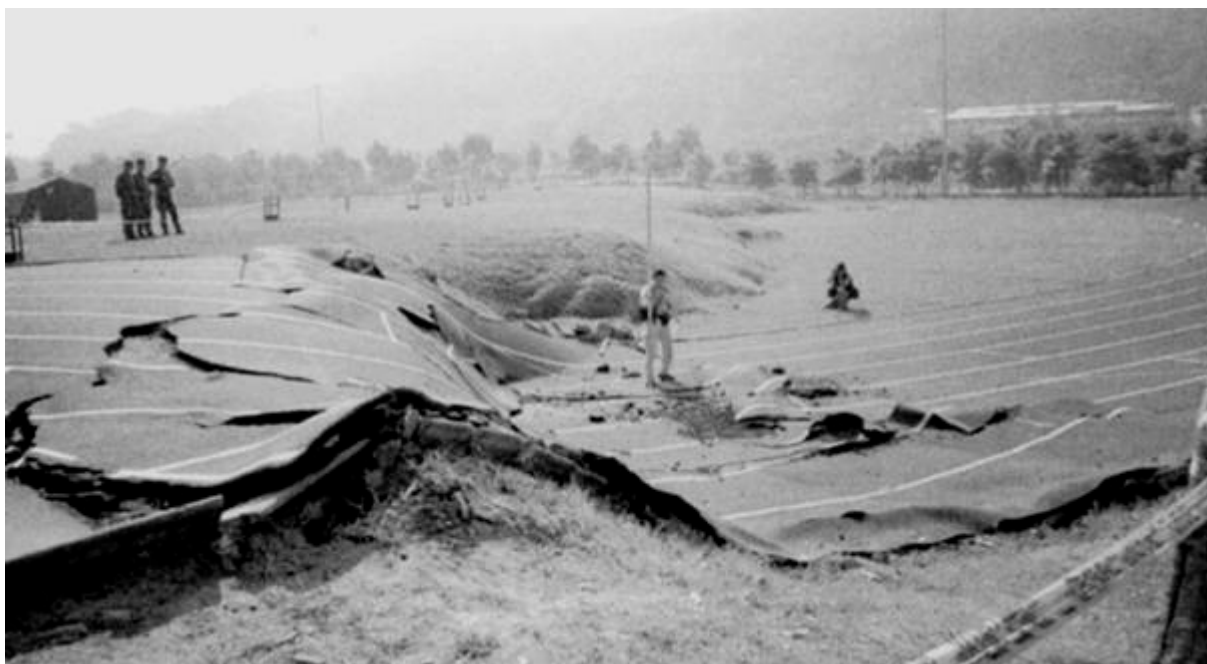
**Figure 10** Fault scarp formed on the Chelungpu Fault during the magnitude 7.6 Chi-Chi Earthquake, Taiwan, 1999. The disrupted running track shows damage typical of a reverse fault ground-surface rupture, which is well expressed on the brittle surface (note the smoother rupture across grass behind). This location lies on a stream terrace that is younger than the previous rupture event on the fault, so that there was no scarp here before the earthquake. This example illustrates the sorts of effects that can be expected across fault scarps in the Kaikoura District the next time any particular fault experiences a surface rupture earthquake. Photo from Kelson et al. (2001).
