**General distribution and characteristics of active  
faults and folds in the Kaikoura District, North  
Canterbury**

D. J. A. Barrell

**GNS Science Consultancy Report 2014/210**

**Environment Canterbury Report No. R15/23**

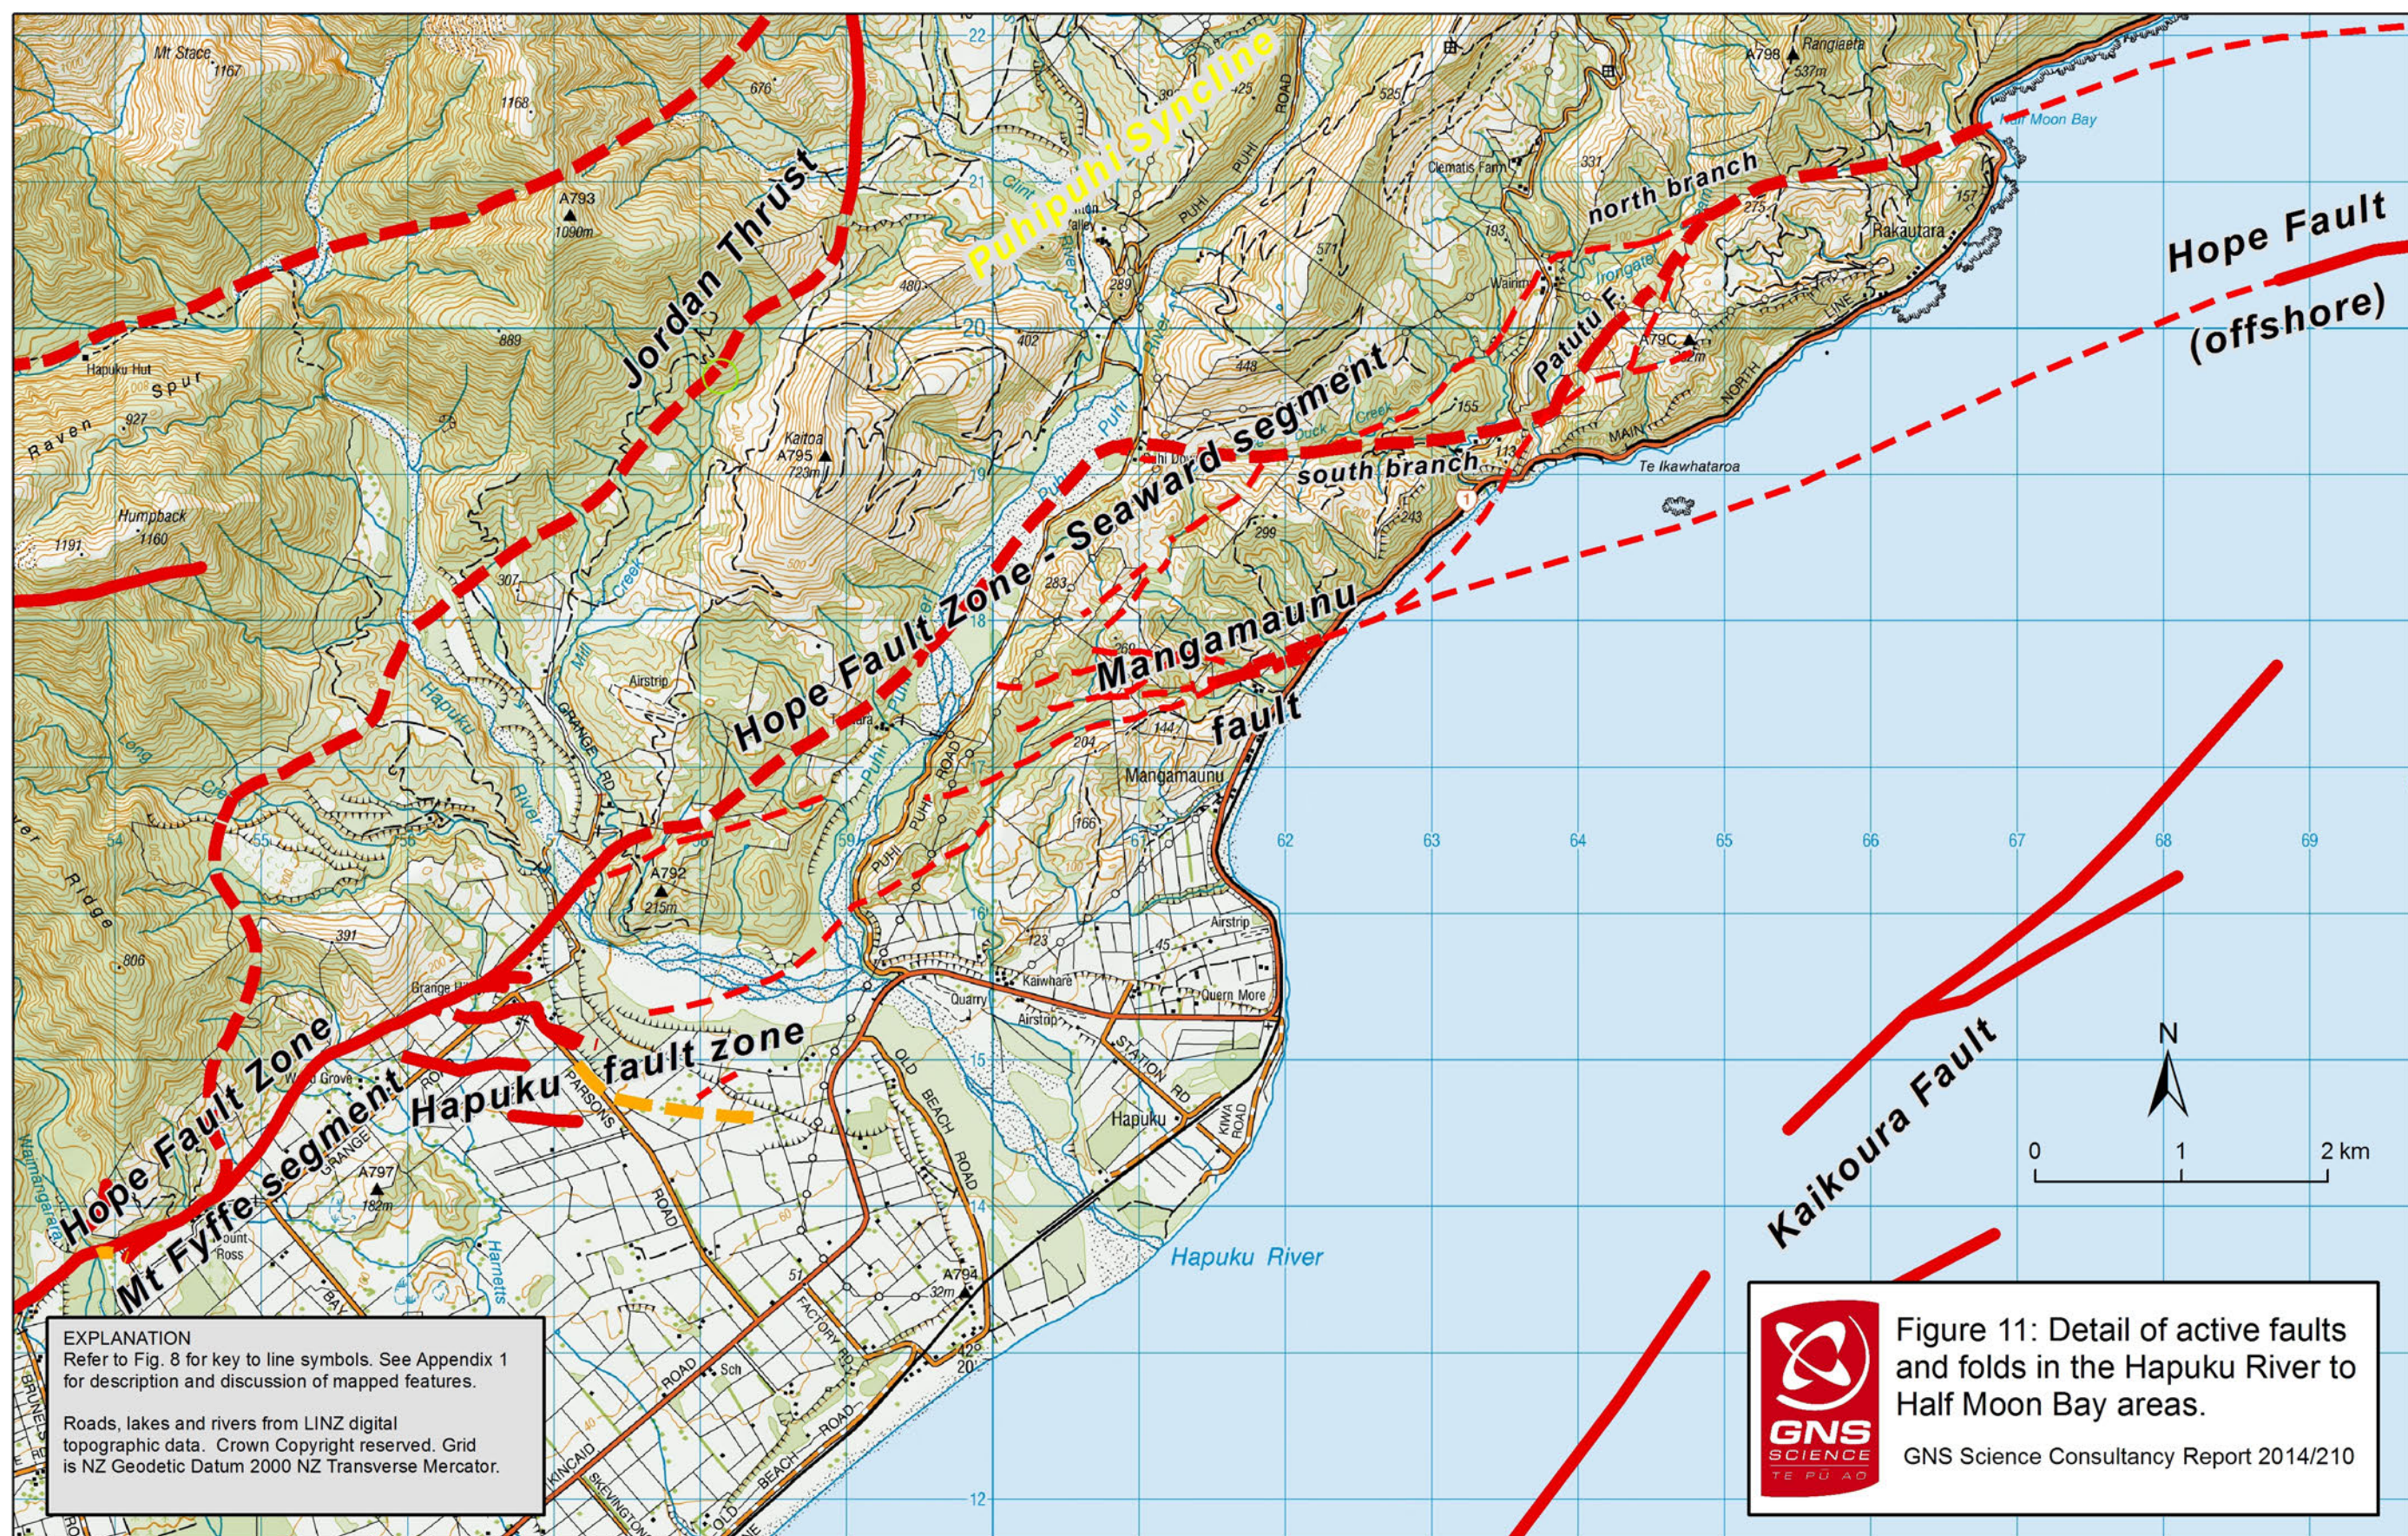
**Figure 11** Detail of active faults and folds in the Hapuku River to Half Moon Bay areas.

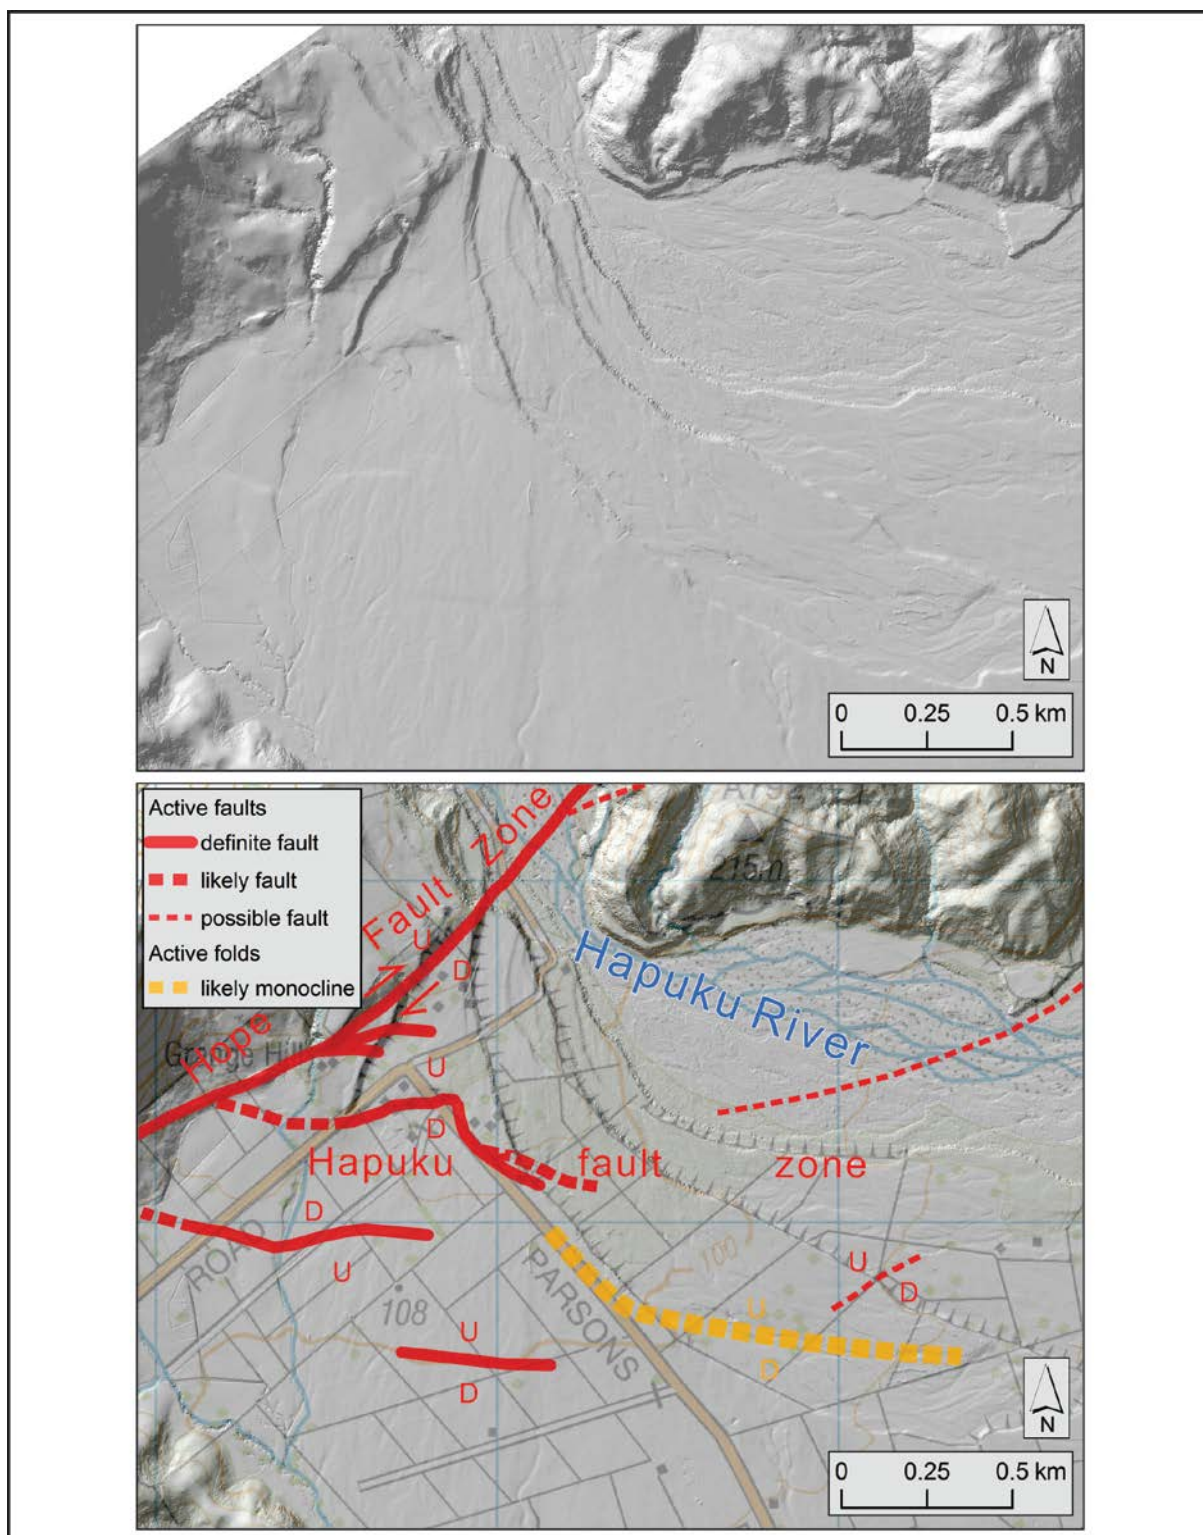
**Figure 12** A lidar DEM with hillshade effect showing the area near the junctions of Grange Road (left) and Parsons Road, near the intersection of the Hapuku fault zone and the Hope Fault Zone. The lower image shows a topographic location map (NZ Topo50) draped on the DEM, and the active fault and fold interpretation plotted from the database accompanying this report.

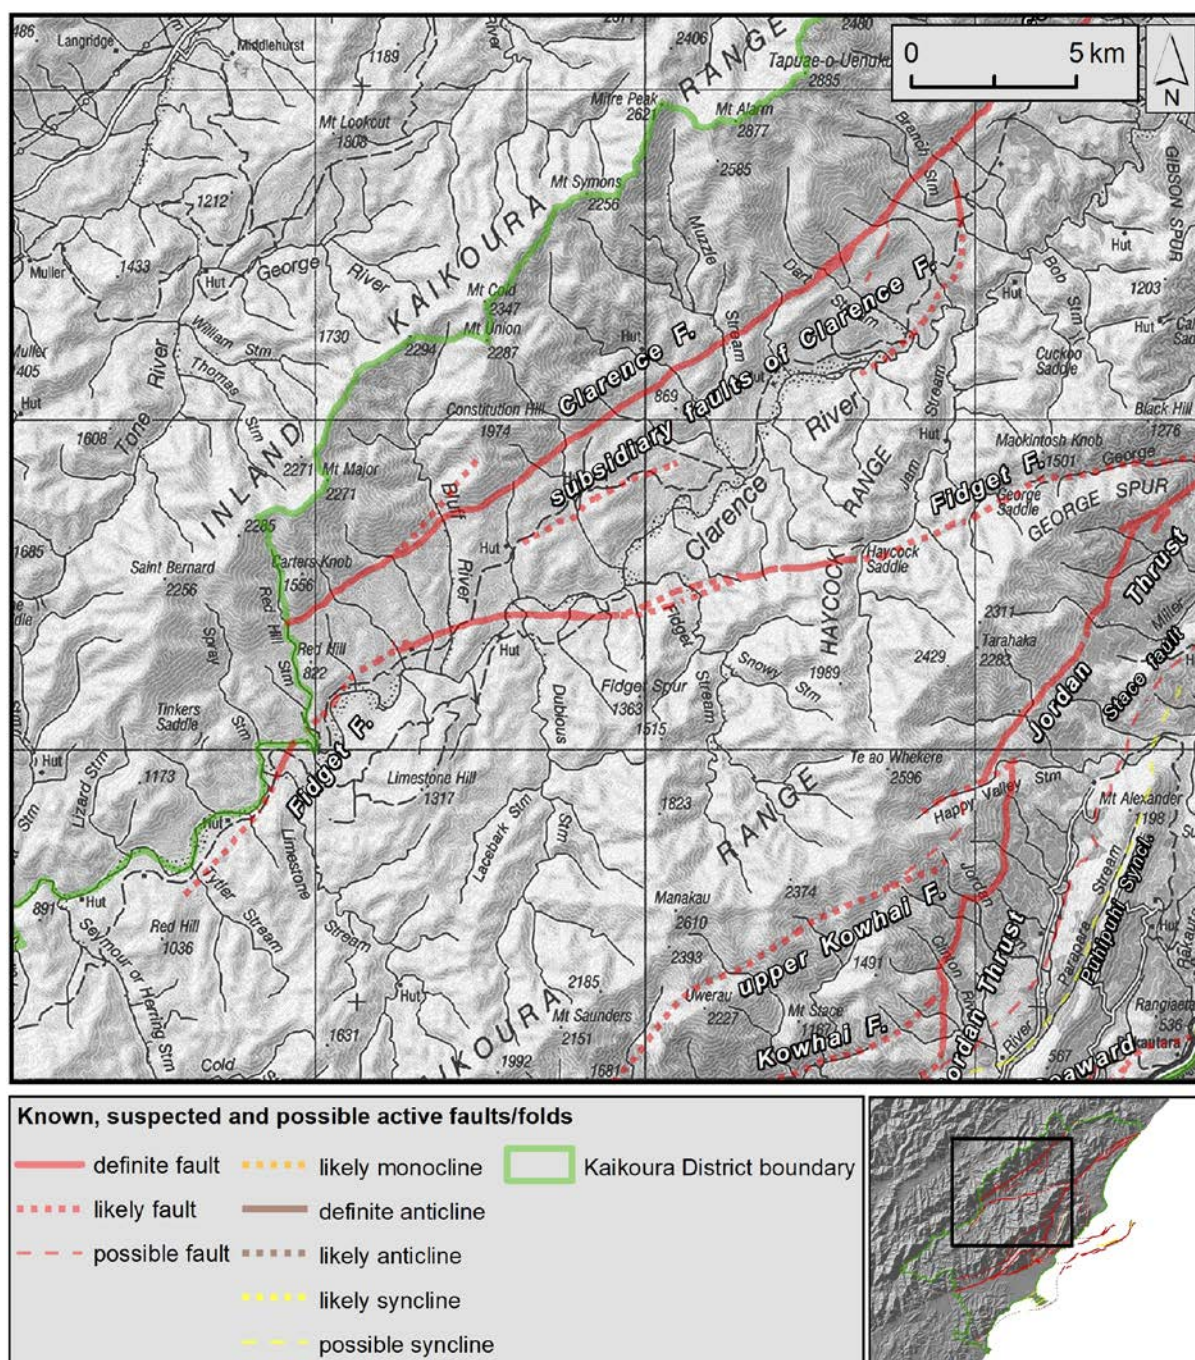
**Figure A2-1a** The known, suspected and possible active faults/folds of the northwestern sector of the Kaikoura District plotted on a greyscale version of topographic map NZTopo 250 (Land Information NZ, Crown Copyright reserved). The map area is shown in the context of the Kaikoura District in the index map at lower right. Fault or fold entities that consist only of 'possible' features are labelled in smaller font than fault or fold entities that include 'definite' or 'likely' features.

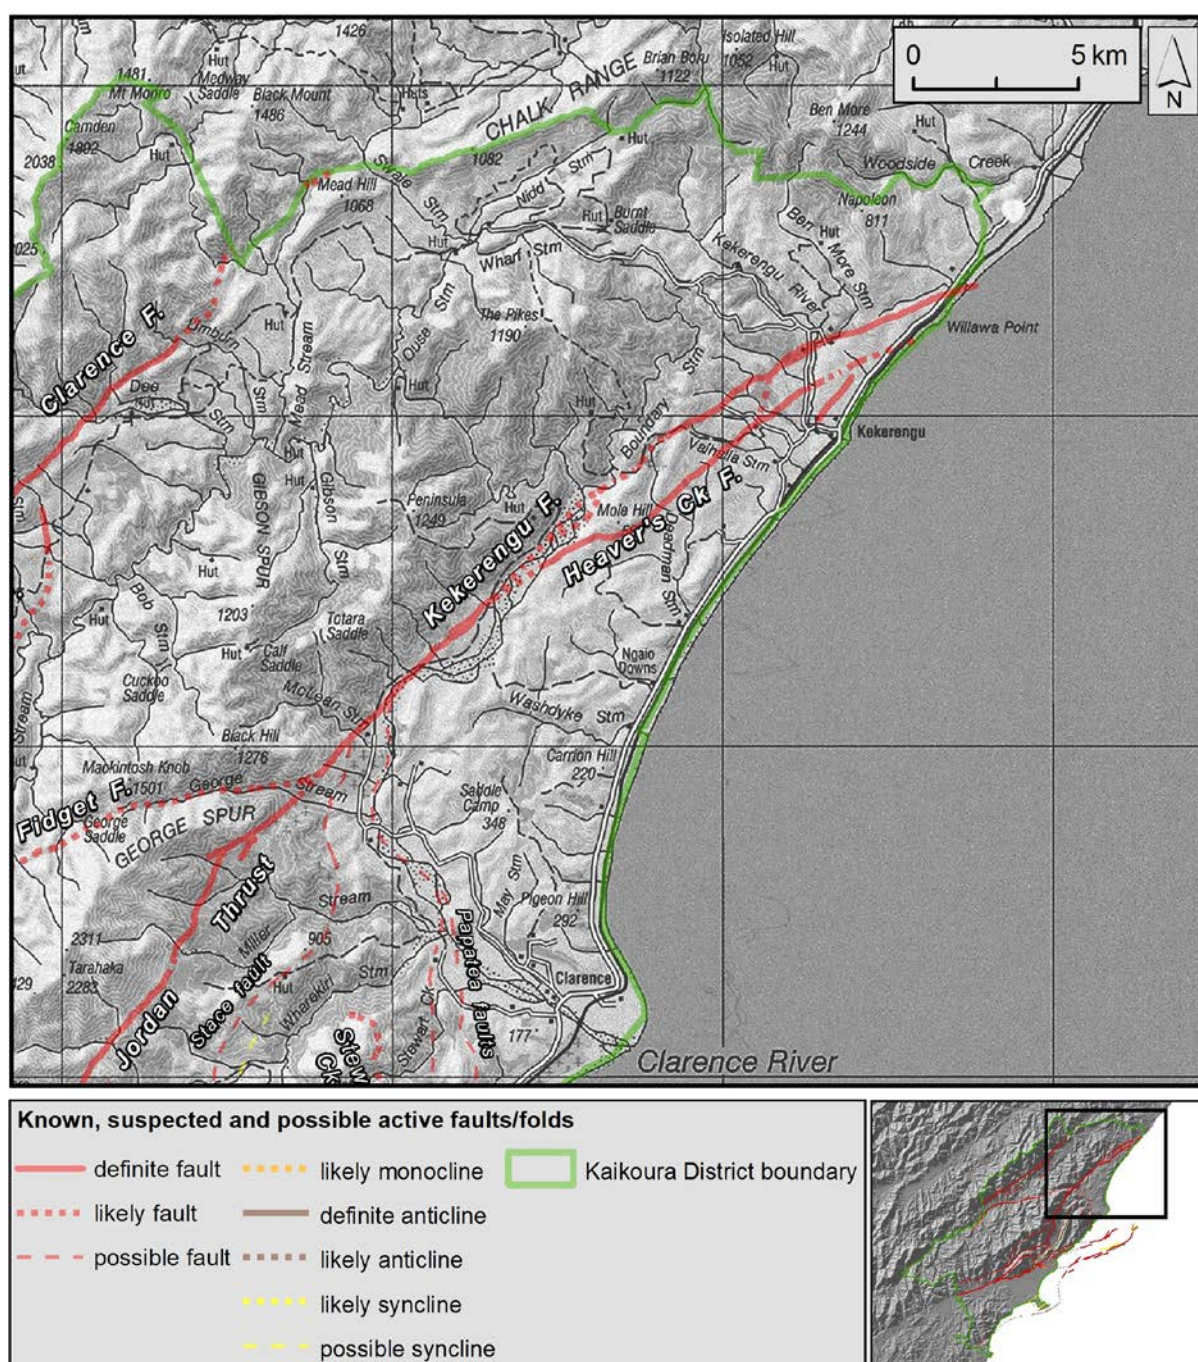
**Figure A2-1b** The known, suspected and possible active faults/folds of the northeastern sector of the Kaikoura District plotted on a greyscale version of topographic map NZTopo 250 (Land Information NZ, Crown Copyright reserved). The map area is shown in the context of the Kaikoura District in the index map at lower right. Fault or fold entities that consist only of 'possible' features are labelled in smaller font than fault or fold entities that include 'definite' or 'likely' features.

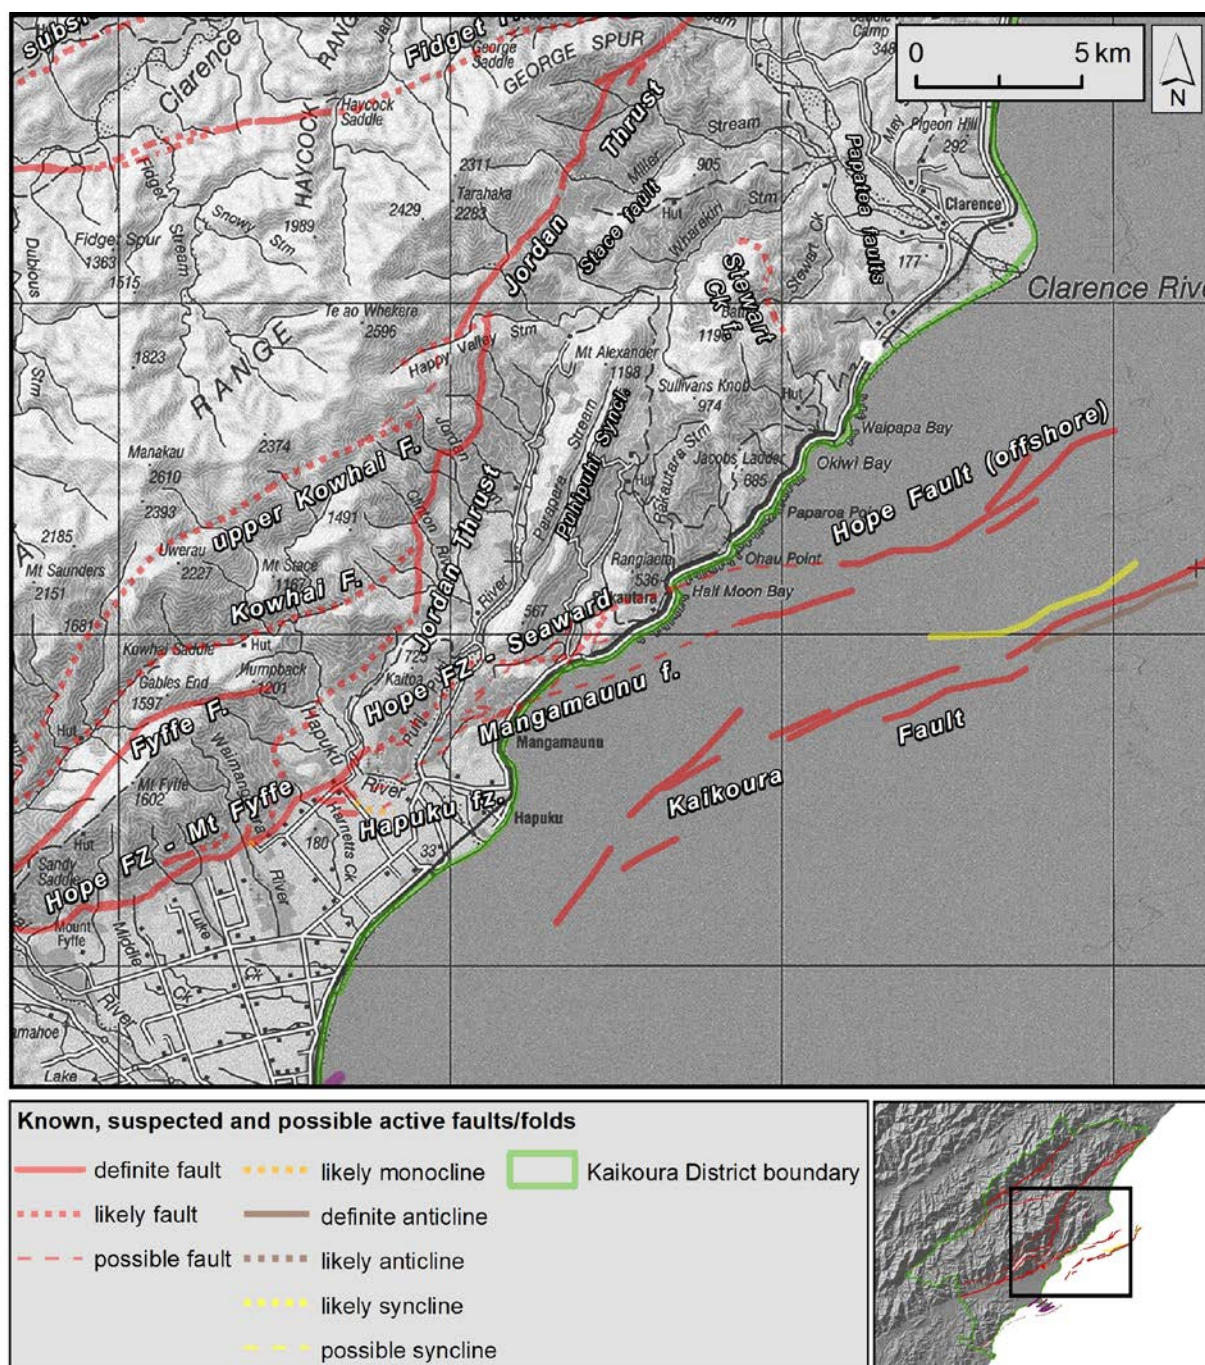
**Figure A2-1c** The known, suspected and possible active faults/folds of the southwestern sector of the Kaikoura District plotted on a greyscale version of topographic map NZTopo 250 (Land Information NZ, Crown Copyright reserved). The map area is shown in the context of the Kaikoura District in the index map at lower right. Fault or fold entities that consist only of 'possible' features are labelled in smaller font than fault or fold entities that include 'definite' or 'likely' features.

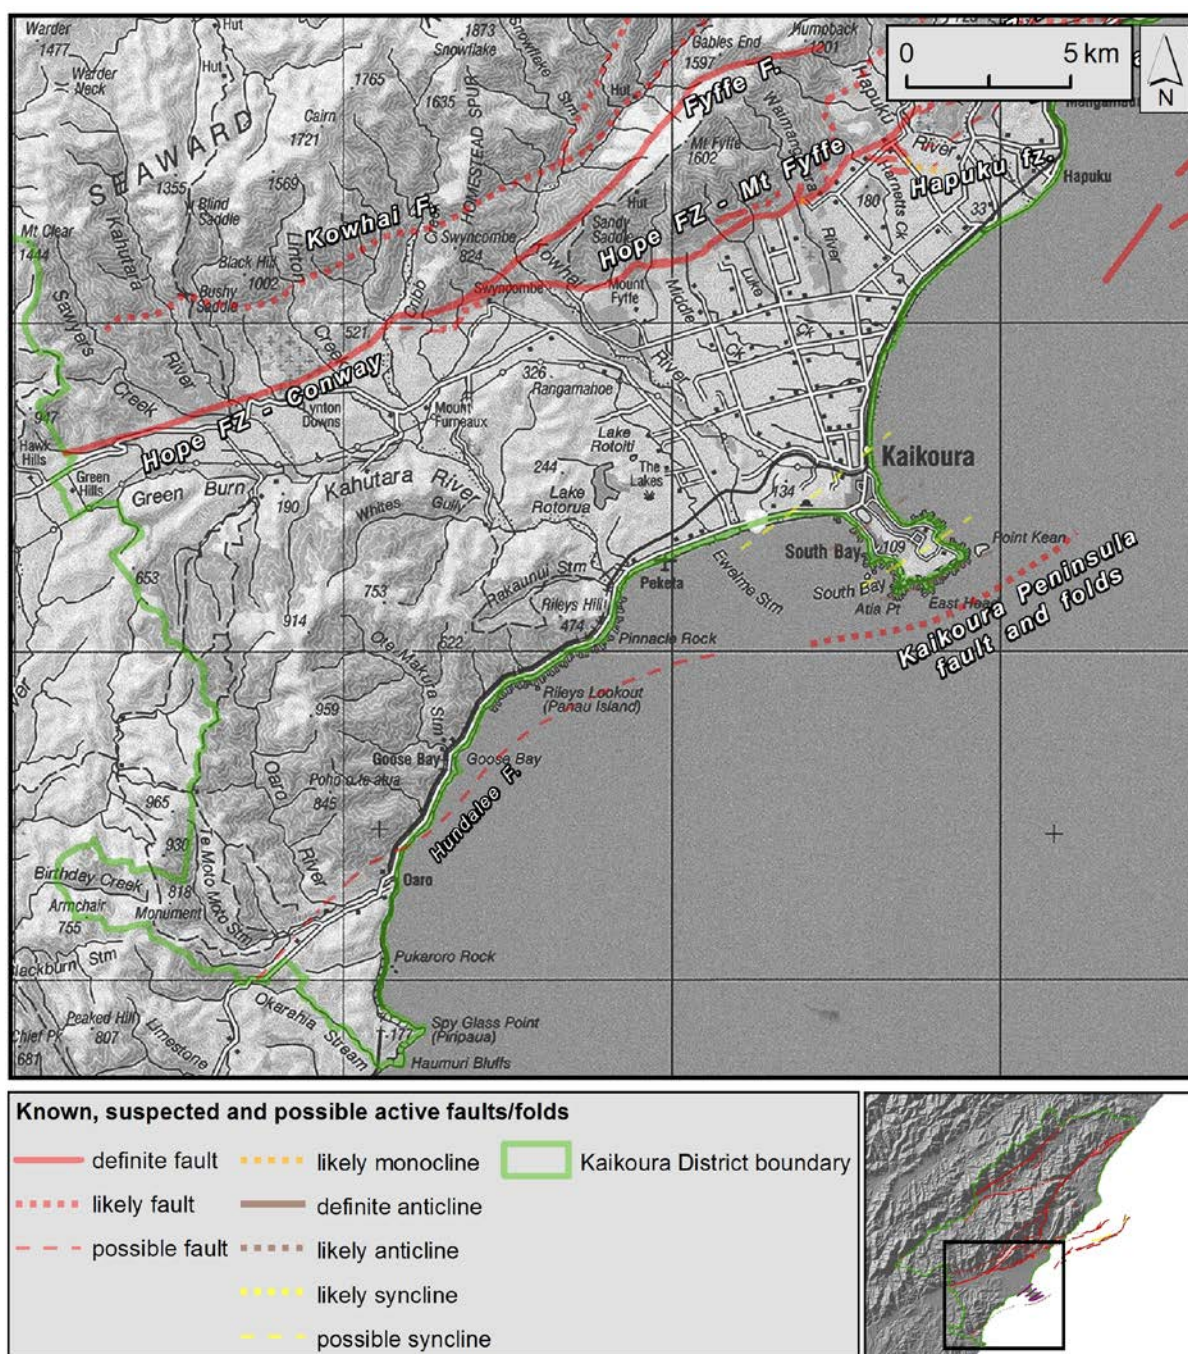
**Figure A2-1d** The known, suspected and possible active faults/folds of the eastern sector of the Kaikoura District plotted on a greyscale version of topographic map NZTopo 250 (Land Information NZ, Crown Copyright reserved). The map area is shown in the context of the Kaikoura District in the index map at lower right. Fault or fold entities that consist only of 'possible' features are labelled in smaller font than fault or fold entities that include 'definite' or 'likely' features.
