FLOOD HAZARD ASSESSMENT – Lot 20 DP 578956 & Lot 2 DP 501321, SH1/Inland Road, KAIKOURA

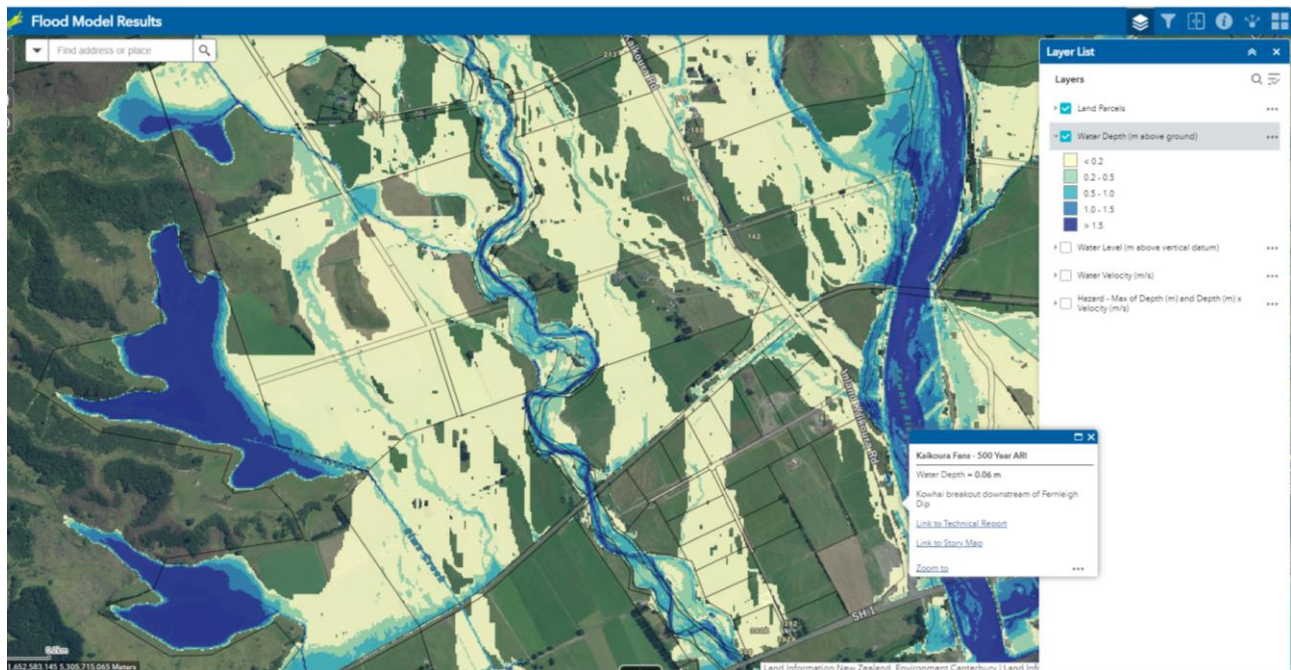
The map below shows the 500 year ARI maximum flood depths for a Kowhai breakout downstream of Fernleigh Dip.

- Shallow flood depths of up to ~0.3 m at the property (in the area within ~40 m of the eastern boundary). These modelled flood depths do not account for local surface water runoff or backing up of water against barriers (e.g., buildings).
- The property is not likely to be considered a High Flood Hazard Area [where the water depth (m) x velocity (m/s) is greater than or equal to 1 or where depths are greater than 1 m in a 500 year ARI flood event] unless Kowhai River bank erosion is able to migrate the Kowhai Riverbed to the west and onto the property.
- Evacuation from the property may not be possible during a flood event due to flooding in the vicinity of the property (e.g., Inland Road).
- Flood water flowing over the property may cause scour, erosion and/or deposition of debris, resulting in damage to land and fencing.

Based on the available flood information above, the property is outside of any High Flood Hazard Area and is not likely to be affected by significant flooding in a 500 year ARI event, as the property is only likely to receive limited overflows from breakouts upslope from the property.
