GEOTECHNICAL INVESTIGATION REPORT

FOR PROPOSED LAND USE CHANGE

69 Inland Kaikoura Road, Kaikoura

Project Reference: LTC22138

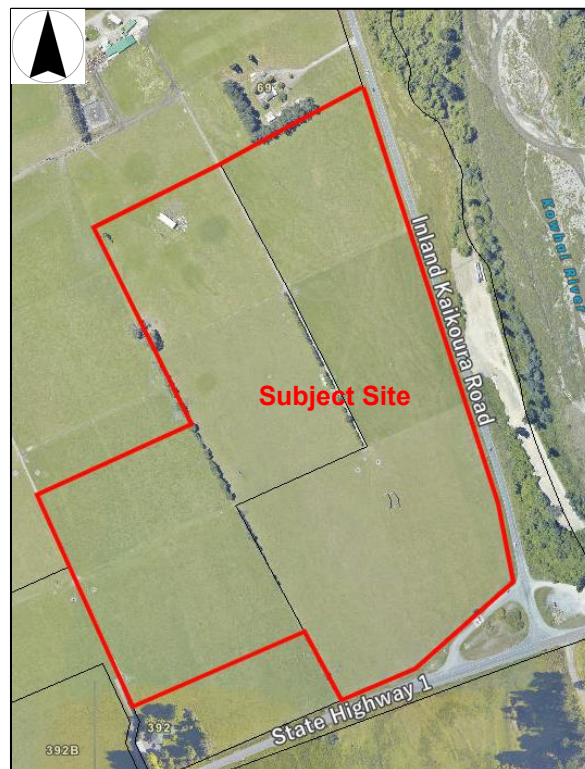
Figure 1: Aerial photograph of investigation site

(Source: Canterbury Maps image captured 16 June 2022)

The site is located at 69 Inland Kaikoura Road, Kaikoura and is legally described as Lot 2 Deposited Plan 501321 and part of lot 2 Deposited Plan 527436 with a combined area of approximately 21.5ha according to LINZ¹. The site is shown on the LandTech *Test Location Plan*, Drawing No. LTC22138 / 1 (attached in Appendix A) and Figure 1 (below).

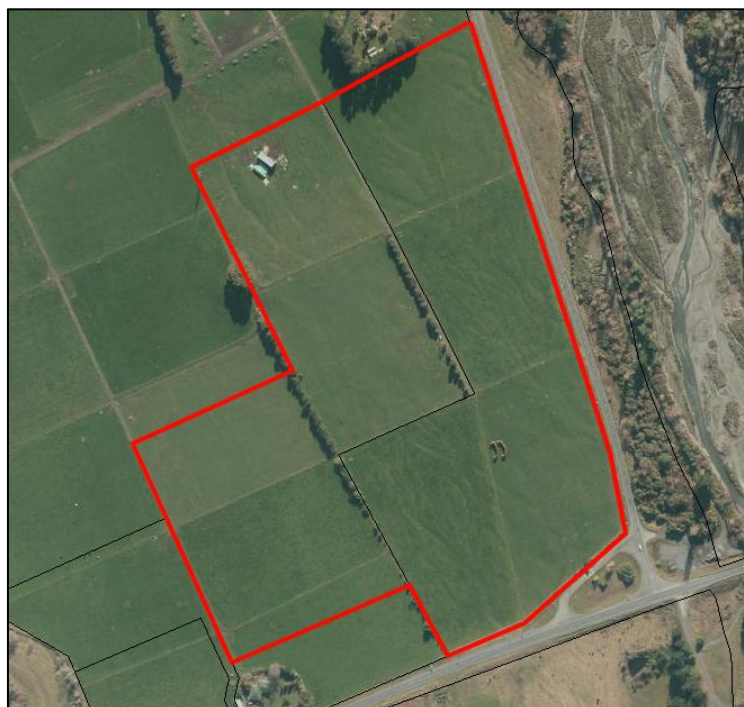
Figure 4: Aerial photograph of the site from the 1990–1994 image set.

(source: <https://mapviewer.canterburymaps.govt.nz/>, accessed 16 June 2022)

- A review of historical photograph of the site from between 1960 and 2014 has been carried out on Canterbury Maps. Imagery from 2010-2014 (shown below in Figure 4), shows evidence of braided historic river channels through the site. Some historic infilling of these river channels could have taken place as part of farming activities. However, our investigation found limited evidence of filling having taken place across the general site.

Overall, the review of the historic images showed little obvious change in the landscape, with farmland and river occupying the same areas throughout this time period.

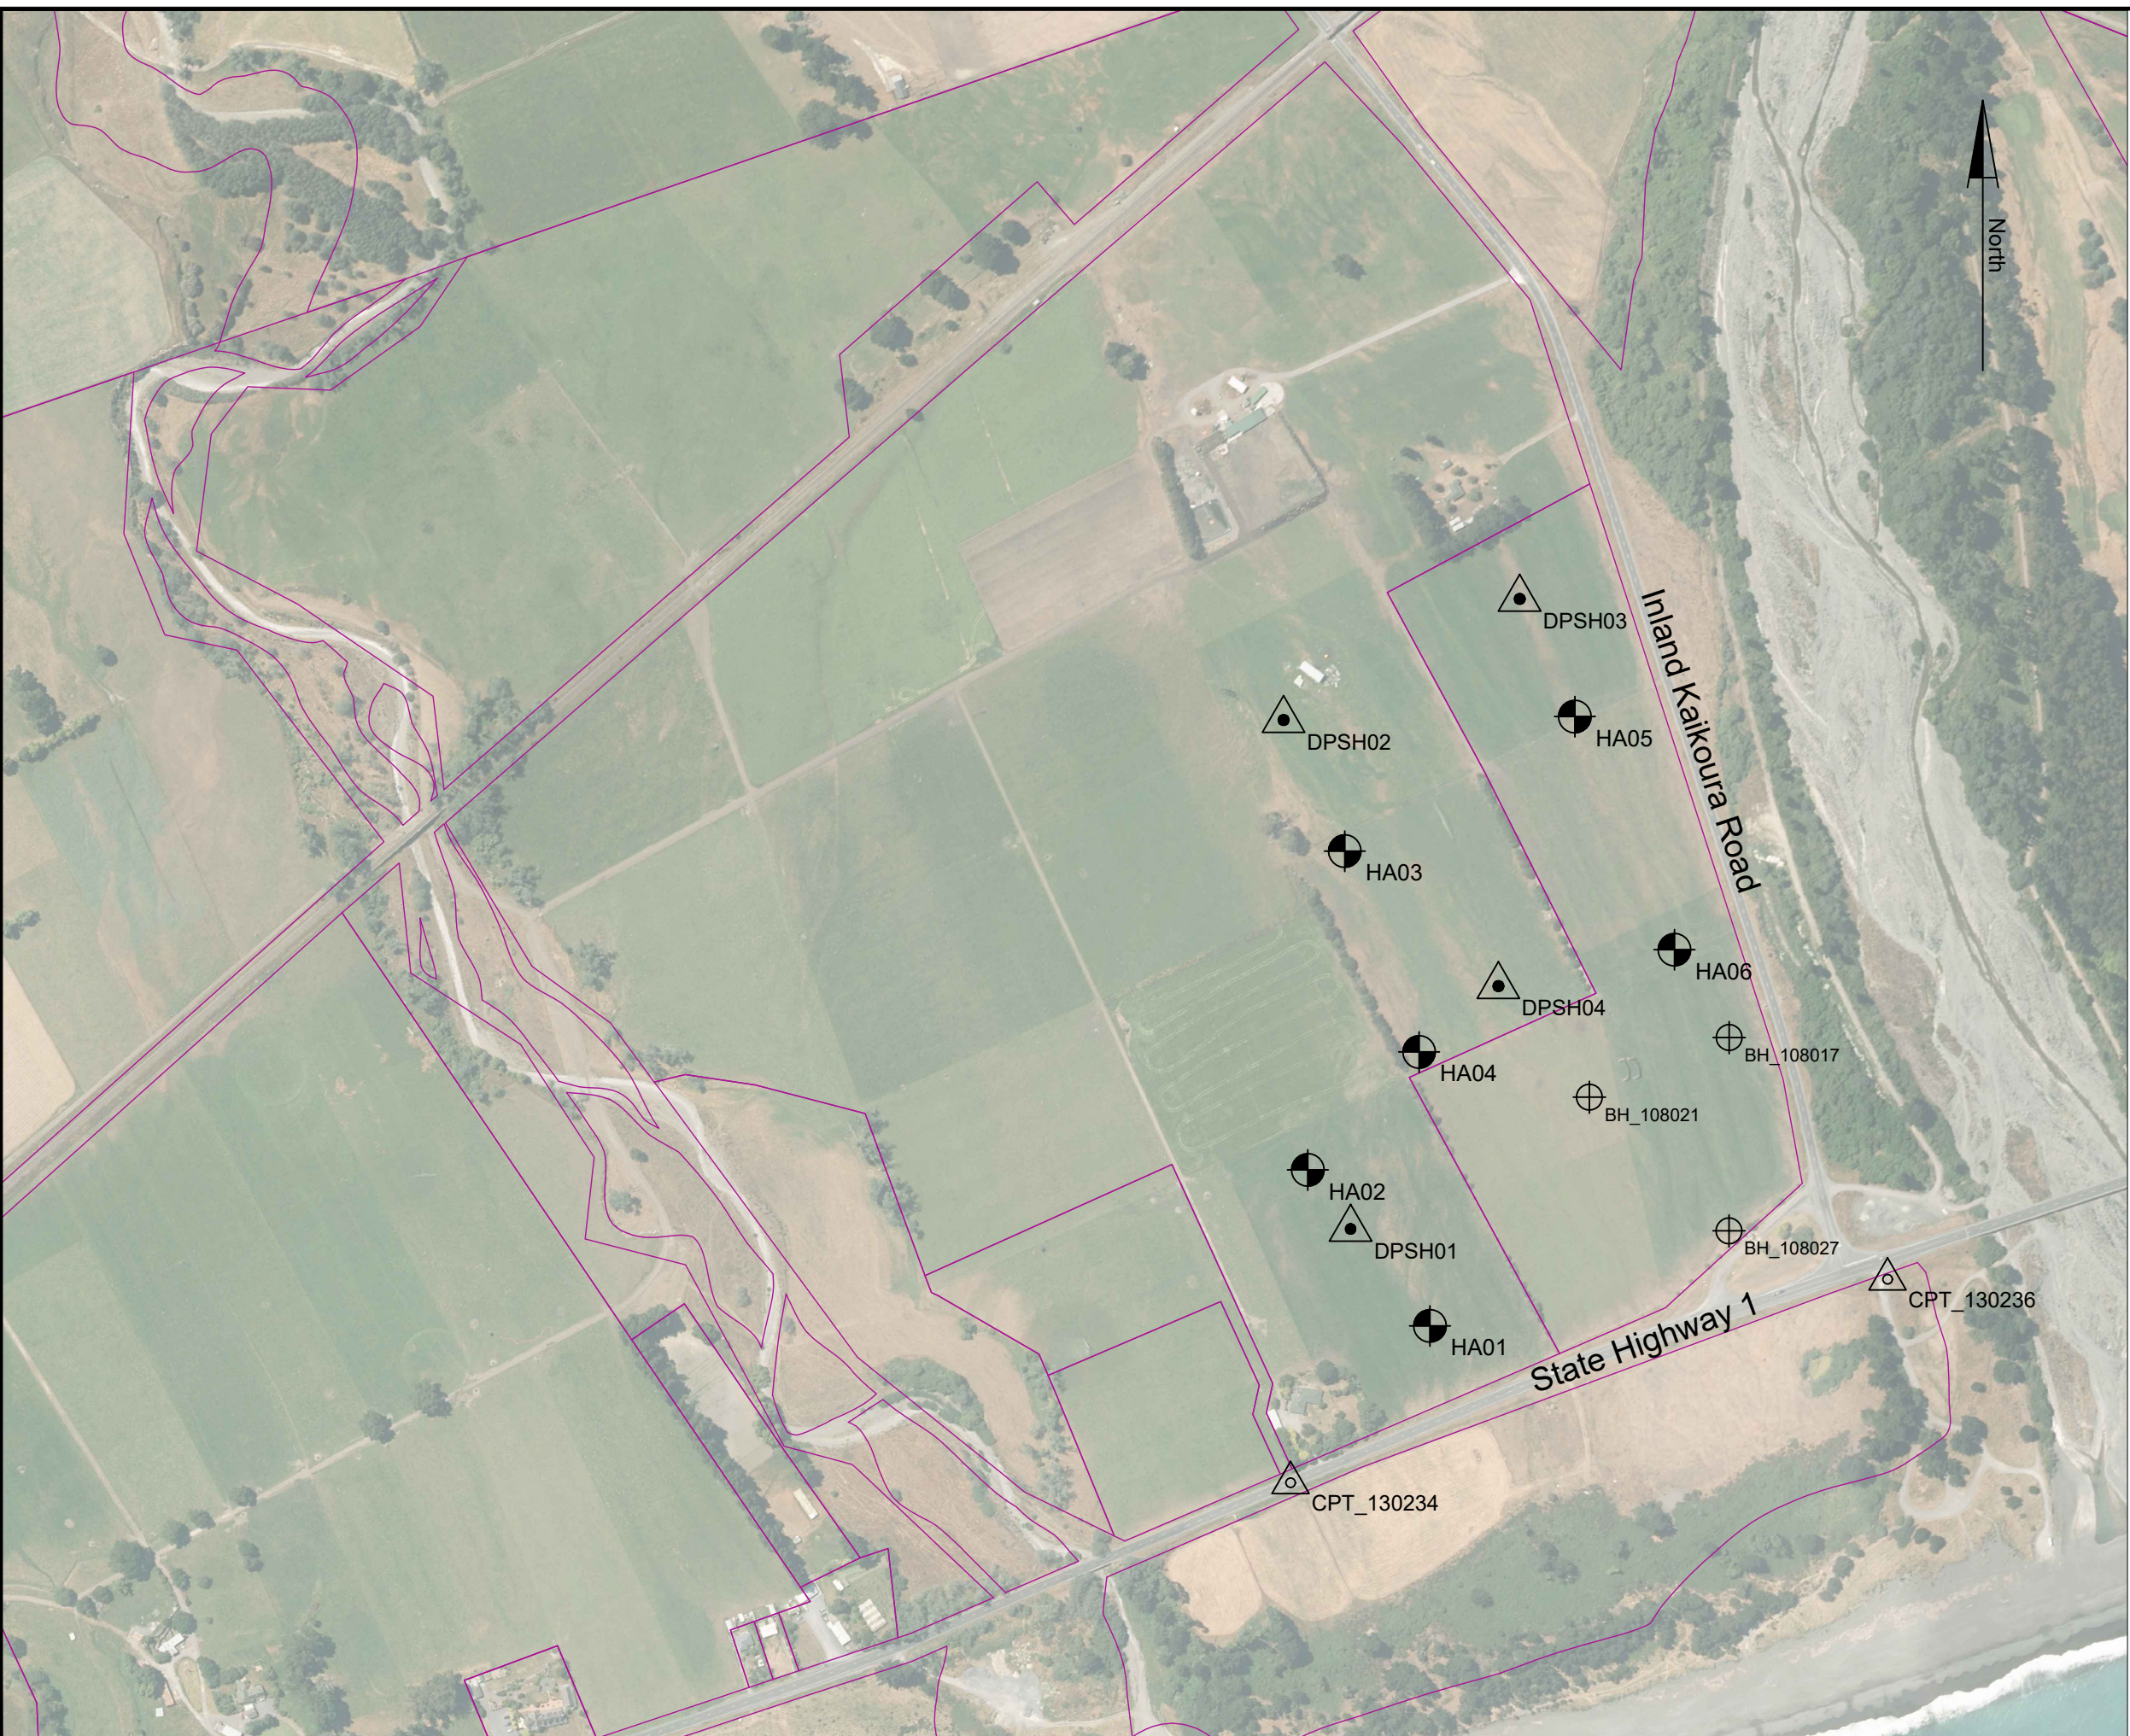
- KEY:**
- HA01 LandTech Consulting Ltd. augerhole locations, drilled 31 May 2022
 - DPSH01 LandTech Consulting Ltd. DPSH test locations, tested 31 May 2022
 - BH01 PDP machine borehole location, drilled July 2017
 - CPT01 Geotechnics CPT test locations, tested 10 September 2017
 - Existing boundary

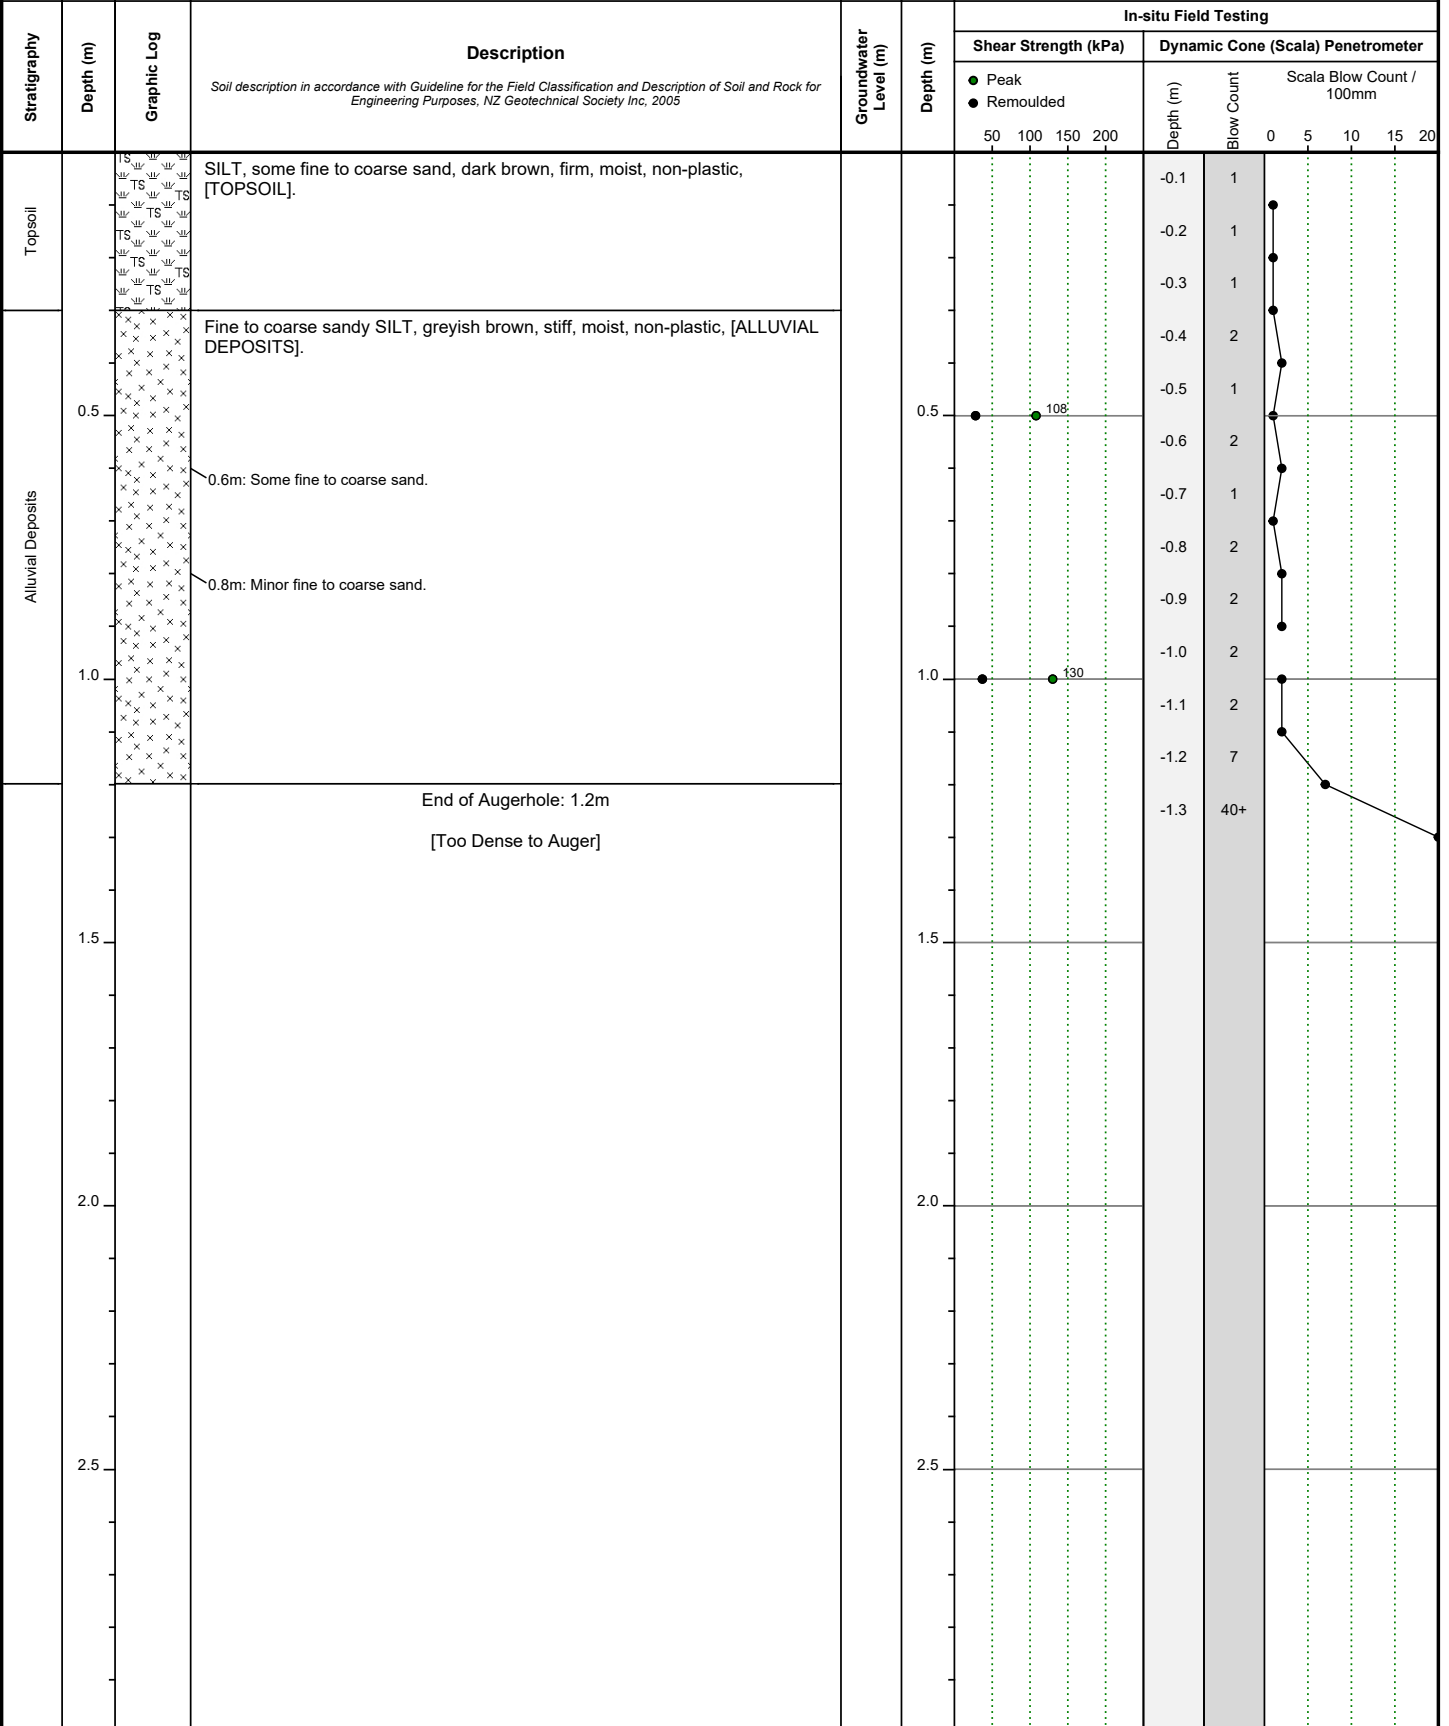
Project No.: LTC22138 **Coordinates:** NZTM2000: E1651435.78, N5303878.75 **Logged By:** CN
Drill Type: 50mm Hand Auger **Reduced Level:** 10.20m (NZVD2016) **Shear Vane No.:** 1999
Date Started: 31-May-22 **Ground Conditions:** Near Level, Grass **Calibration Factor:** 1.447
Date Finished: 31-May-22 **Groundwater Level (m):** Not Encountered **Calibration Date:** 20-Apr-22

Too dense to auger due to inferred gravel

In-situ testing in accordance with the following standards:
 Scala Penetrometer Testing: NZS 4402:1988, Test 6.5.2, Dynamic Cone Penetrometer
 Shear Vane Testing: Guideline for Hand Held Shear Vane Test, NZGS, August 2001

The soil conditions encountered within the hand auger holes were logged by LandTech technical staff³. The hand auger hole logs are attached in Appendix B, together with the results of the various tests undertaken, including the groundwater conditions determined during the site investigation.

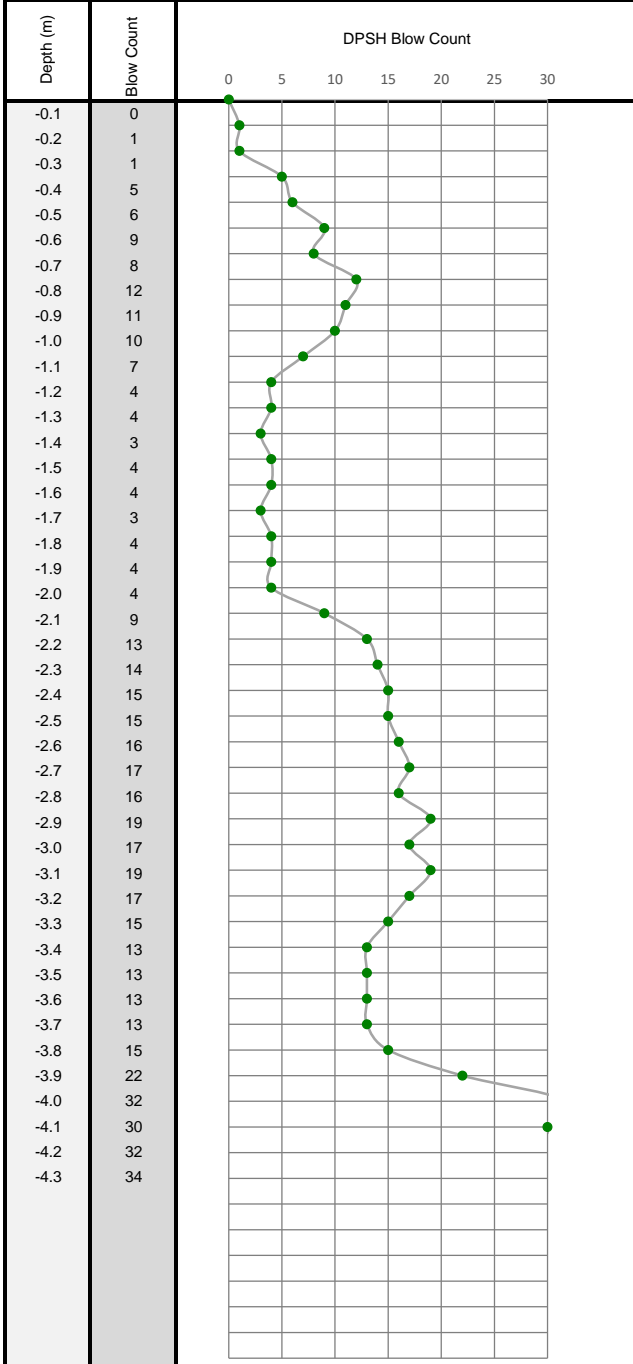
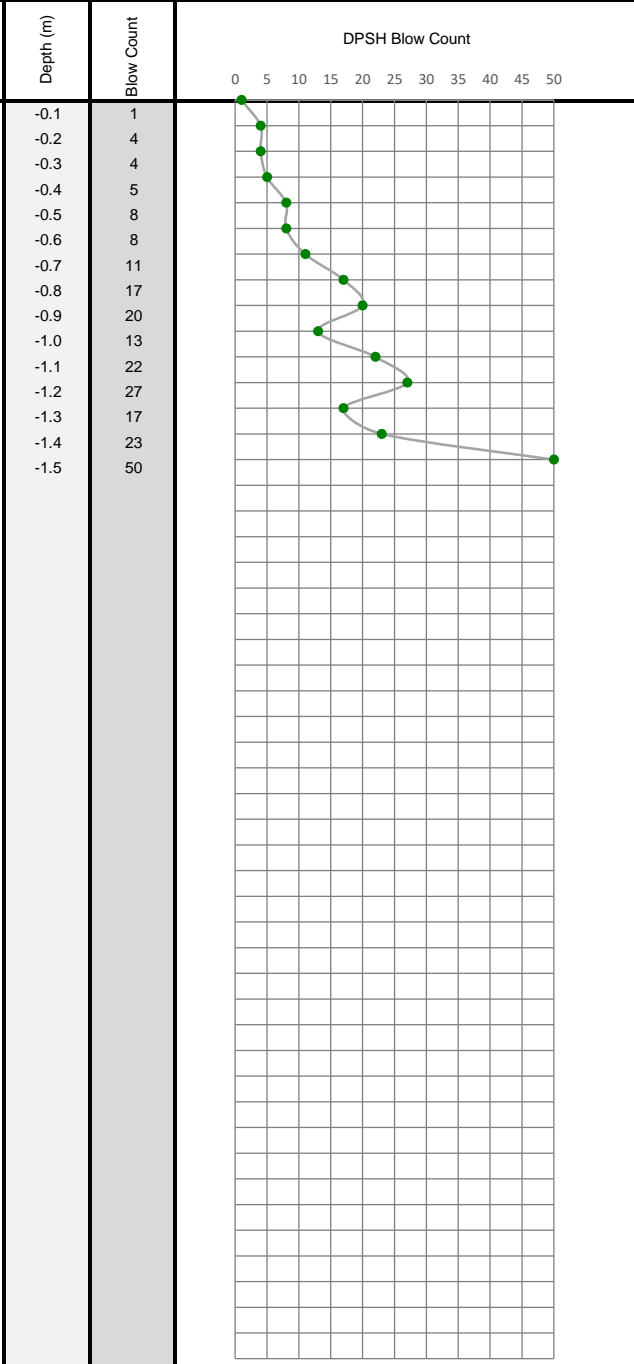
Test ID: DPSH01 Test ID: DPSH02
 Surface Condition: Near Level, Grass Surface Condition: Near Level, Grass

Test Type: Dynamic Probe Super Heavy Project No: LTC22138
 Tested By: CW & JM Test Date:

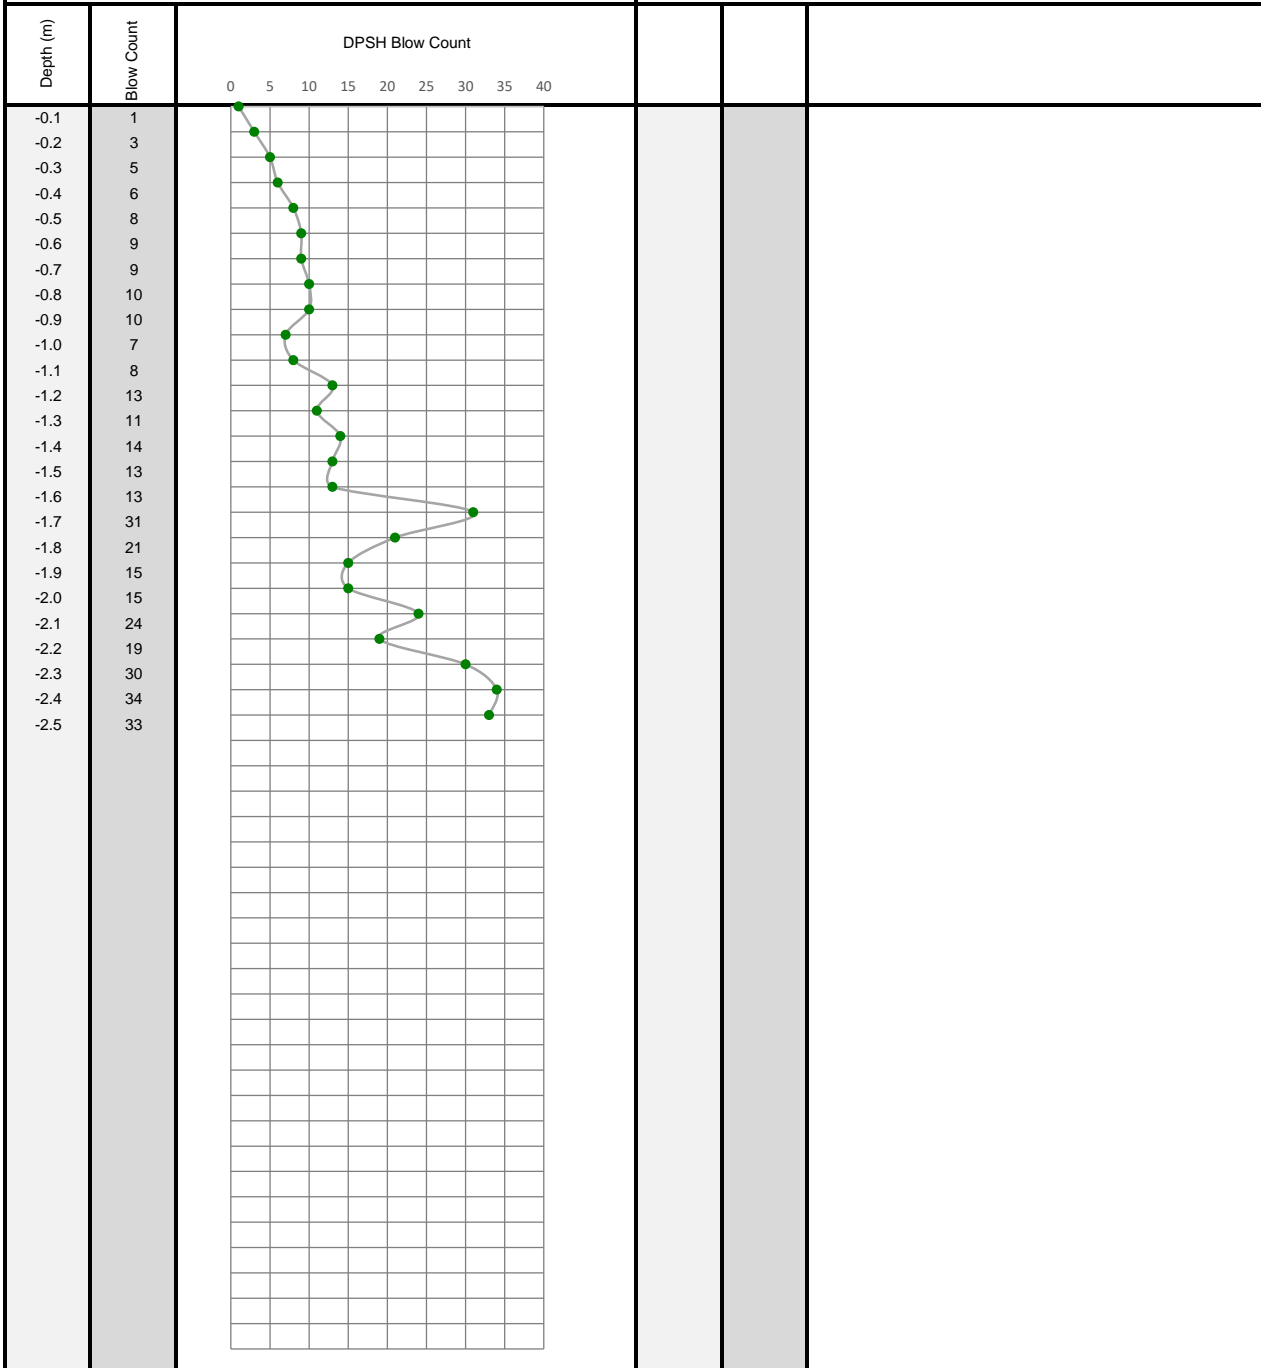
Test ID: DPSH04

Surface Condition: Near Level, Grass

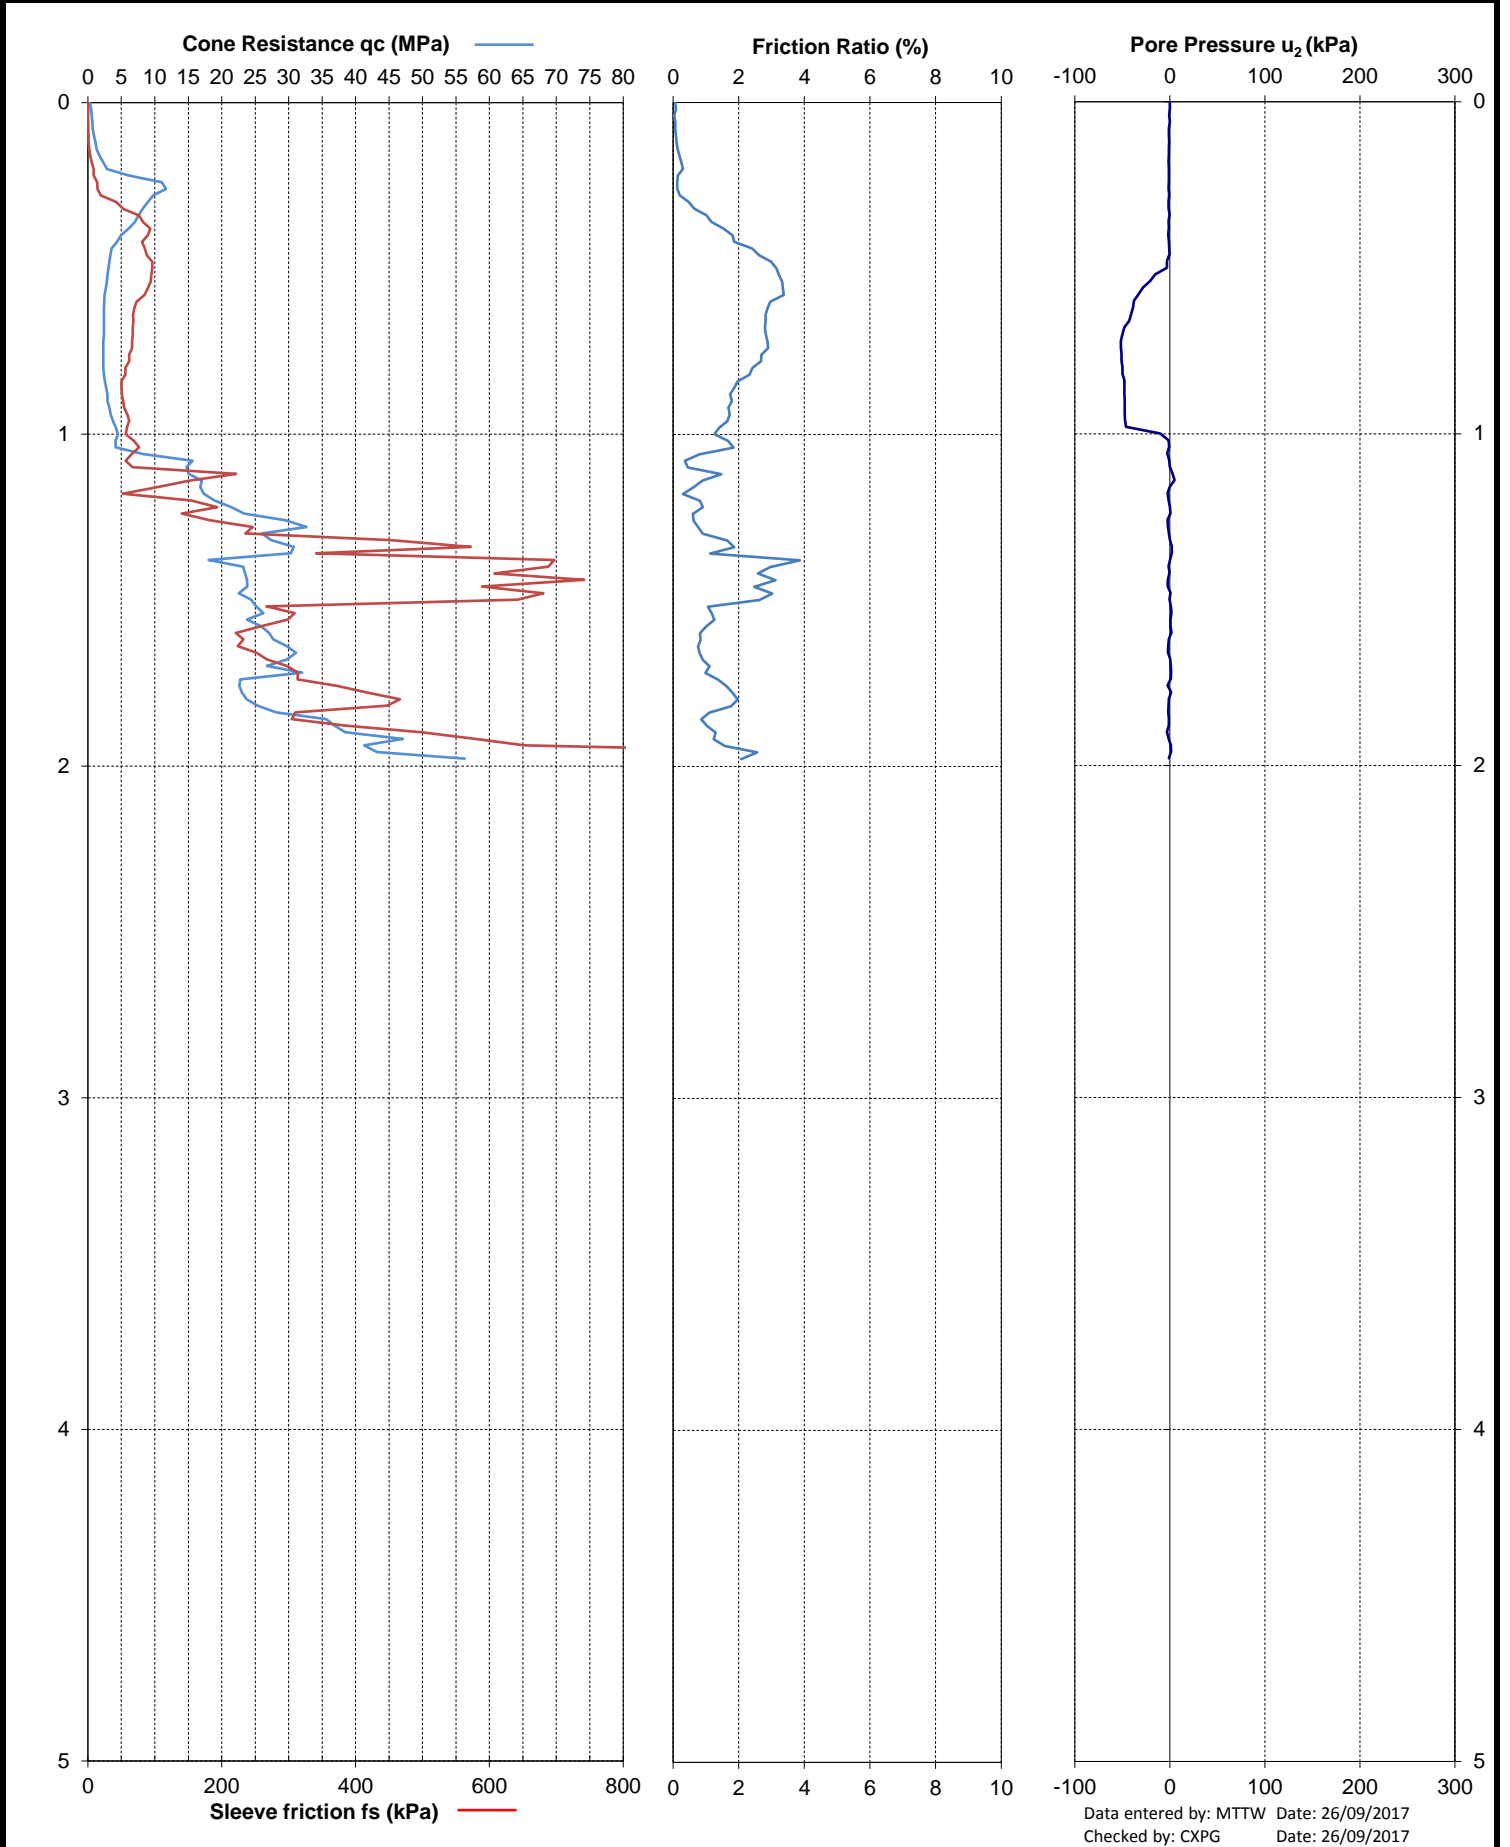
CPT012 Peketa - Kaikoura SH1 - 14 September, 2017

Pre-Drill: 0.2m **NZMG** 2561905mE 5865467mN 8m(amsl)
 Assumed GWL: Not encountered **Other Tests: None**
 Operator: MTTW **Comments:** Test refusal at 3.37m > 66Mpa
 Located By: Hand GPS/GE (el)
